ASBESTOS SAMPLING REPORT

**SAN PASQUAL VALLEY HIGH SCHOOL-OLD GYM
676 BASELINE ROAD
WINTERHAVEN, CALIFORNIA 92283**

AUGUST 27, 2024

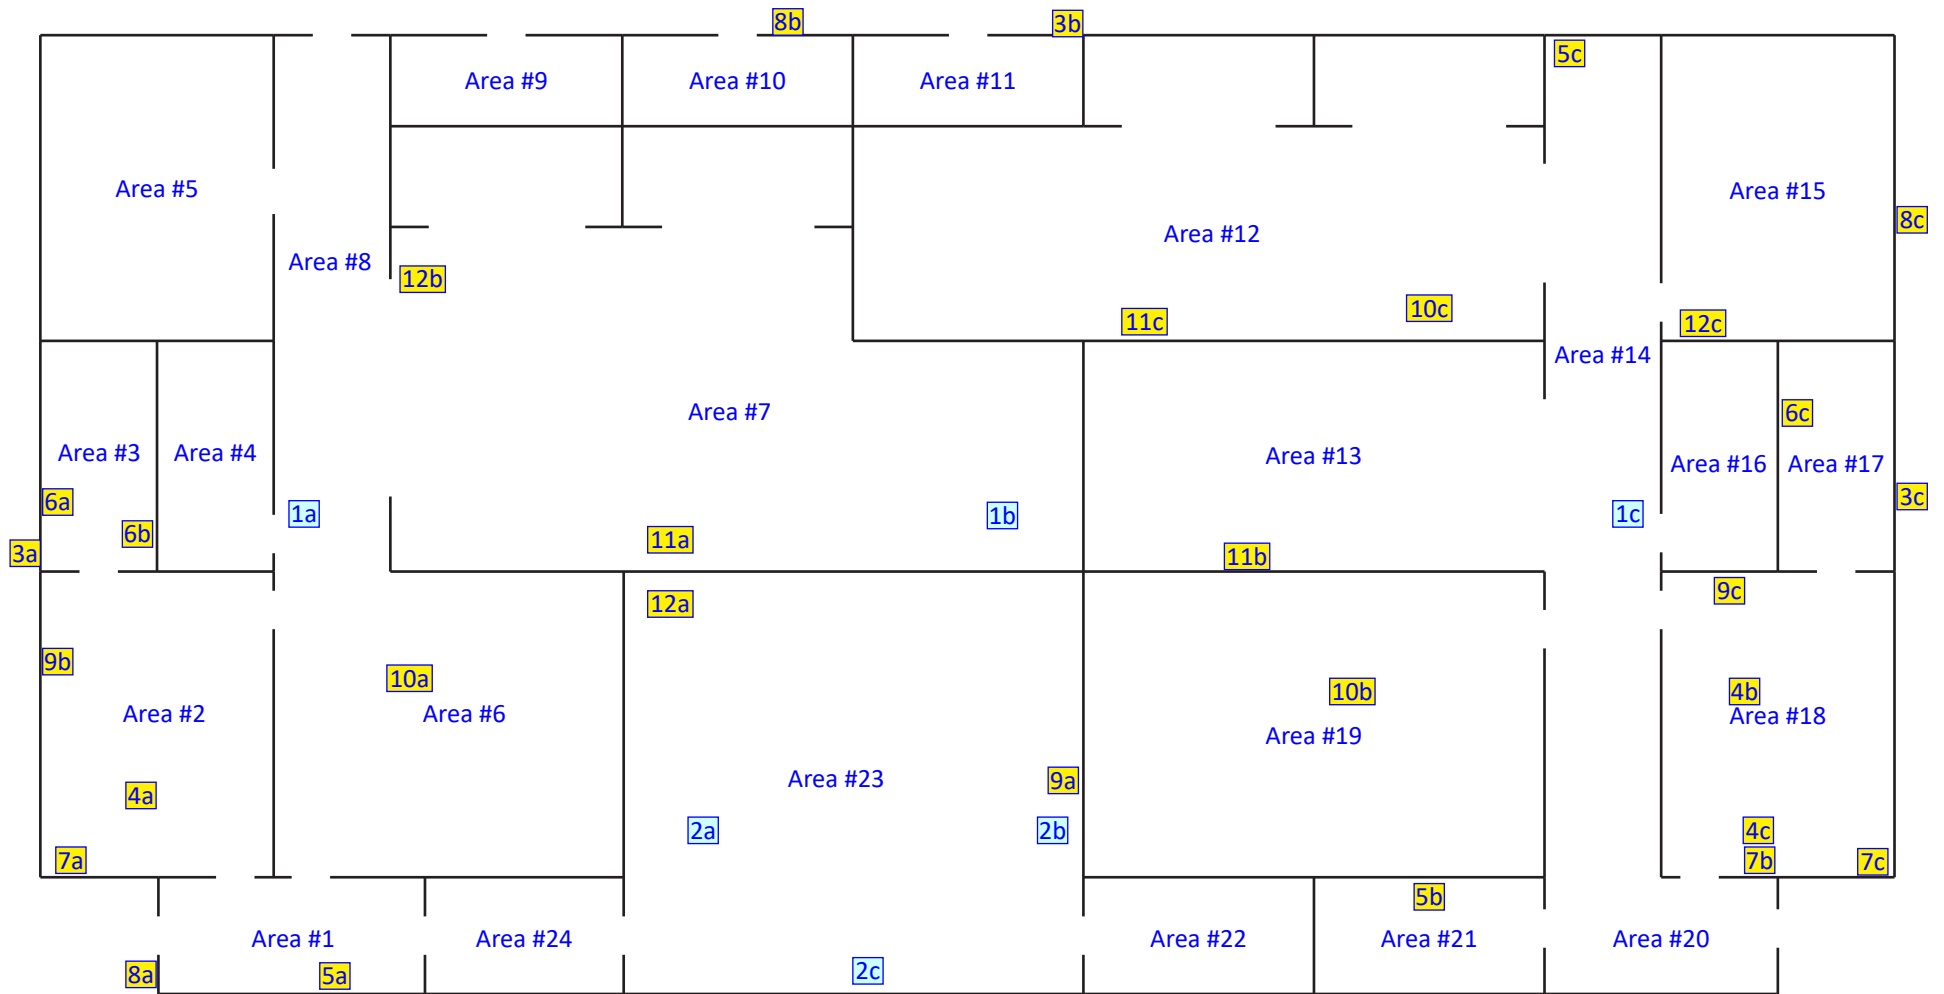
Area #25: Exterior

Area #26: Roof

Int./Ext. Sample Location

Roof Sample Location
