## **Civil/Site Assessment & Recommendations**

### **Mountain View Los Altos High School District**

**Brelje & Race Consulting Engineers**

### **Campus Assessments**

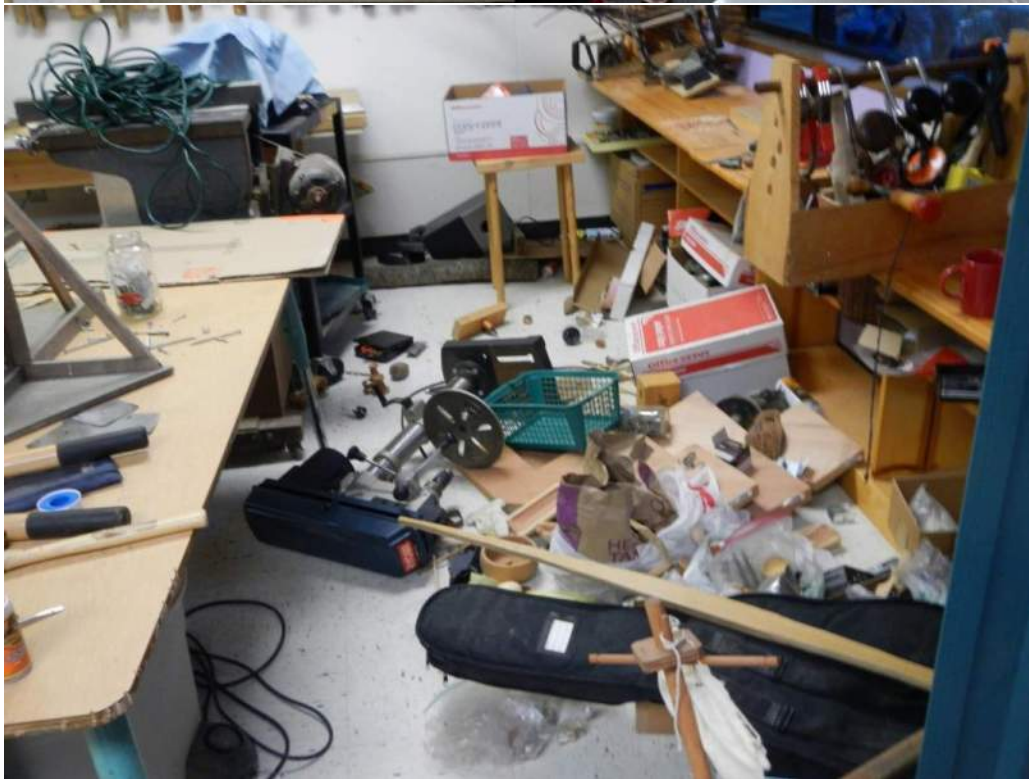
Free standing  
cabinets placed  
next to classroom  
doors can block  
exits

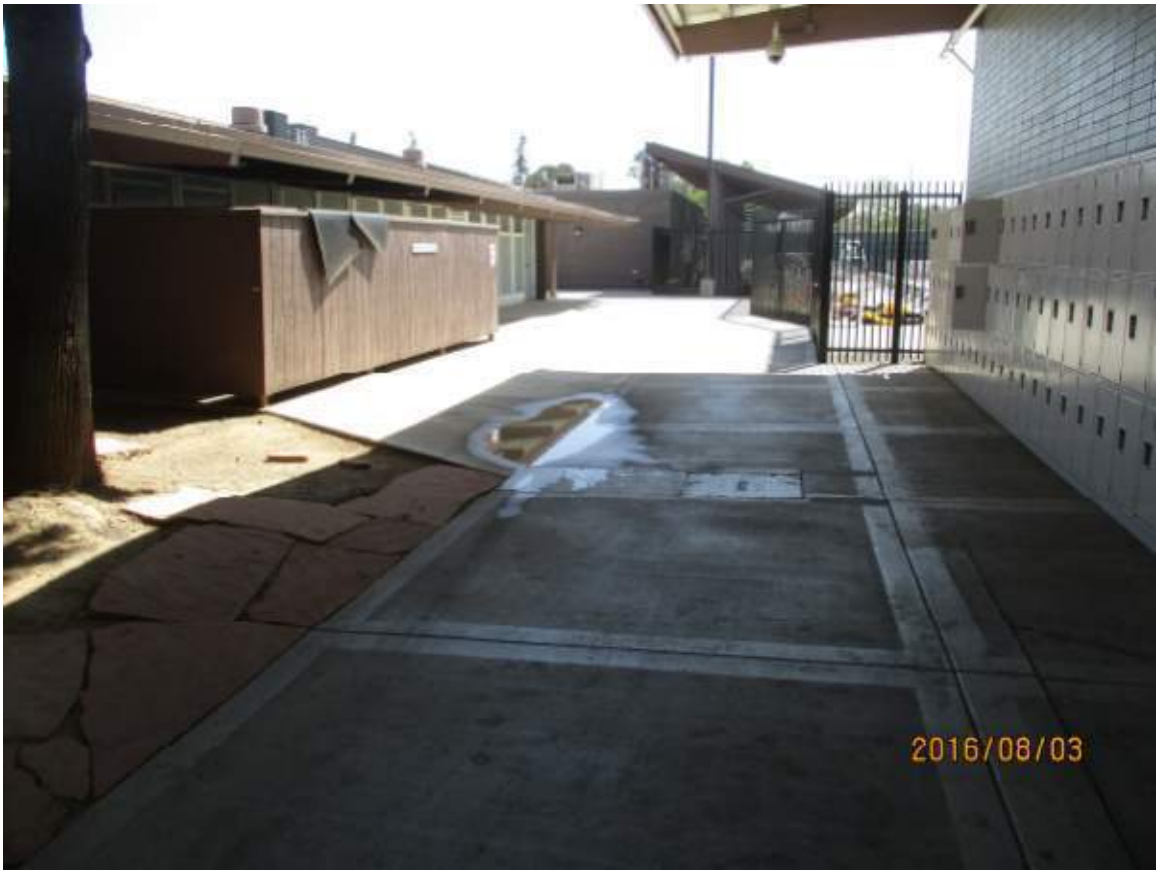
①

**MOUNTAIN VIEW HIGH SCHOOL**  
INADEQUATE DRAINAGE AND PONDING

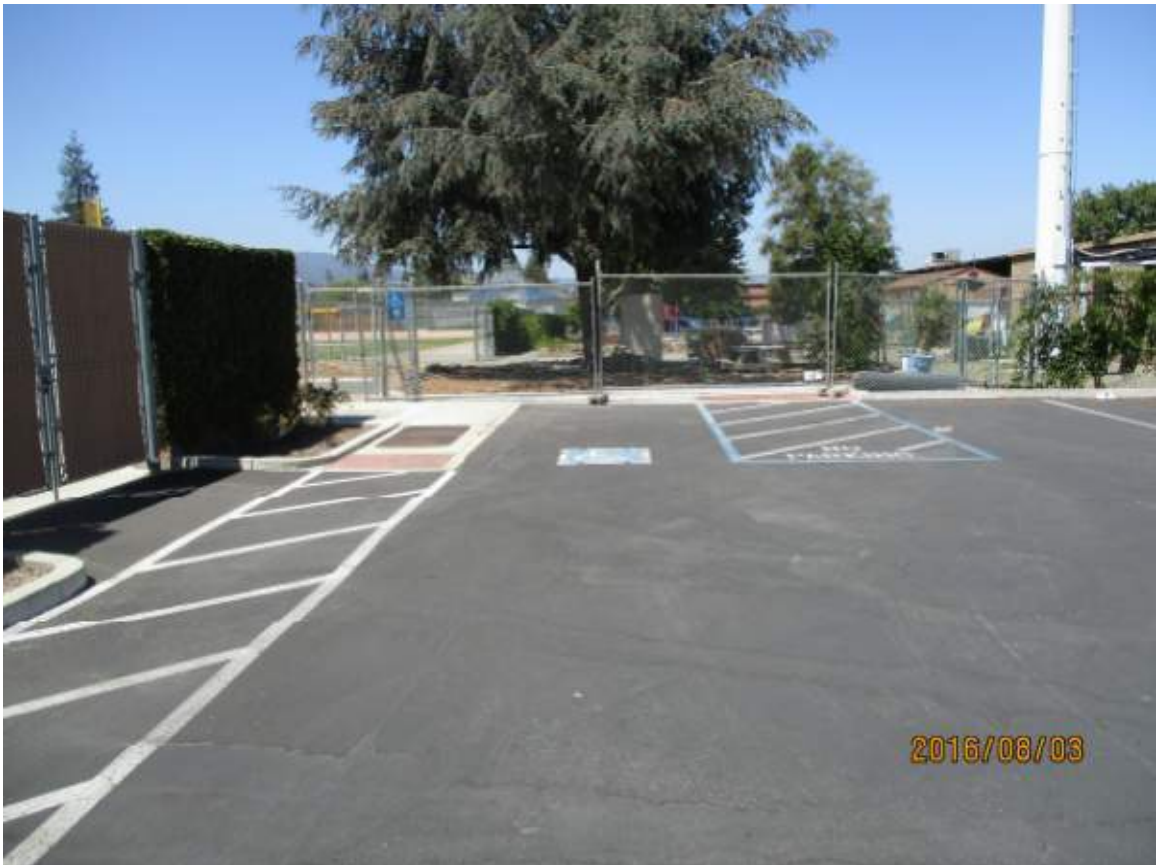
②

**MOUNTAIN VIEW HIGH SCHOOL**  
MISSING ADA SIGNAGE

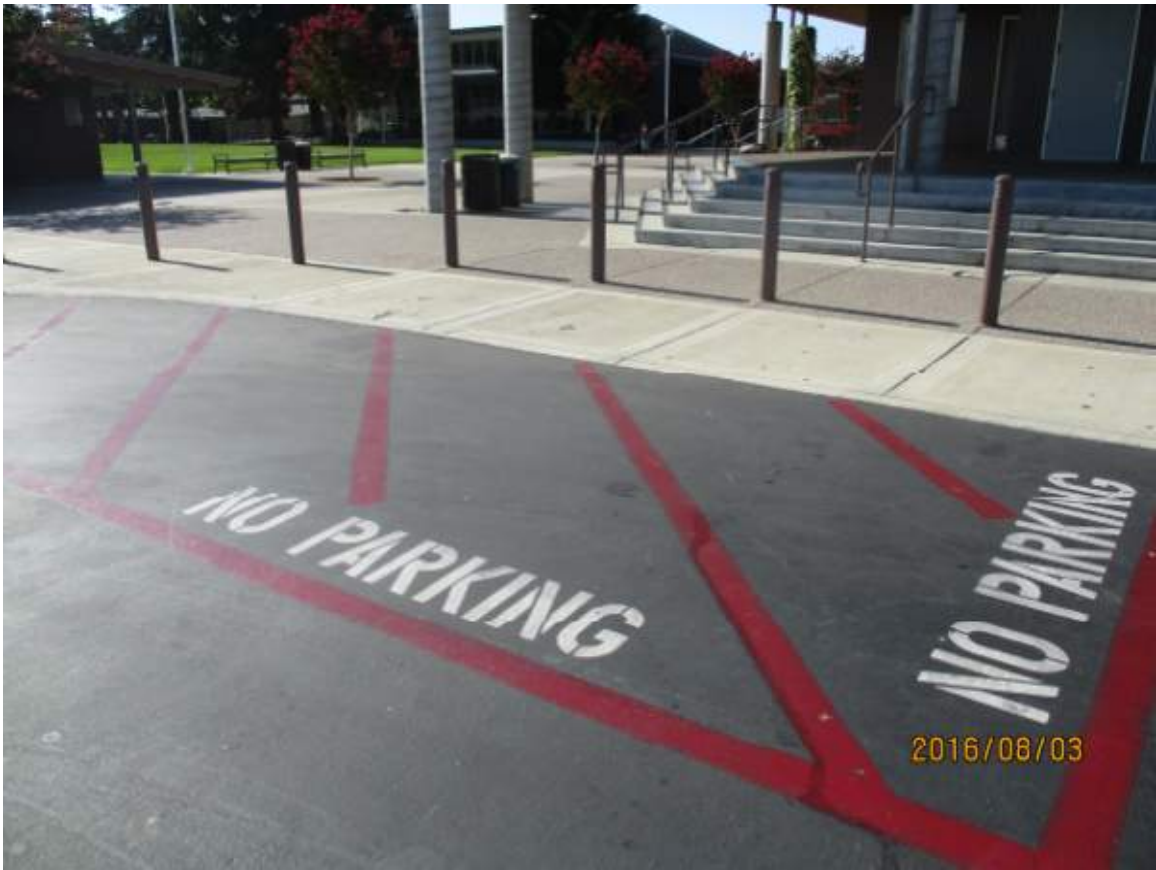
③

**MOUNTAIN VIEW HIGH SCHOOL**  
MISSING TRUNCATED DOMES AT WALKOUT

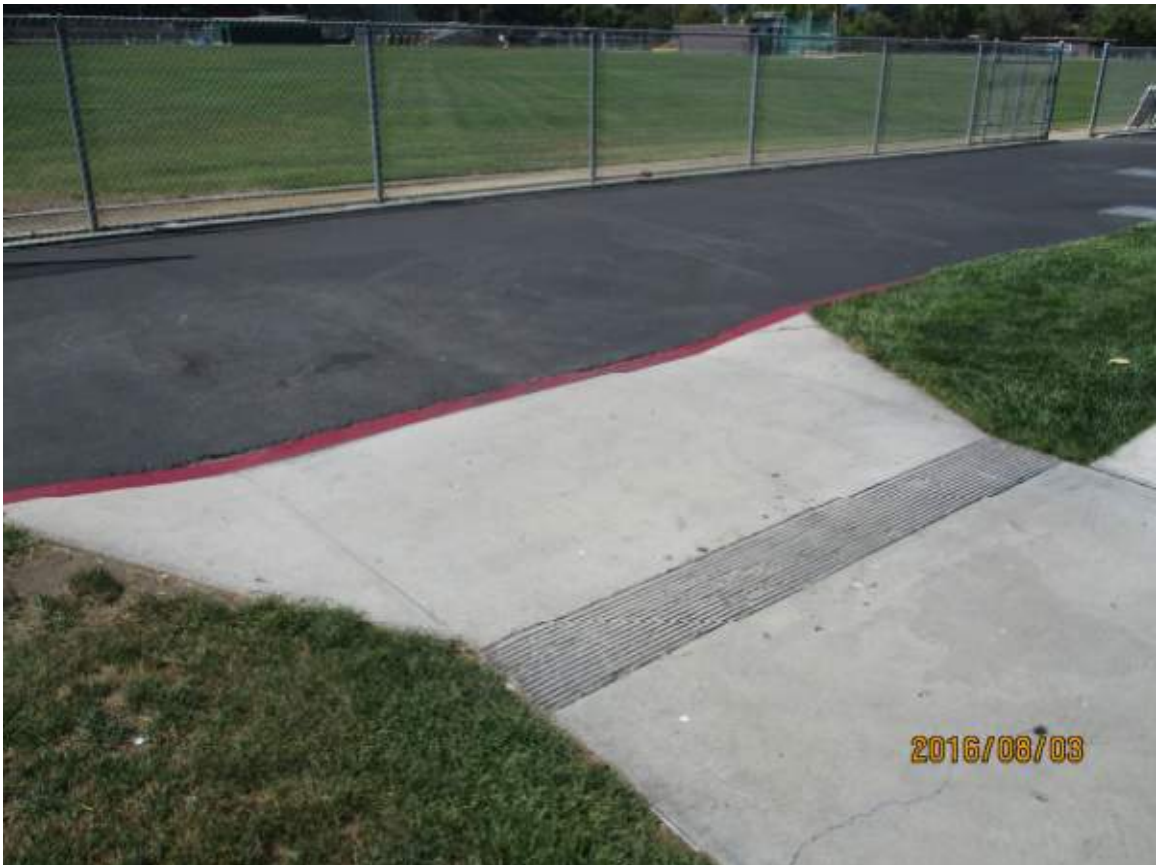
④

**MOUNTAIN VIEW HIGH SCHOOL**  
NO TRUNCATED DOMES AT WALKOUT

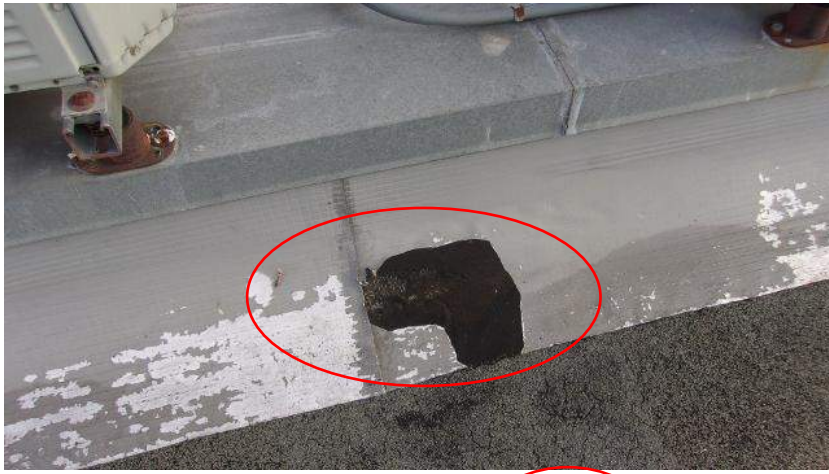
**Photo 5**

Worn flashing materials are present.  
Corrections are recommended.

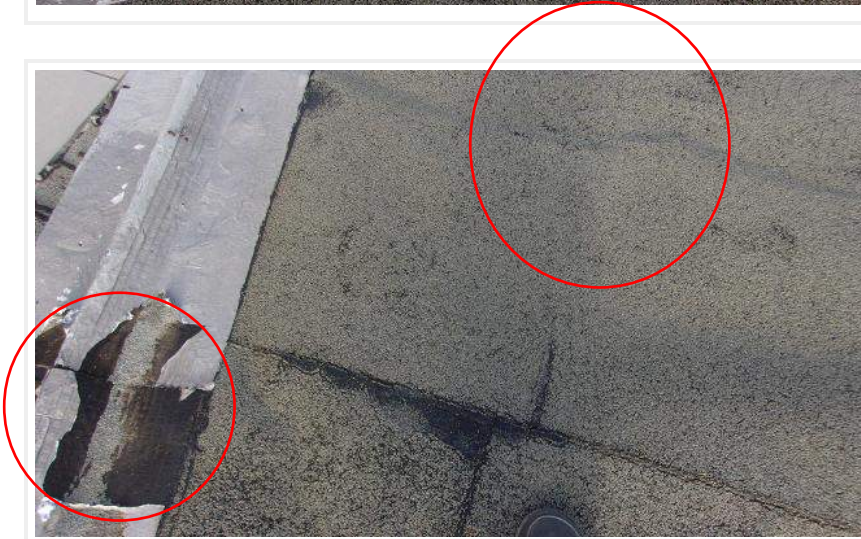
**Photo 6**

Flashing surfacing is being pulled apart by students or birds.

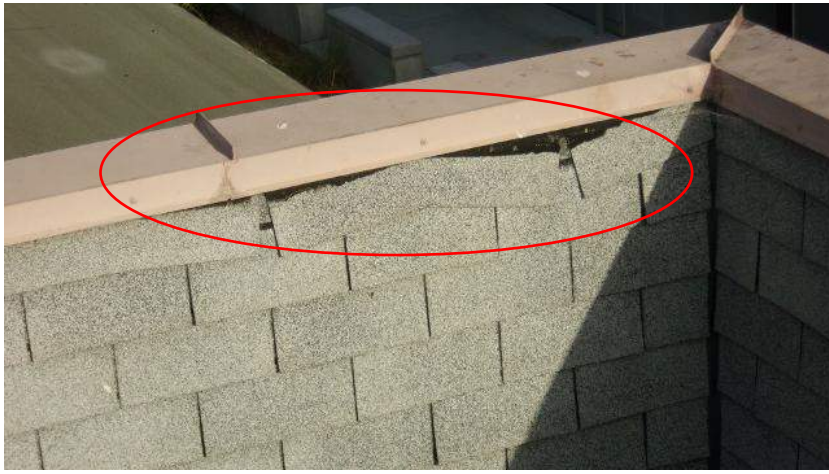
**Photo 32**

Damaged/missing parapet wall shingles are present. Corrections are recommended.

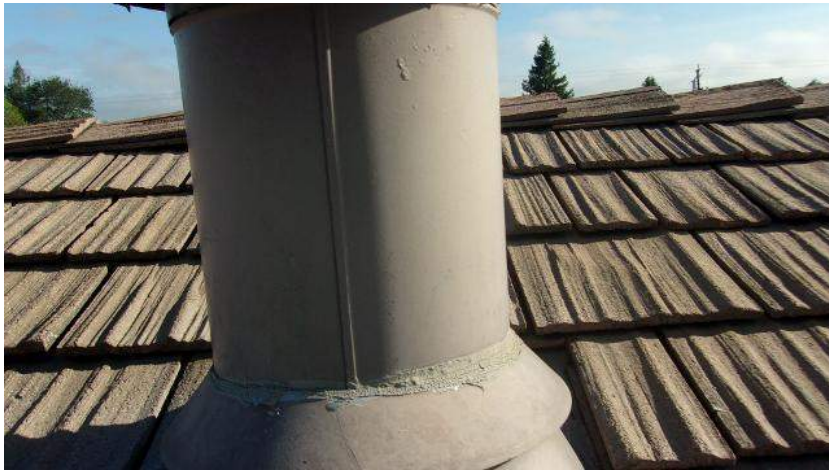
**Photo 128**

Worn cracked expansion joints are present. Corrections are recommended.

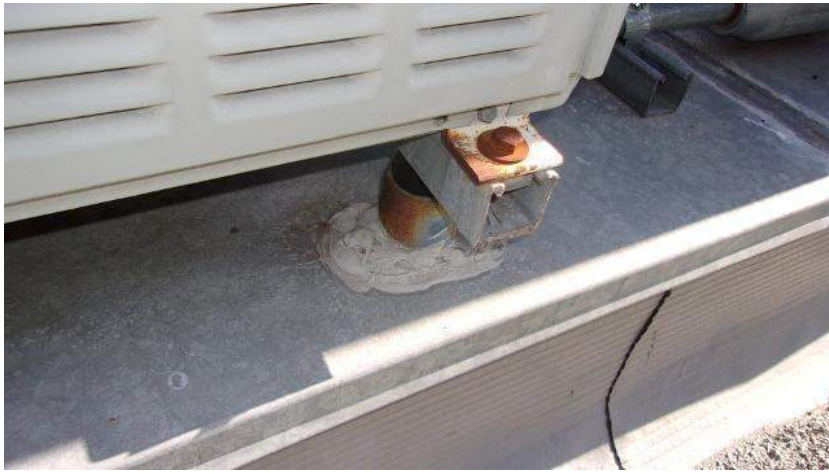
**Photo 161**

Vent pipe/roof jacks should be re-sealed.

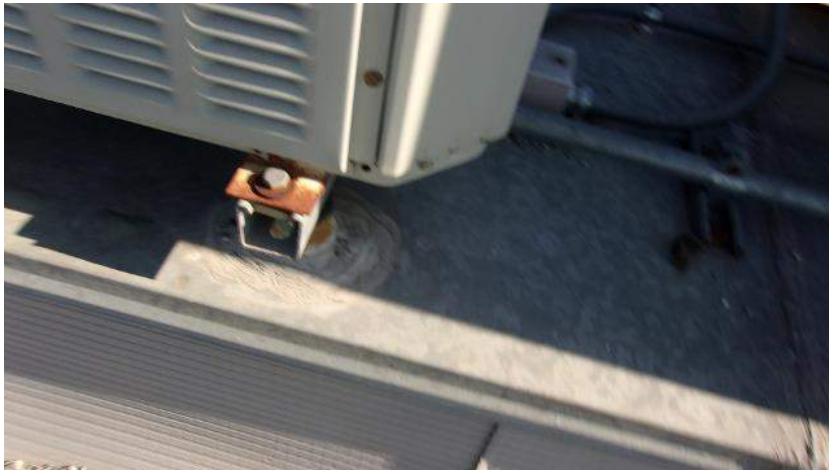
**Photo 218**

Draw band and sealant are needed at lead jack/conduit connection.

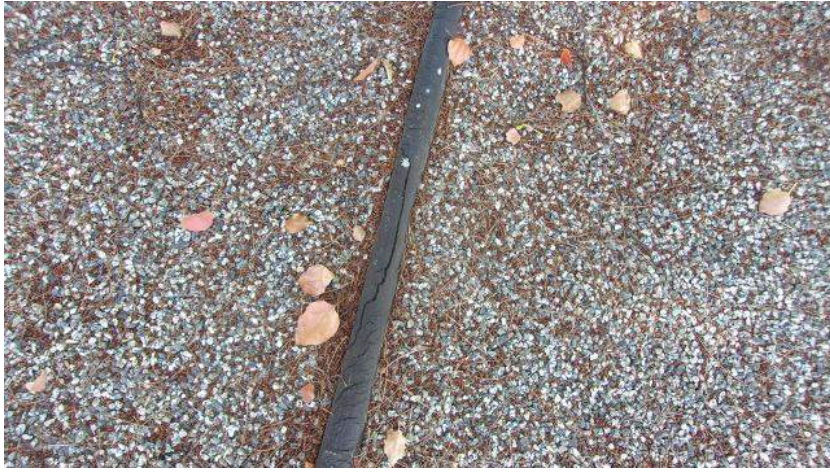
**Photo 221**

Wear/weathering/exposed plies noted at the roof edges. Repair/replacement is recommended.

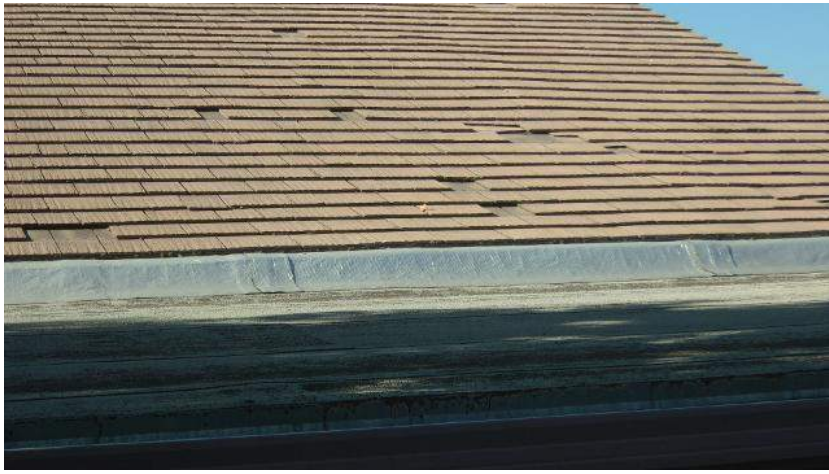
The gym roof assembly is uninsulated and there is no plywood over the plank deck. When roof is replaced insulation should be added and the deck should get 1/2" plywood nailed down over the entire surface.

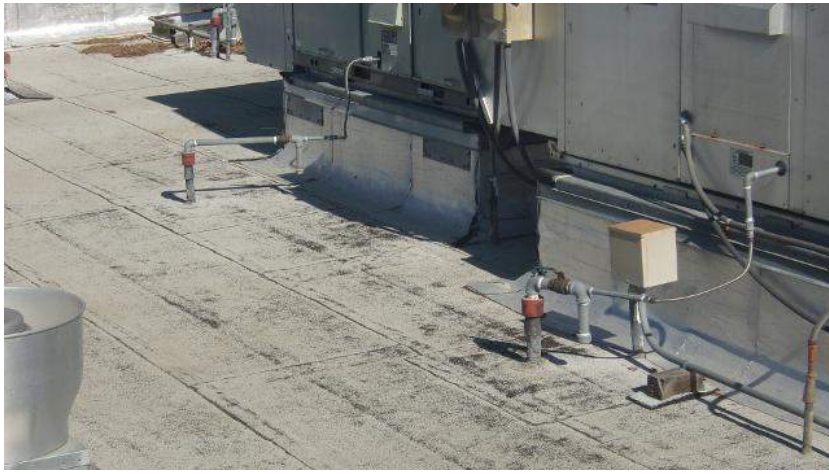
**Photo 389**

Recommend clearing tree debris from flat roof areas.

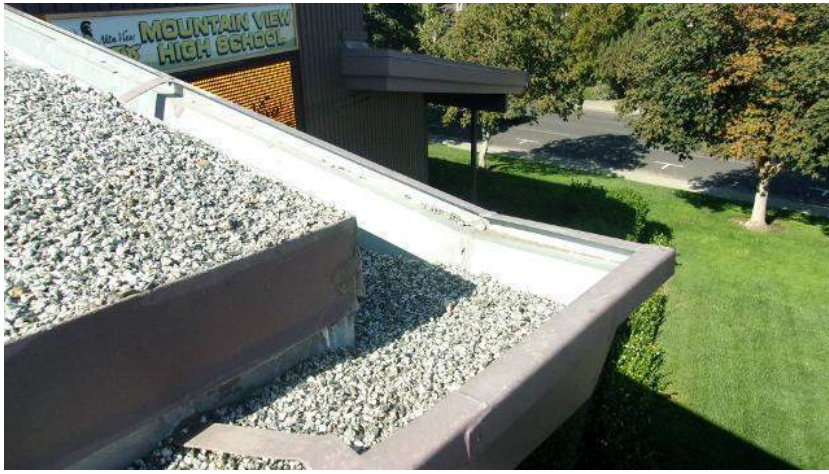
**Photo 392**

Outside curb corners should be three coursed with mastic and mesh.

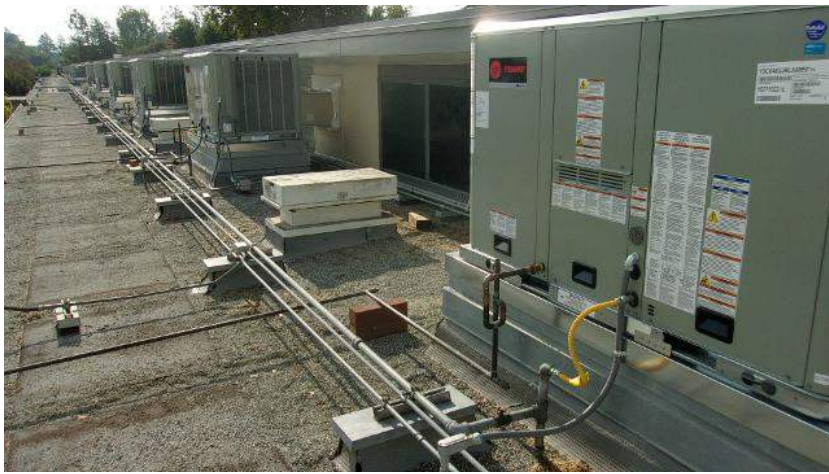
**Photo 99**

Roof is in poor condition and needs to be repaced.

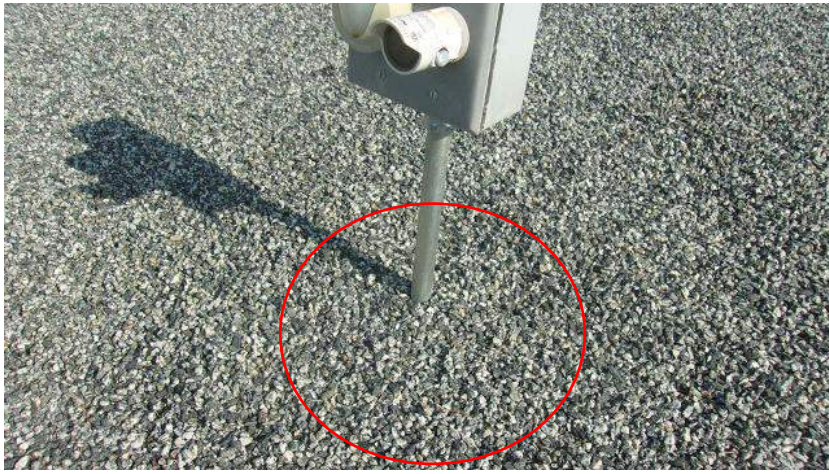
**Photo 119**

Recommend re-sealing lead jack/vent pipe penetrations (Check all).

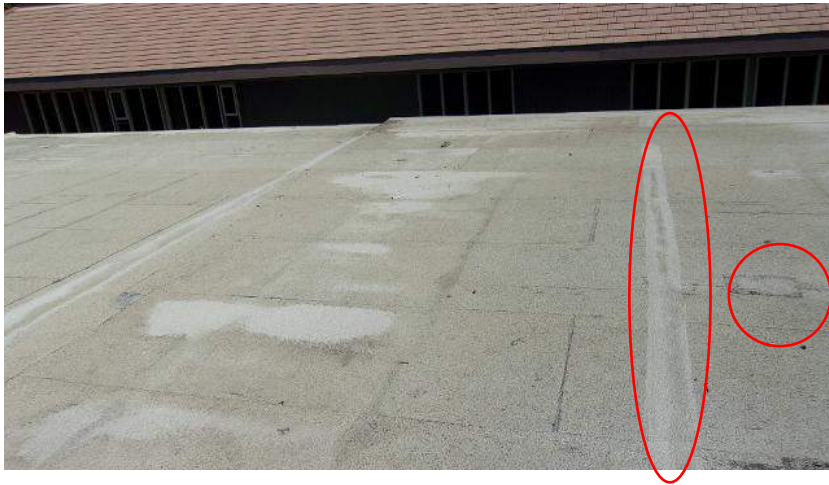
**Photo 15**

Roof has numerous patches and needs to be replaced.

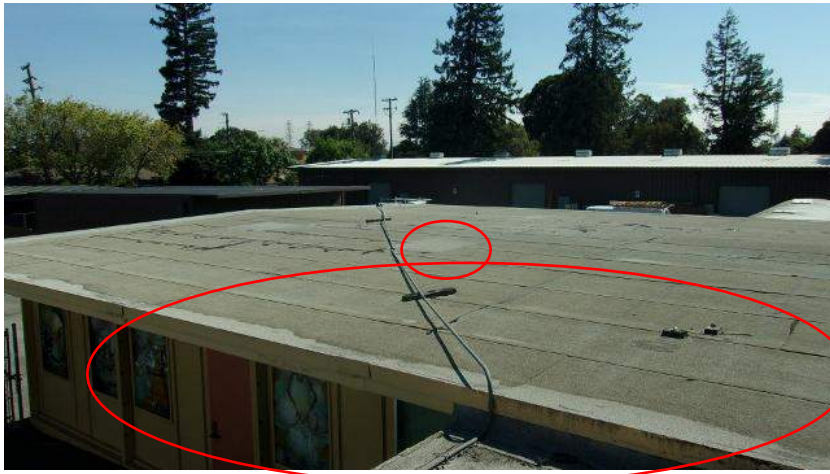
**Photo 20**

Overall the flat roof area at building 3 was found to be in poor condition. Roof is heavily patched.

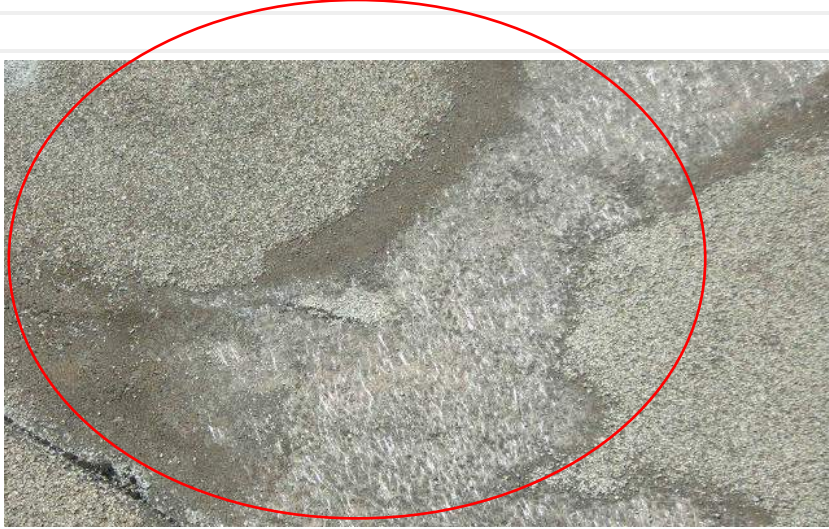
**Photo 36**

Damaged cap sheet noted (Multiple locations).

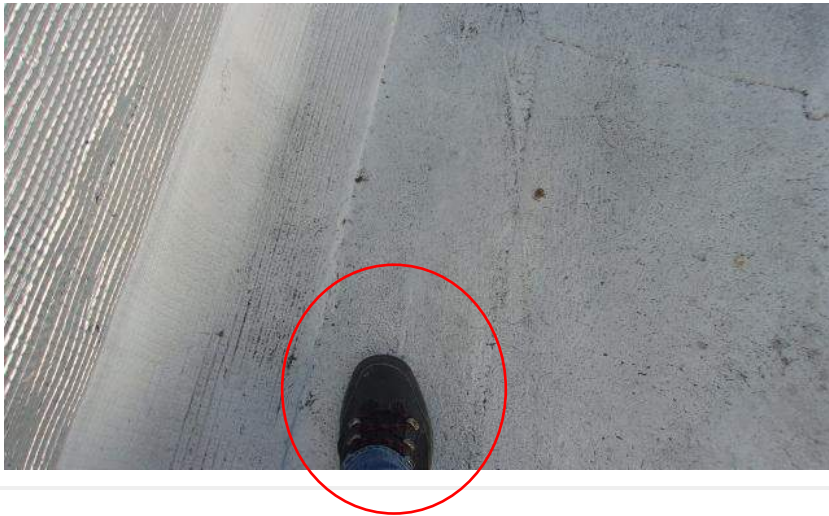
**Photo 8**

Minor damage noted at the wall/equipment  
flashing's. Check all and repair as needed.
