**PITTSBURG UNIFIED SCHOOL DISTRICT
HIGHLANDS ELEMENTARY SCHOOL
PORTABLES REPLACEMENT PROJECT**

**BID ADDENDUM NO. 2
June 29, 2026**

Hazardous Building Materials Survey Report

LIMITED ASBESTOS AND LEAD-BASED PAINT INSPECTION REPORT
HIGHLANDS ELEMENTARY SCHOOL – PORTABLE REPLACEMENT PROJECT
4141 HARBOR STREET
PITTSBURG, CA 94565

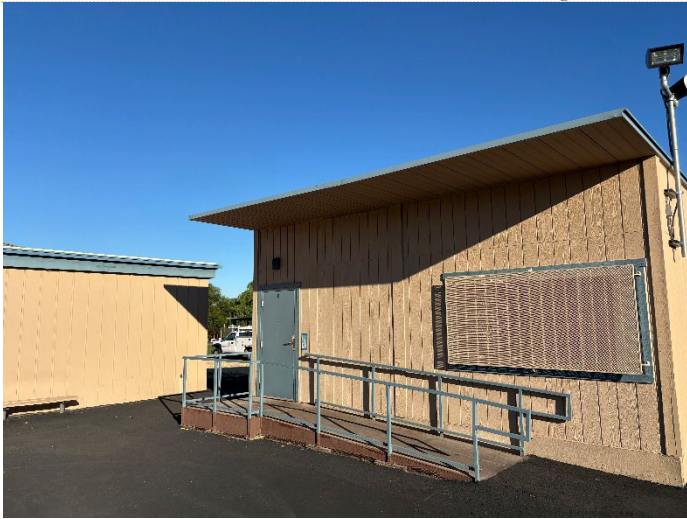
Exterior of Portable

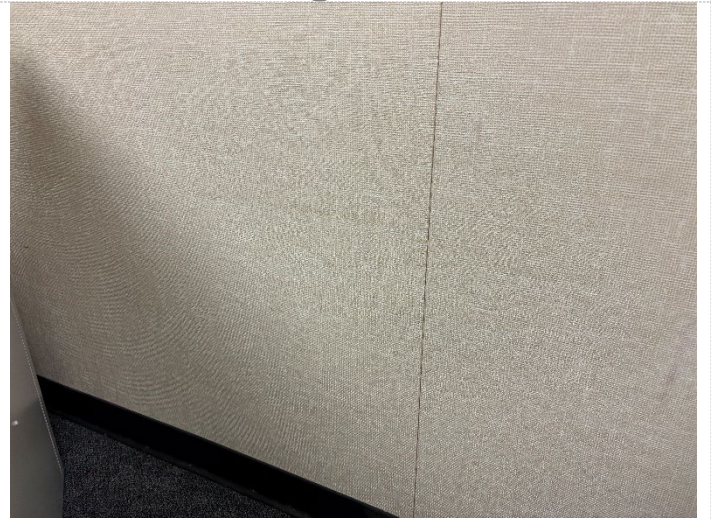
Gypsum Board

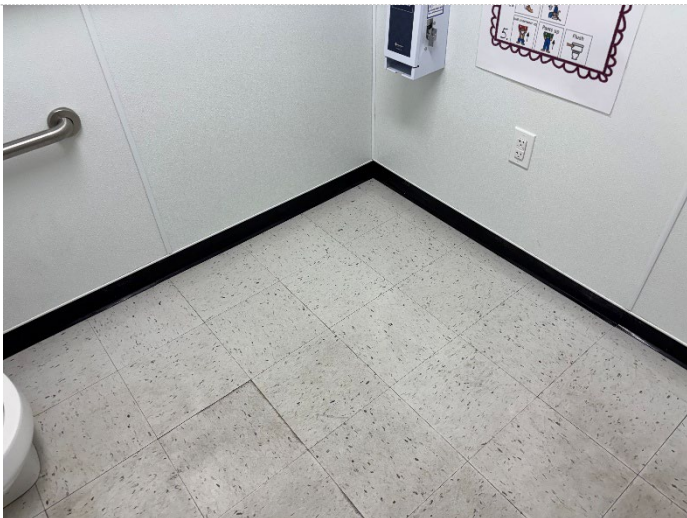
12" White Speckled VFT

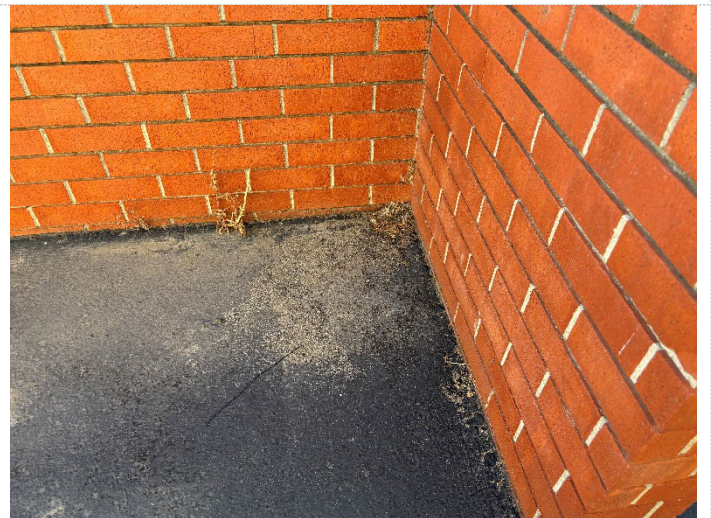
Asphalt

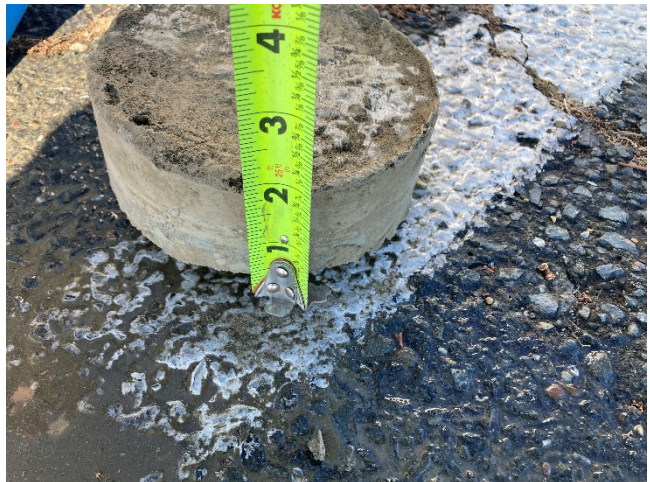
View of asphalt core in the north parking at completion of coring activities (thickness 2"). Sample ID: 2-1-1.

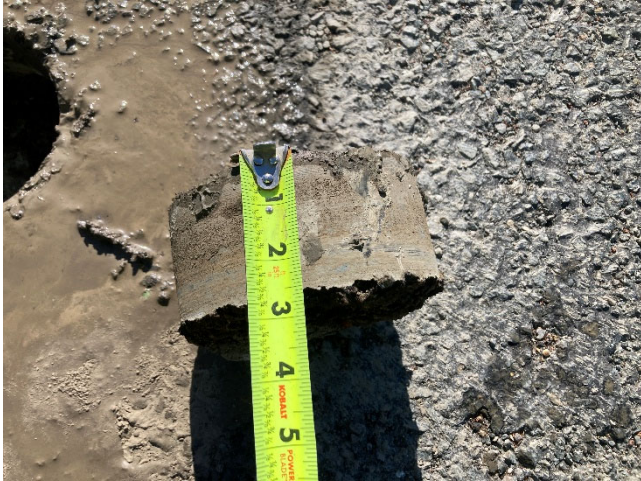
View of asphalt core at completion of coring activities (thickness 3"). Sample ID: 2-1-2.

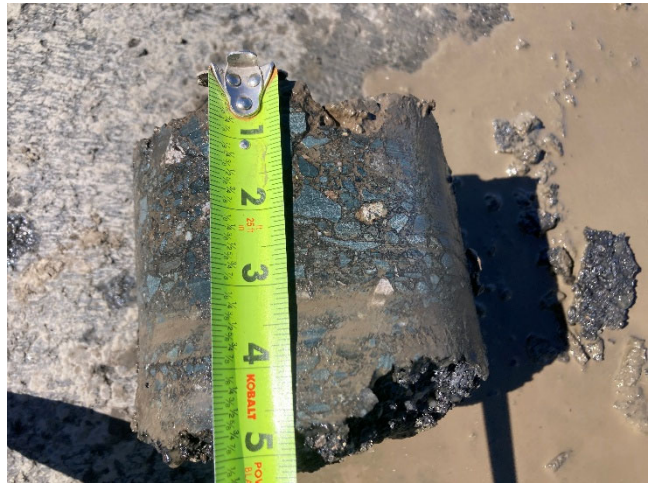
View of asphalt core at the south parking lot at completion of coring activities (thickness 5"). Sample ID: 2-9-1.

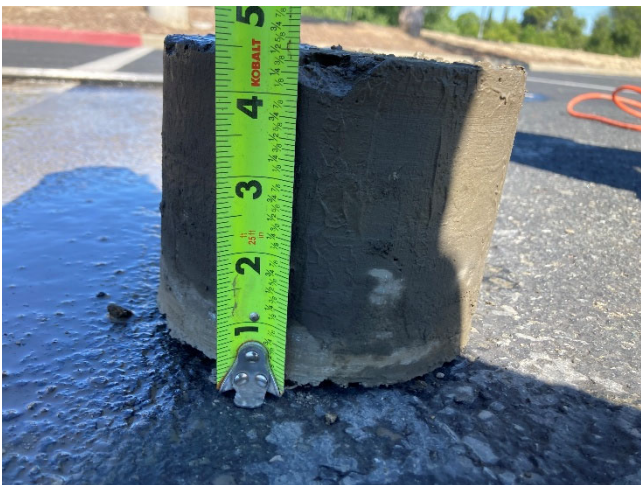
View of asphalt core at the south parking lot at completion of coring activities (thickness 4 1/2"). Sampled ID: 2-9-2.

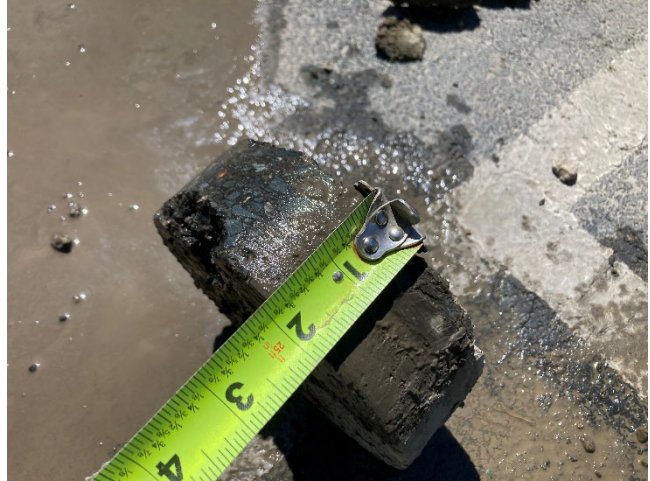
View of asphalt core at the TK/Kindergarten play yard at completion of coring activities (thickness 2"). Sampled IDs: 2-18-1 and 2-18-2.

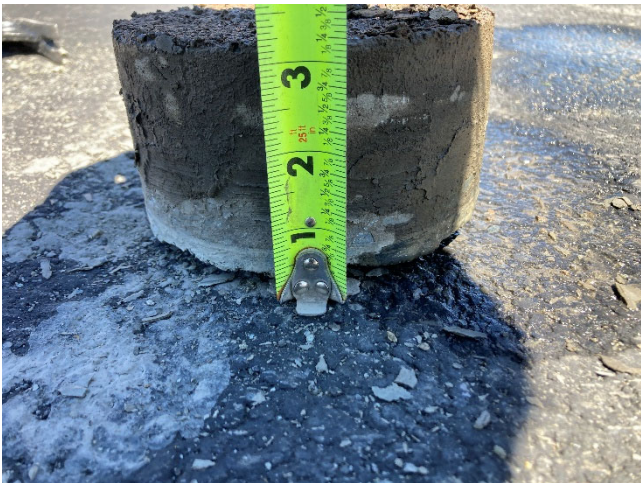
View of asphalt core at portable buildings area at completion of coring activities (thickness 3 1/2"). Sample ID: 2-27-1.

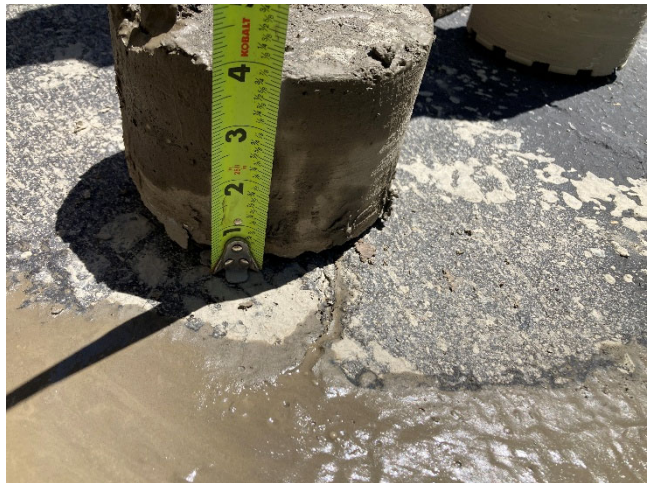
View of asphalt core at portable buildings area at completion of coring activities (thickness 4"). Sample ID: 2-27-2.

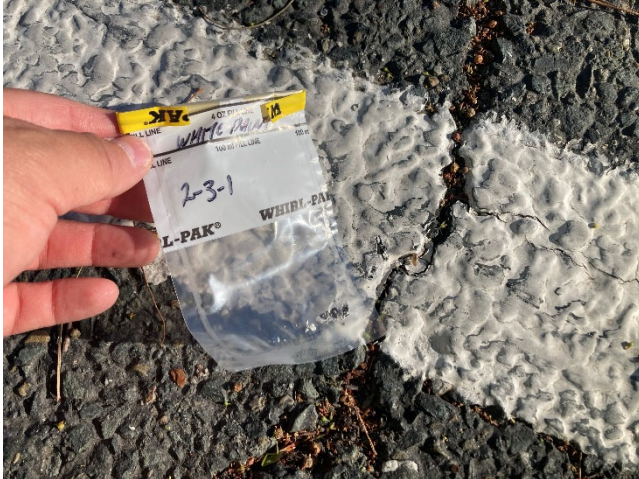
North Parking Lot: View of Sample 2-3-1. The black mastic located beneath the white paint striping was identified to contain asbestos.

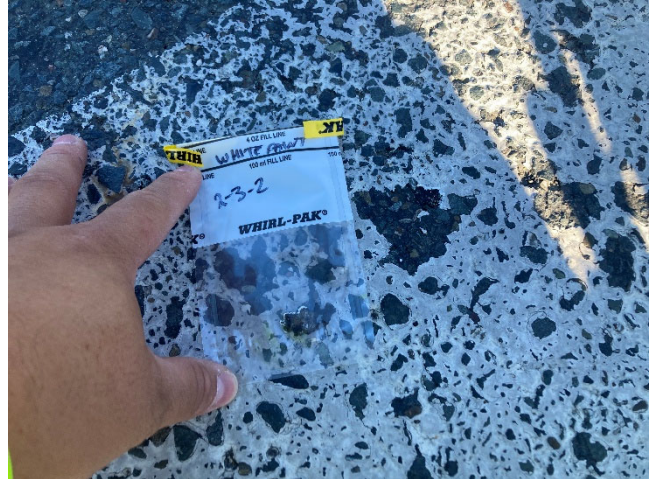
North Parking Lot: View of Sample 2-3-2. The black mastic located beneath the white paint striping was identified to contain asbestos.

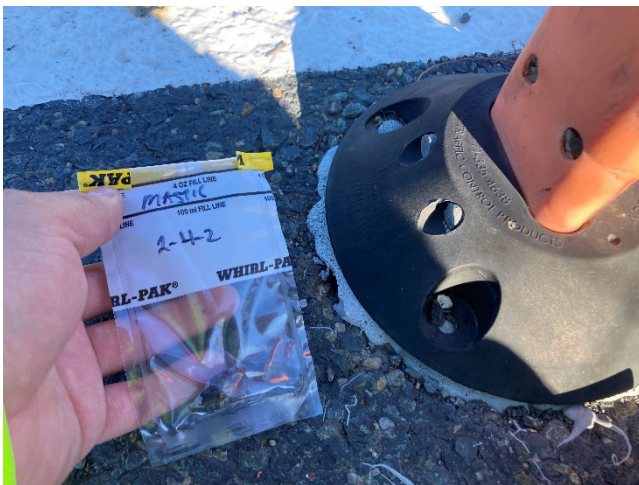
North Parking Lot: View of Sample 2-4-2. The black mastic located beneath orange plastic delineator posts was identified to contain asbestos.

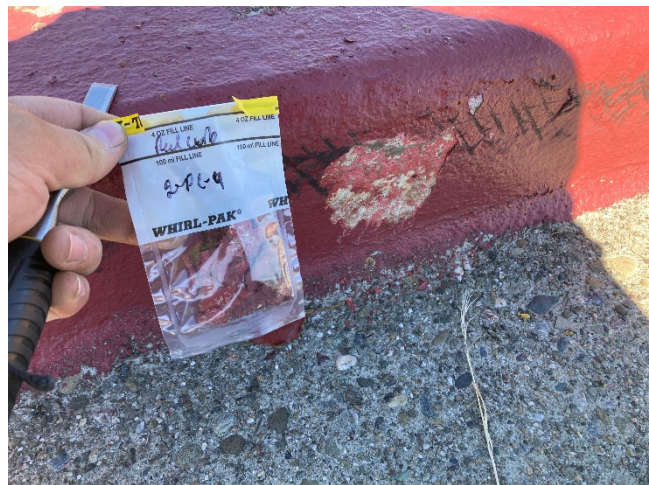
South Parking Lot: View of Sample 2-PC9. The red paint on concrete curbs was identified to contain lead-based paint (LBP) at 13,000 parts per million (ppm).

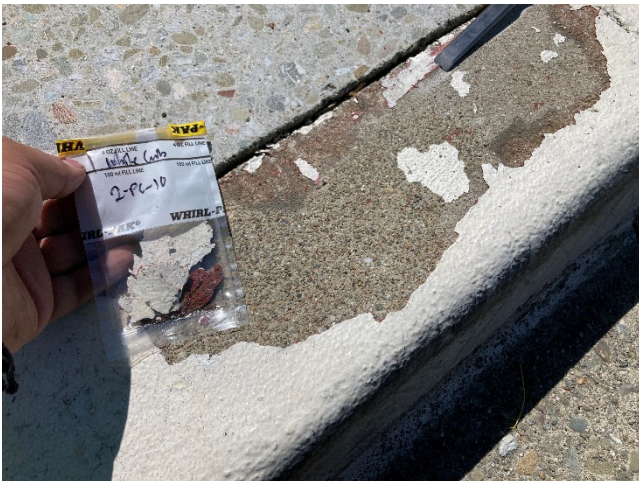
South Parking Lot: View of Sample 2-PC10. The white paint and underlying red paint on concrete curbs were identified to contain lead-containing paint (LCP) at 1,700 ppm.

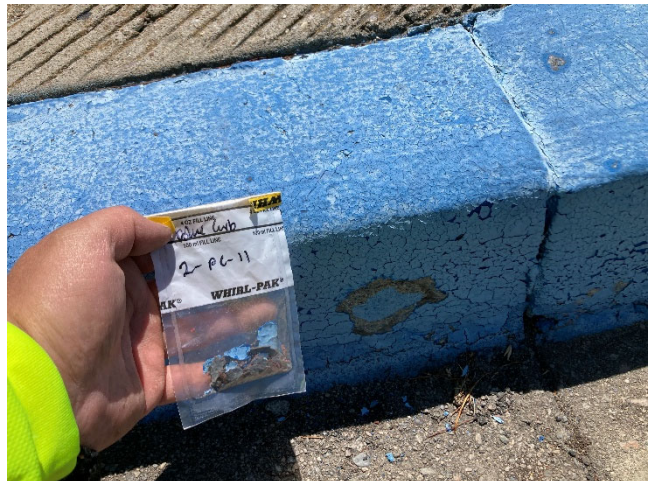
South Parking Lot: View of Sample 2-PC11. The blue paint and underlying red paint on concrete curbs were identified to contain lead-containing paint (LCP) at 1,700 ppm.
