City of Biggs Housing Conditions Inventory

Prepared for the City of Biggs

**HousingTools**

October 2024

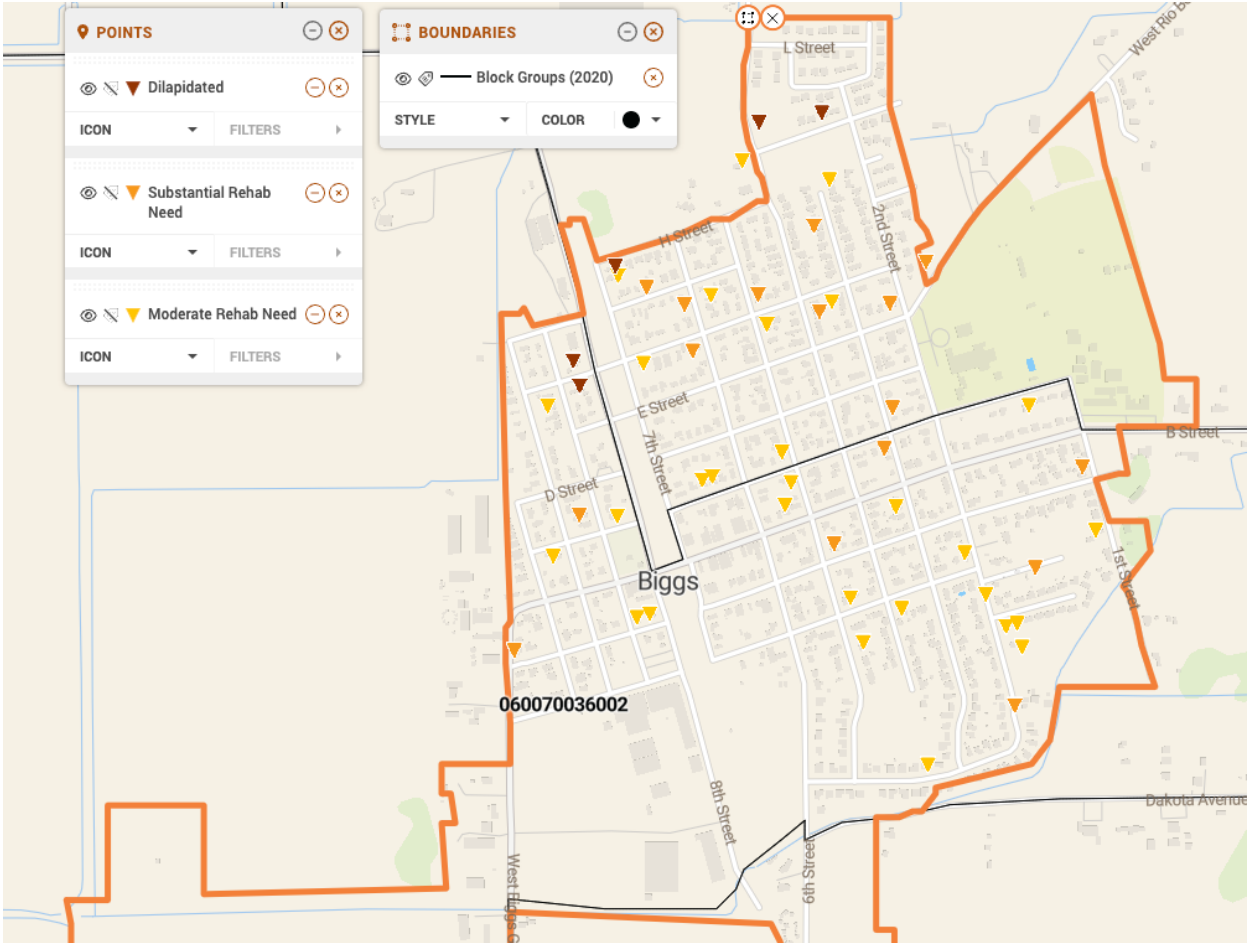
Figure 6: Parcels with Residential Structures in Need of Rehabilitation

Figure 6 illustrates the geographic distribution of surveyed parcels with residential structures in need of rehabilitation, scoring 3, 4, or 5 across the Survey Area.

Parcels with residential structures that scored a 3 are fairly evenly distributed throughout the city, with a small concentration in the southeast from the intersection of 2nd and Bannock Streets to the intersection of 2nd Street and Mary L Court (5 parcels), and a small concentration in the central four blocks bounded by D Street, 5th Street, B Street, and 7th Street (5 parcels).

Parcels with residential structures that scored a 4 are also fairly evenly distributed throughout the city, with most located north of E Street (8 parcels), including 3 parcels along F Street.

The five parcels with dilapidated residential structures scoring a 5 are in the northwest and north parts of the city.

Taken altogether, there appears to be concentrations of housing needs in the following areas:

- North of E Street, in particular along F Street and surrounding blocks
- Southern end of 2nd Street and adjacent Mary L Court

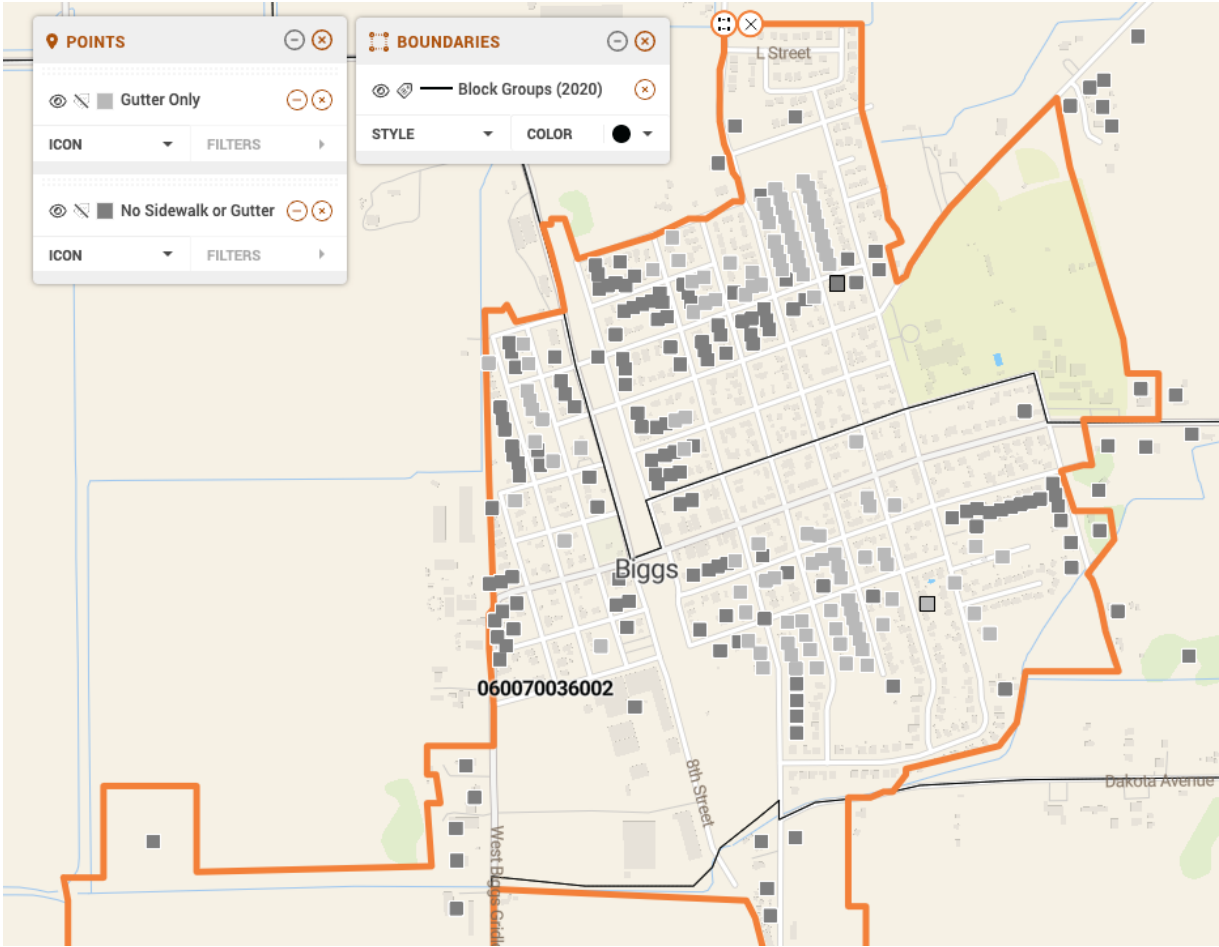
Figure 8: Parcels with Frontage that Has Gutter Only, or No Sidewalk or Gutter

The locations of parcels with frontage that have storm drainage gutter only, or that have no sidewalk or gutter, are shown in Figure 8 below. The following areas have concentrations of parcels with no sidewalk or storm drainage gutter:

- Most of 8th Street
- G Street between 5th and 7th Streets
- D Street between 6th and 7th Streets, and 7th Street between C and E Streets
- 10th Street between D and G Streets
- B Street between 11th and Aleut Streets
- Aleut Street between 1st and 2nd Streets, and 1st Street south of Aleut Street

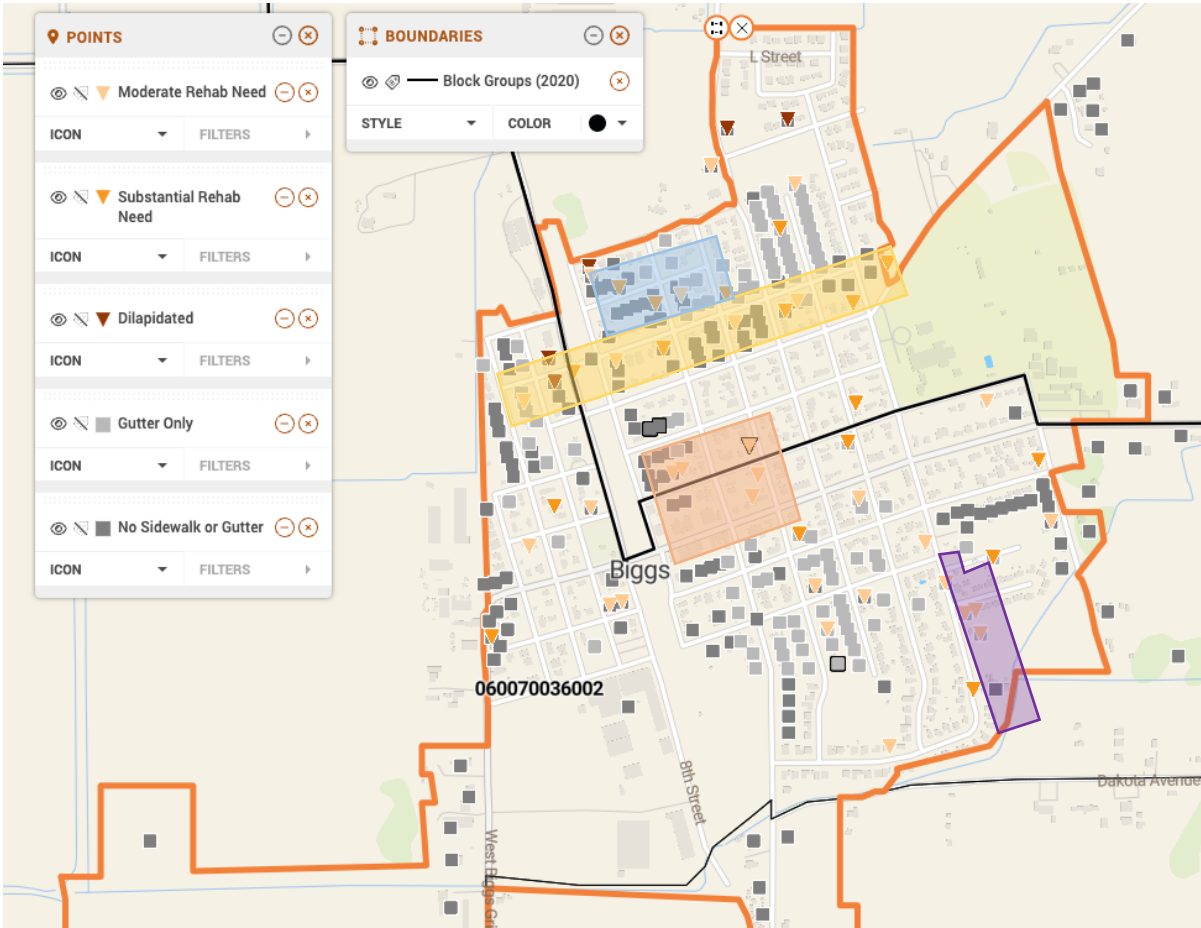
Figure 11: Housing Rehabilitation Target Investment Areas

Based on analysis of data gathered from the housing conditions survey, Figure 10 below identifies areas with concentrations of residential structures in need of rehabilitation, and sidewalk/storm drainage gutter needs. They could potentially benefit from a targeted housing rehabilitation and infrastructure upgrade project that is supported by a combination of state and local funds. The color of the row for each Target Area in the Figure 10 table below corresponds with the highlighted Target Area shown in the Figure 11 map.

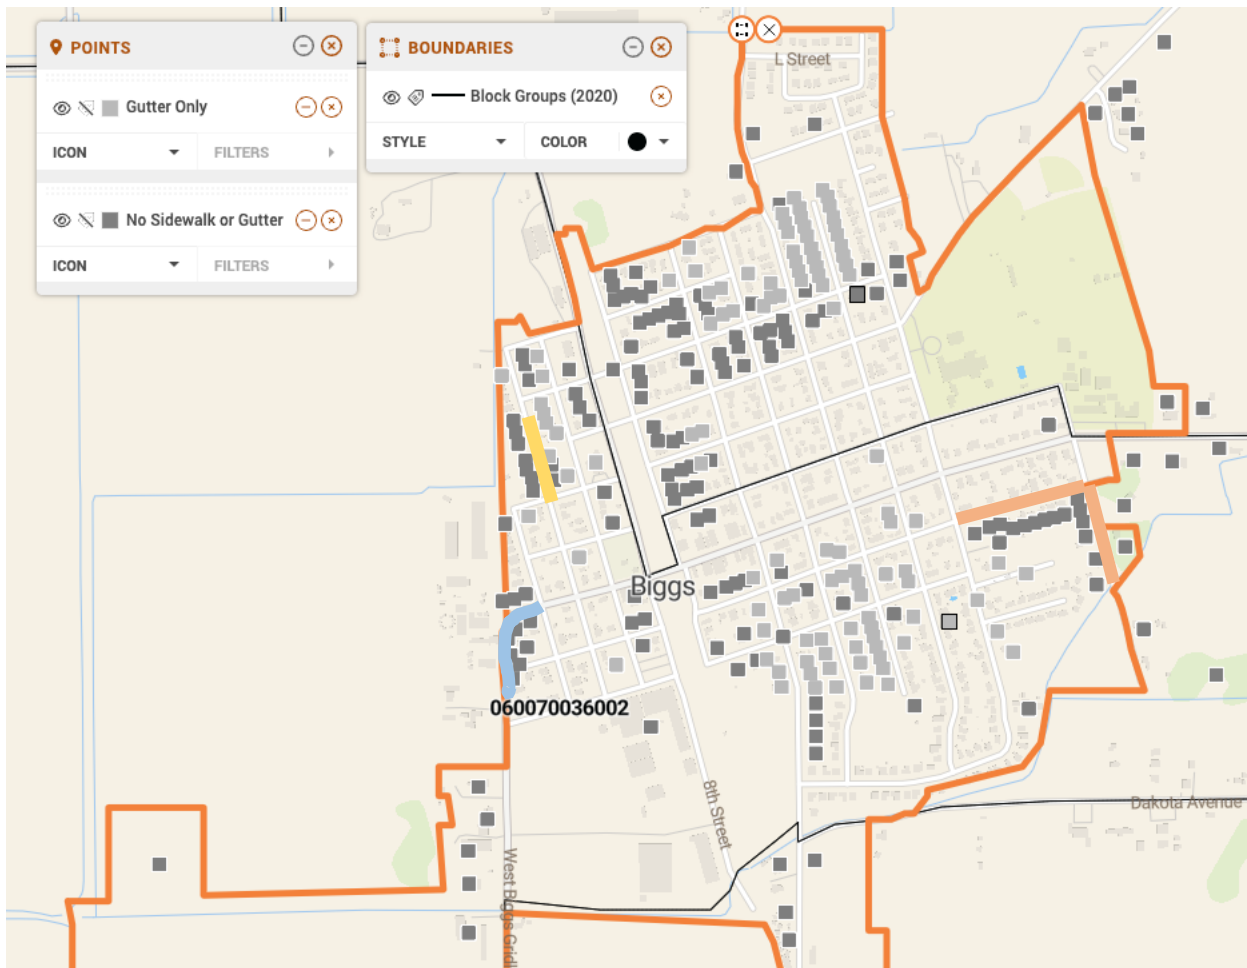
Figure 13: Infrastructure Improvement Target Investment Areas

Figure 12 below identifies Infrastructure Improvement Target Investment Areas with concentrations of parcels that have no sidewalk or storm drainage gutter. These areas could be targeted for CDBG investment. These areas do not overlap with the Housing Rehabilitation Target Investment Areas shown above in Figure 11. The color of the row for each Target Area in the Figure 12 table below corresponds with the colored right-of-way Target Area shown in the Figure 13 map.
