MVLA

v1.0
DRAFT
September 2016

FACILITIES ASSESSMENT

Mountain View Los Altos Union High School District

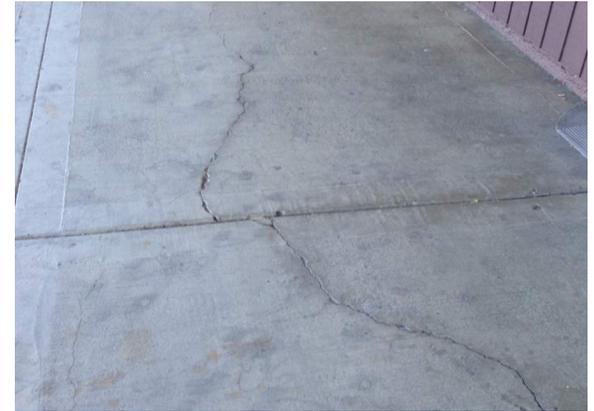
Cracking at walkway surfaces

- Implementation of a pavement management program is encouraged to prolong pavement life. Seal cracks, slurry seal asphalt surface and restripe parking as necessary.

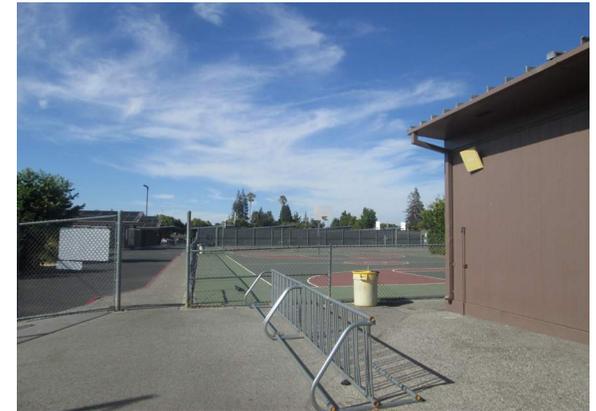
Hardscape tennis and basketball court area

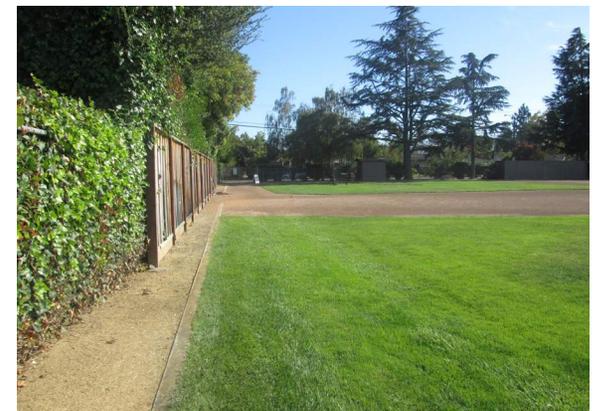
Field area with numerous divots

Safety hazard: wood fence located too close to field

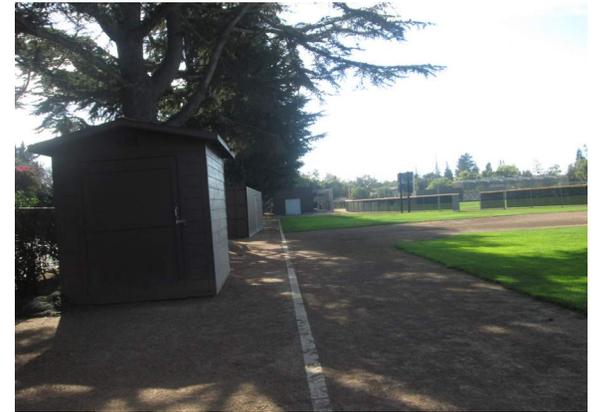
Safety hazard: trees & storage sheds located near fields

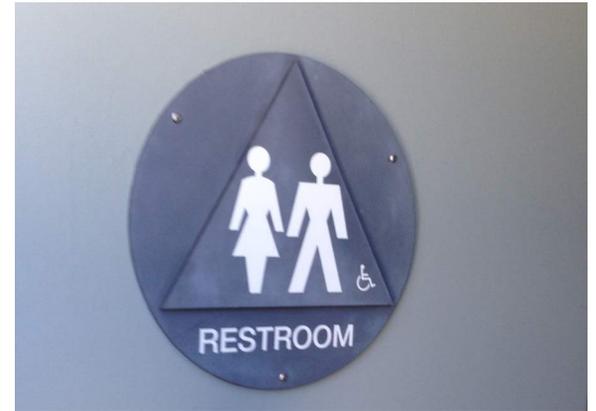
- Classroom signage is provided in accordance with CBC chapter 11B requirements. Restroom signage is missing Braille below the text characters per chapter 11B requirements.
- Limited replacement of cabinets may be required for ADA compliance as classroom sinks did not appear to be accessible due to a non-removable base and the depth of the sink not allowing for proper knee clearance. Lack of knee and toe clearance prevents access to the soap and paper towel dispenser mounted behind the sink.
- Restroom grab bar/toilet partition conflict. The current configuration does not meet ADA standards.
- Location of paper towel dispenser in Restroom does not allow for proper ADA clearance.

Braille missing at Restroom signage

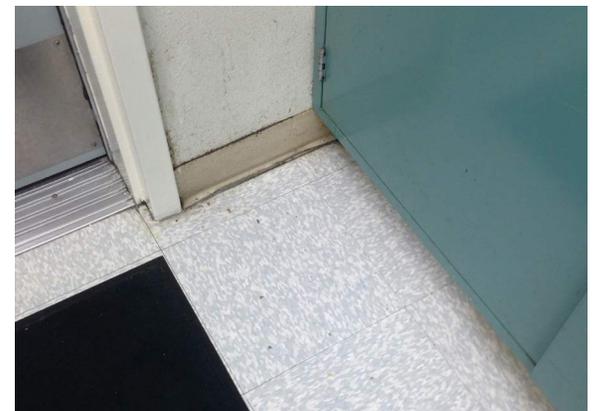
Staining at walls, floors and base

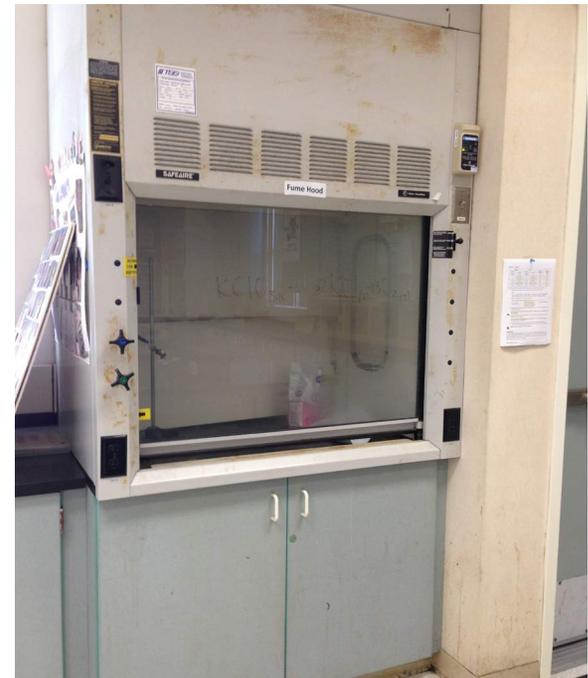
Rusted fume hood

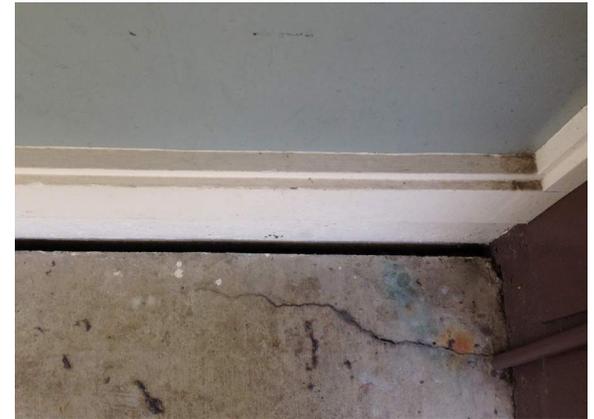
Exterior of Building- Sealant missing

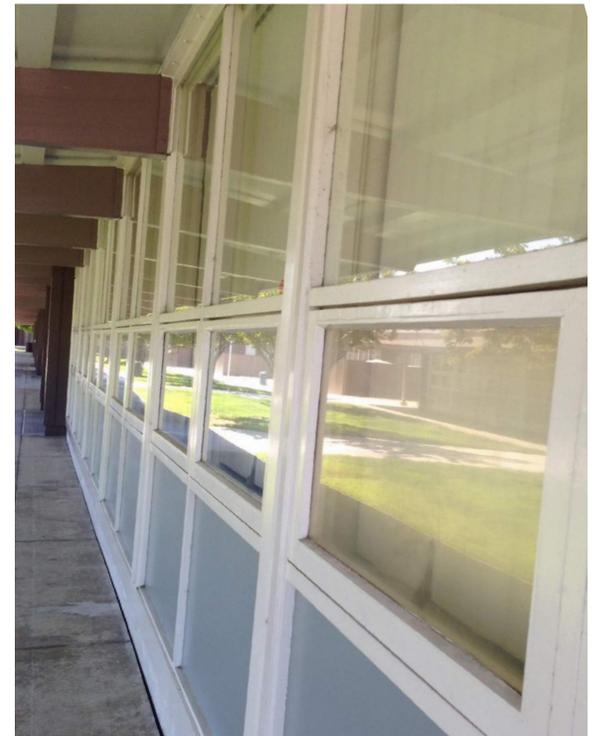
Single-pane wood windows

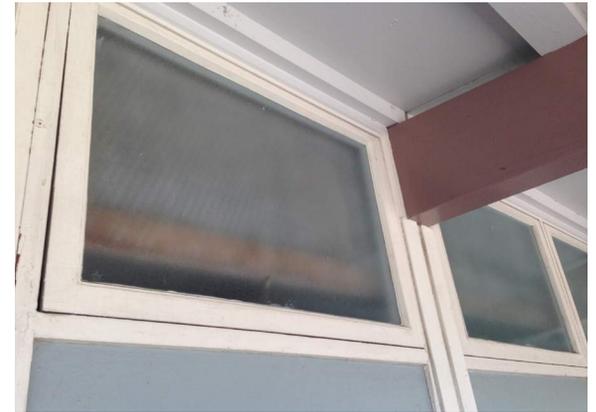
Single-pane windows with translucent glazing

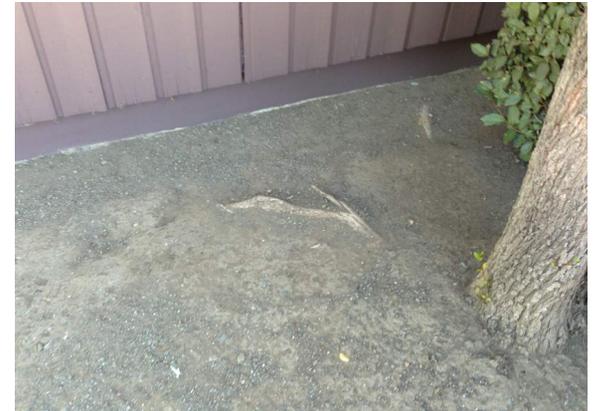
Tree roots growing close to building foundation

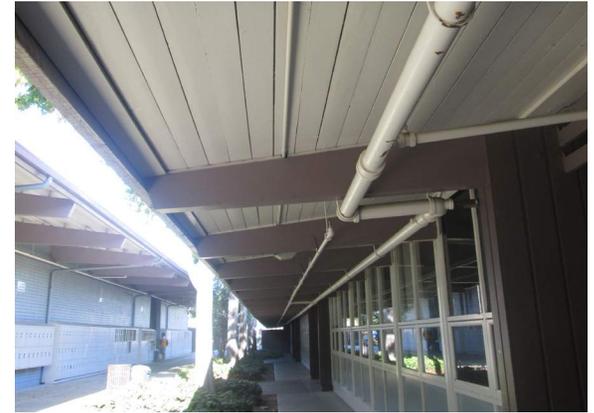
Exterior soffit condition with exposed sprinkler pipes

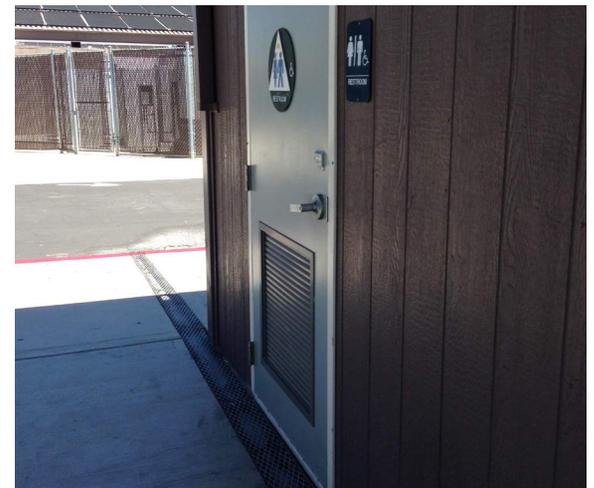
Metal grate at path of travel

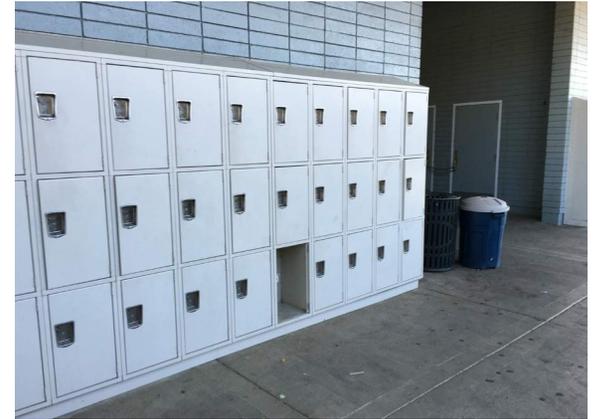
Exterior locker doors missing

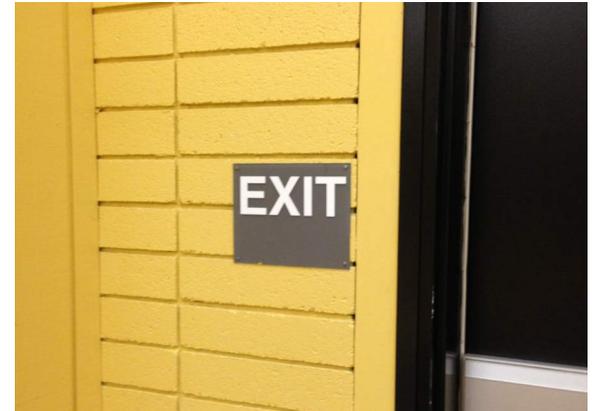
- Room signage is in accordance with CBC chapter 11B requirements.
- Exit signage is not in accordance with CBC chapter 11B requirements for Braille.

Exit signage does not meet ADA standards

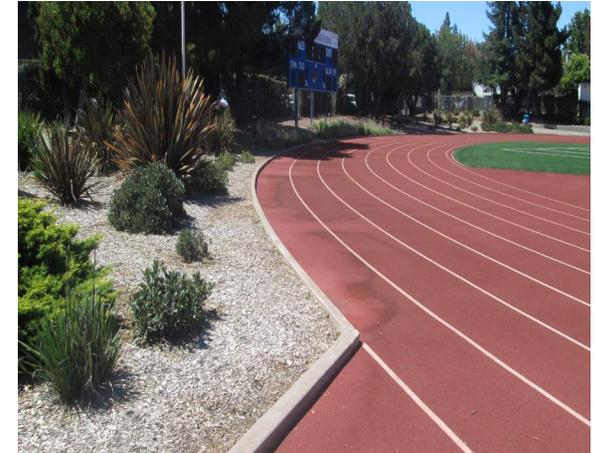
Staining at track surface

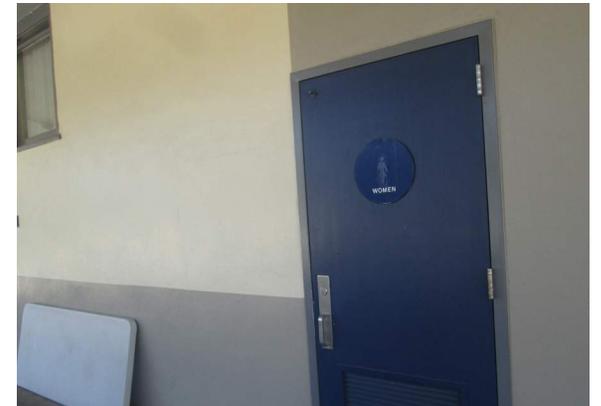
Wall sign is missing

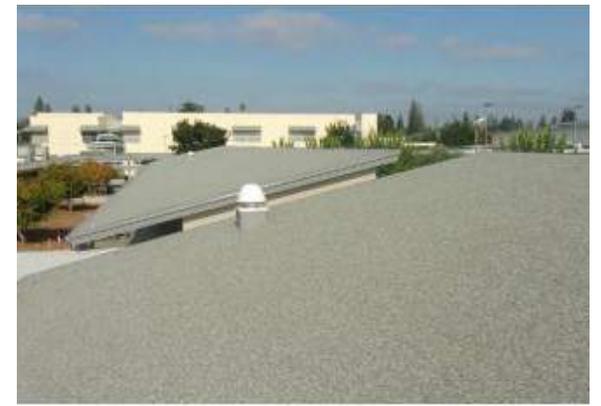
Roof at 400 - Minor Repairs

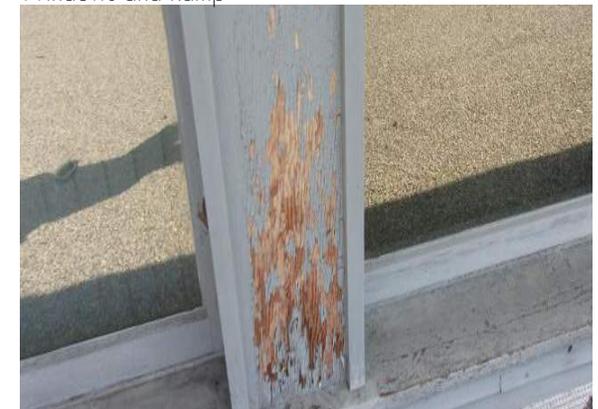
Damage at upper clerestory window

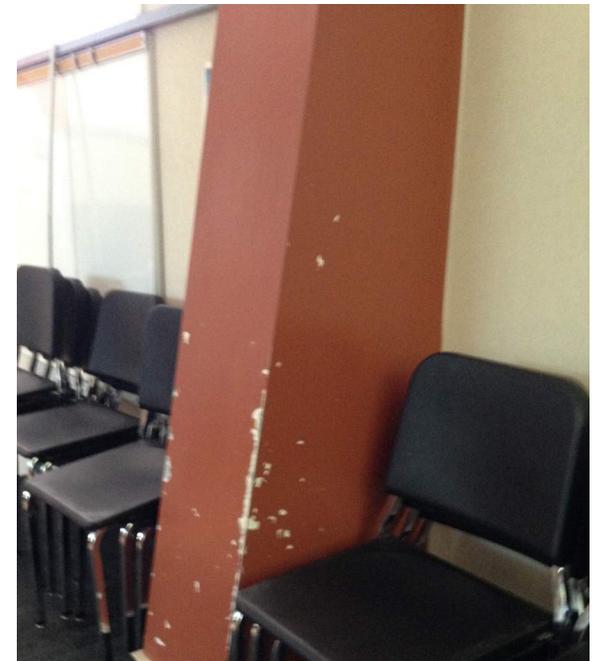
Worn interior finishes

- Future modernizations should provide sturdier and abuse resistant finishes at the interior.
- Replace AC units if more than 15 years old. At time of roof top unit replacement, new systems should have acoustic vibration isolation and be designed to reduce air velocity to reduce noise.
- New ramp hand rail will be required.
- Roof replacement within the next five years

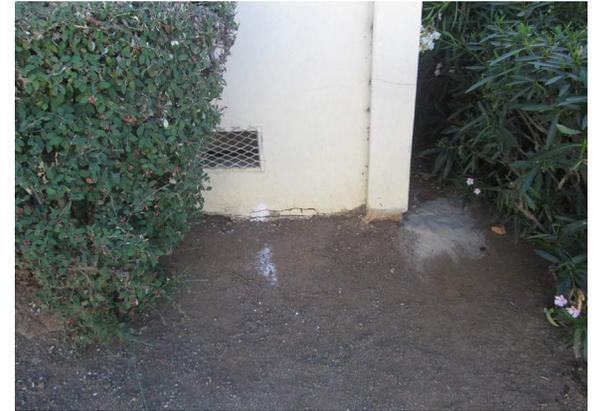
Inadequate grade separation

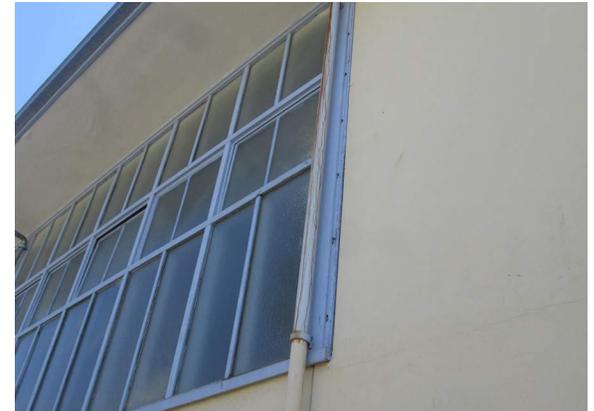
Windows in poor shape

- Install efficient high bay lighting that does not create glare.
- Replace exterior windows to allow ventilation and daylighting, reduce glare.
- Future master planning should evaluate the useful life and functional appropriateness of the small gym. When considered with the adjacent portable classrooms, demolition in this area may allow future growth and facilities that better meet the school's programmatic needs.

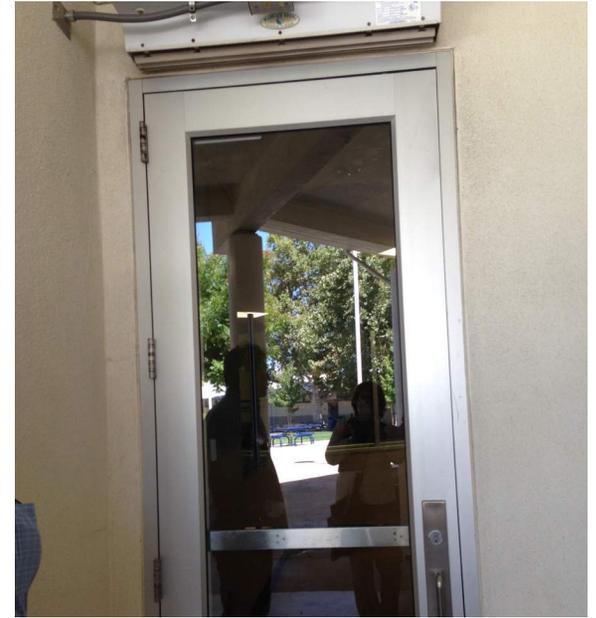
Entry signage and ISA required

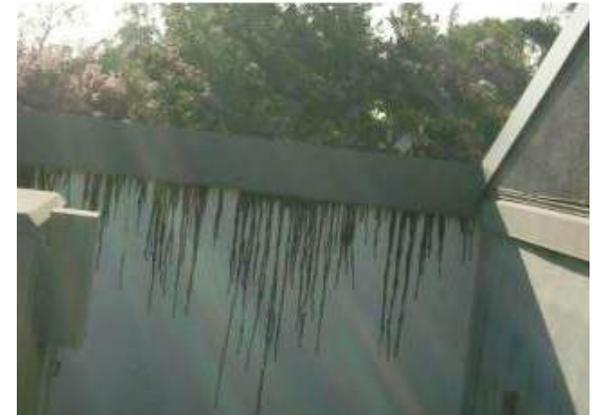
Parapet mastic in need of repair

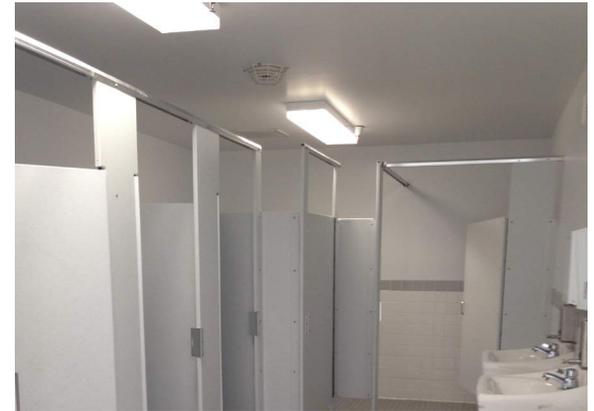
Minor issues in mounting heights and locations

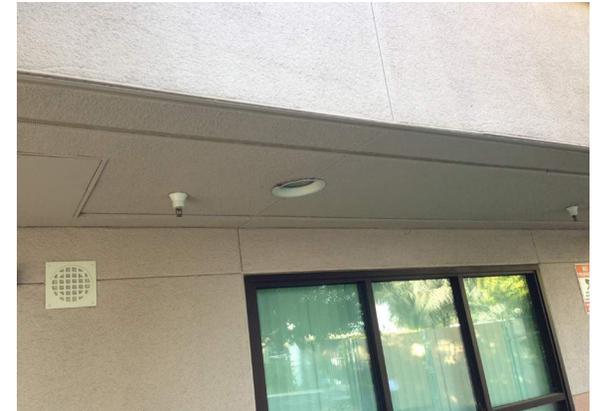
Building soffit - minor water stains

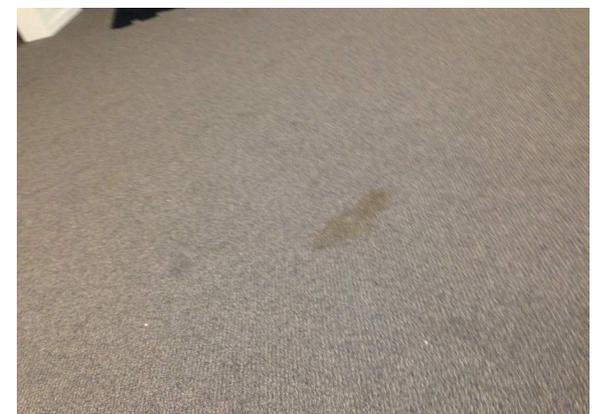
Stained carpet at MPR

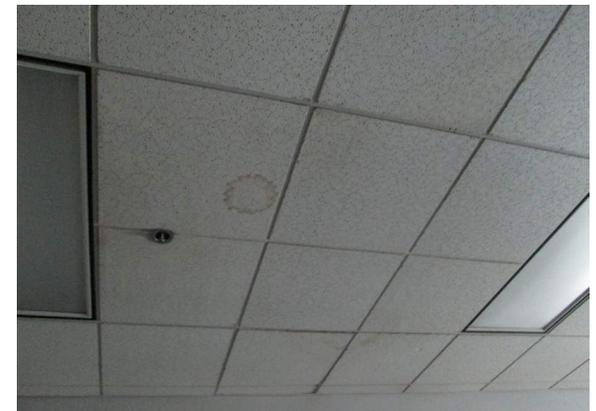
Damaged/stained ceiling tiles

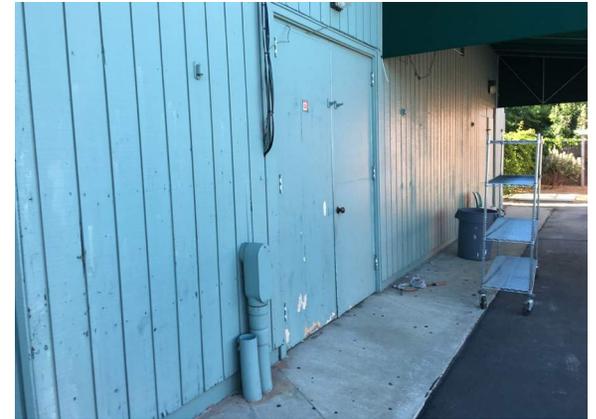
Deterioration at doors and siding

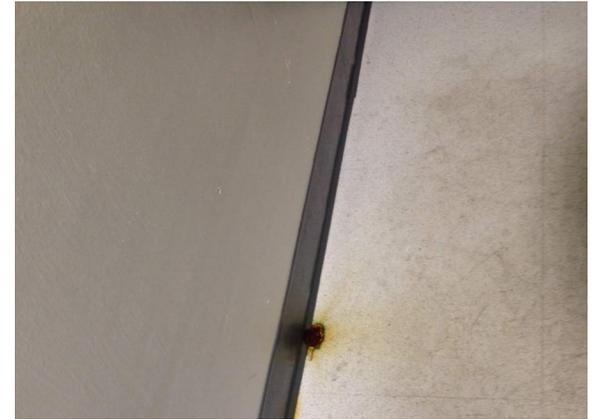
Condensation Drip at MDF

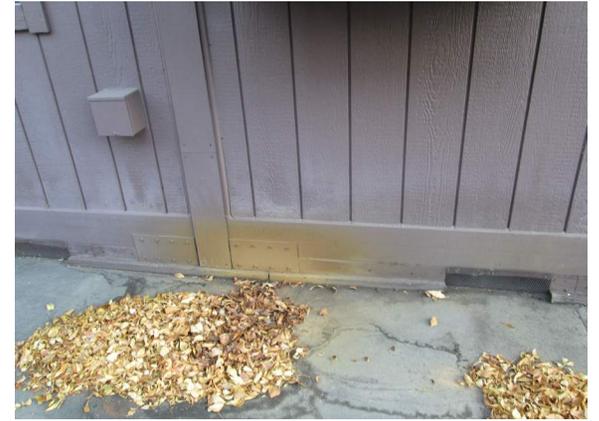
Splash damage at portable
