FACILITIES MASTER PLAN

2025

Persinger Architects

Grass Valley School District Master Plan 2025

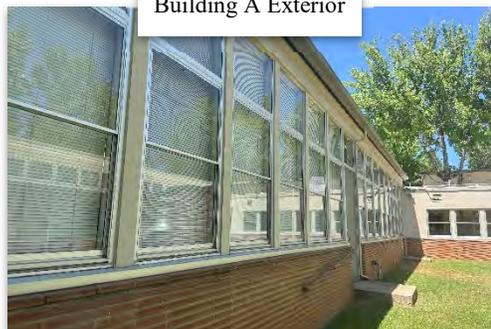
Building A Exterior

The roof of Buildings A and B have been reroofed in recent years and no leaks are noted.

HVAC in Buildings A and B have been replaced recently and are in fair condition.

Exterior brick and plaster siding are in fair condition and paint is in fair condition.

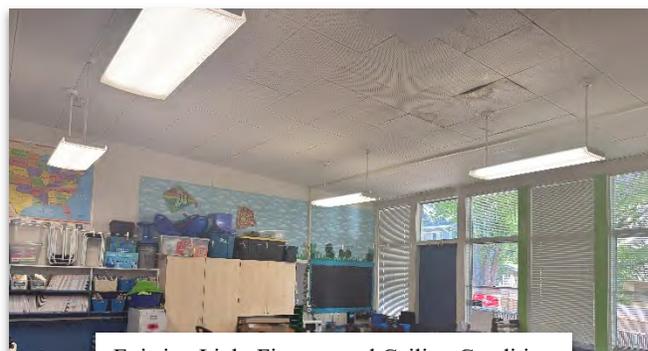
Existing Light Fixtures and Ceiling Condition

Fire alarm, low voltage, and data infrastructure are surface mounted in hallways and classrooms, and in fair condition.

The ceiling is a mix of painted hard lid in hallways and axillary spaces and acoustic tiles fastened directly to hard lid in classrooms. Paint is in fair condition with some areas of cracking, and acoustic tiles vary in condition but are generally poor and in need of replacement

Ceiling tiles should be replaced and repainted where needed.

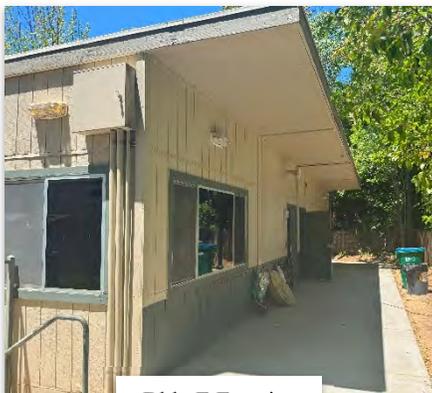
Bldg E Exterior

Exterior siding is generally painted plywood. Bldg C is fiberglass overlaid plywood. Siding and paint is original in fair, if aged, condition. Repairs in specific areas were made in 2025.

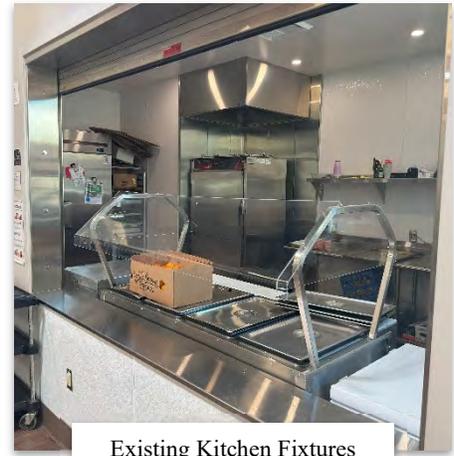
Existing Kitchen Fixtures

The kitchen, while a limited size and serviceability, is in good condition with original equipment.

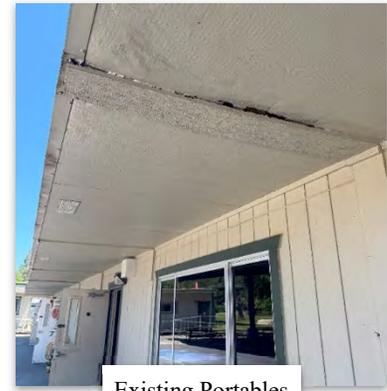
Existing Portables

Portable buildings of varying age provide additional classroom space on campus. The buildings are in aged condition with several items of deferred maintenance. In general, portable buildings are set on concrete foundation at grade at exterior entrances and use more temporary materials such as plywood siding.

Exterior paint and siding in aged condition.

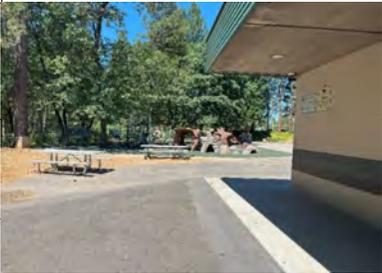
Site Fencing	Fencing is in fair condition with some gaps in security.	Silver: Install additional fencing and gates along N and E of campus. (350 LF)		\$23,625

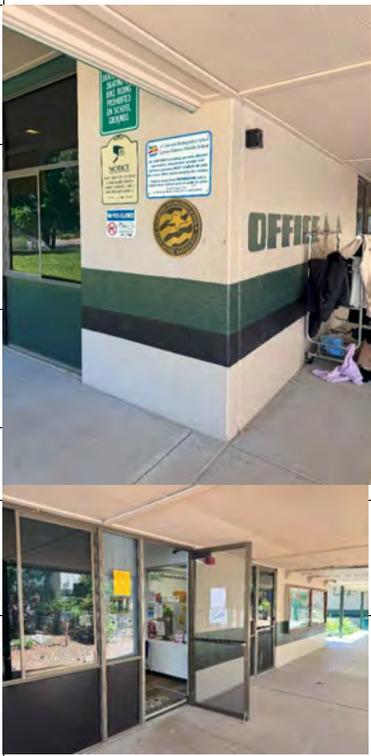
08.9010.021	Exterior Doors	Doors are in fair condition, but closers and hardware need upgrades and limited replacement.	Bronze: Replace door hardware where needed for code. Silver: Replace select doors. Gold: Incorporate keyless entry where appropriate.	\$5,359	\$9,487	\$39,145

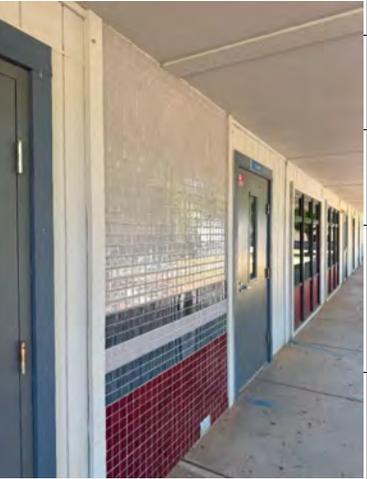
08.9010.021	Exterior Doors	Doors are in fair condition, but closers and hardware may need upgrades and limited replacement.	Bronze: Replace door hardware where needed for code. Gold: Incorporate keyless entry where appropriate.	\$10,718		\$33,553
