Big Chico Creek Erosion Repair Project

Biological Assessment

Butte County, California

July 2025

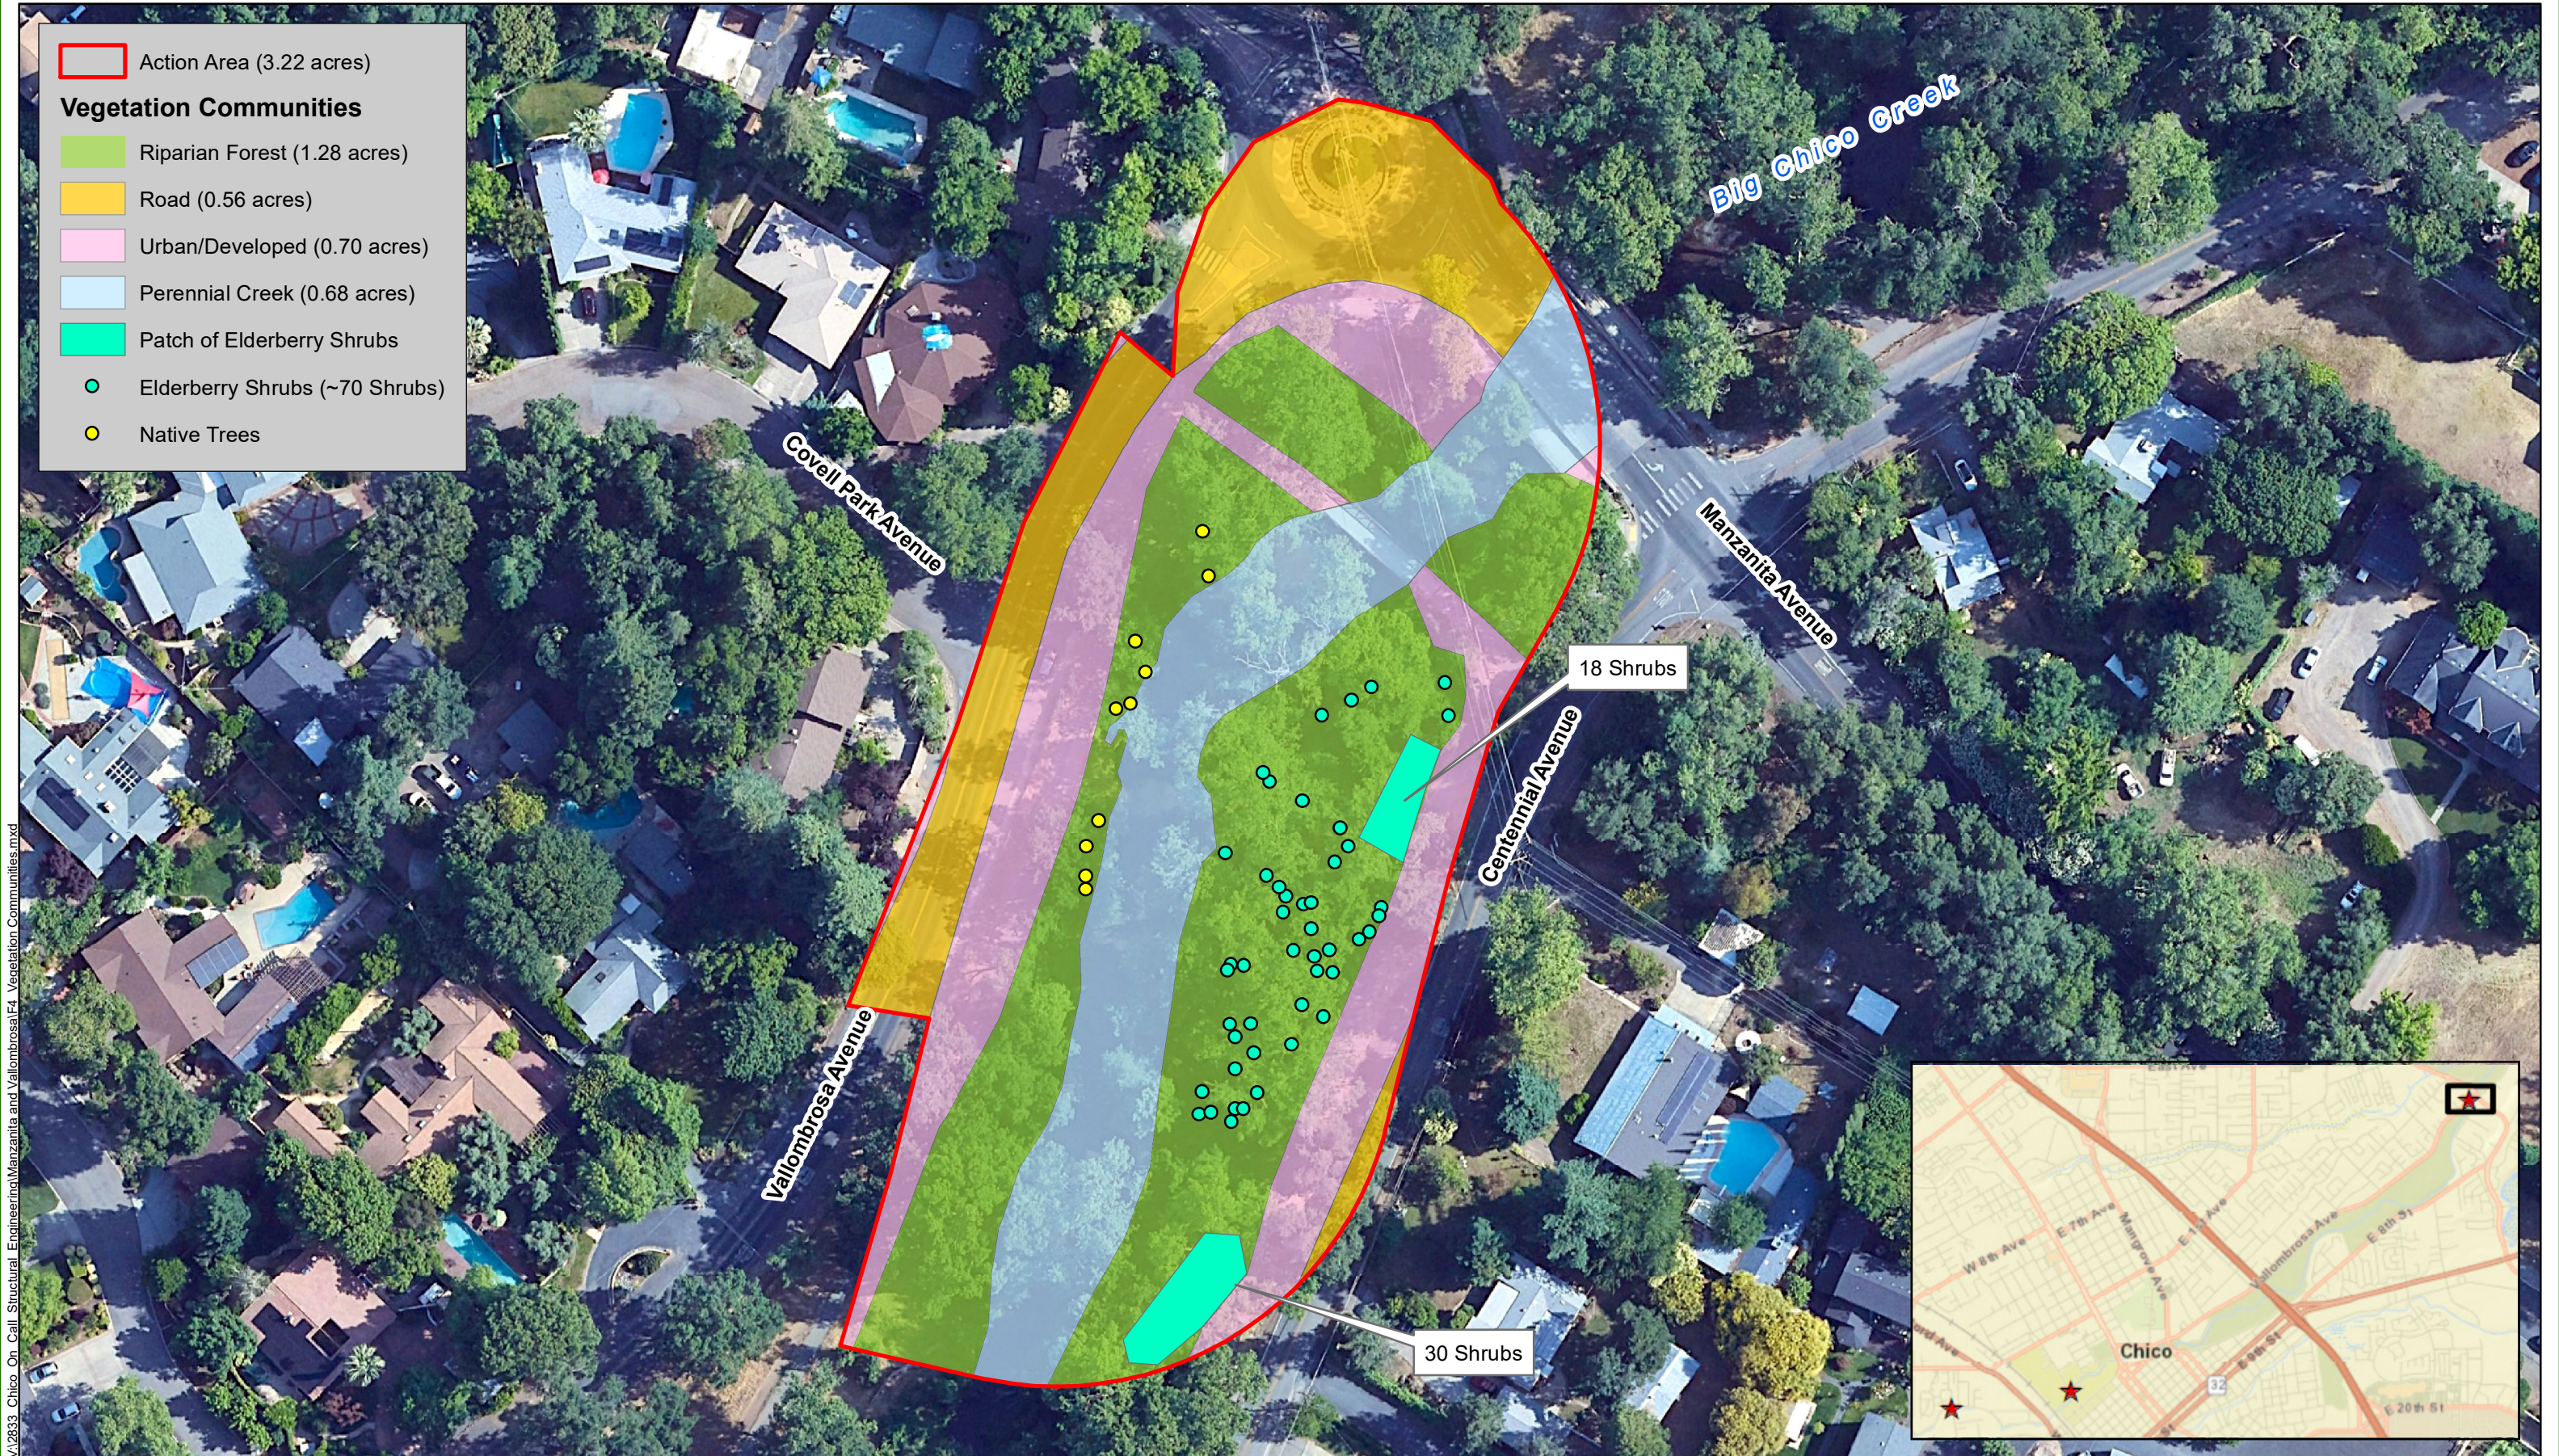
Figure 4
Vegetation Communities
 Page 3 of 4
 Warner Street Bridge
 Big Chico Creek Erosion Repair Project
 City of Chico, Butte County, California

The Action Area is situated within a region that has largely been altered for residential and recreational development. The Action Areas are divided by Big Chico Creek, a perennial channel that flows east to west. Vegetation communities within the Action Area include roadways, urban/developed, riparian forest, and perennial creek (Figure 4. Vegetation Communities). Plant and wildlife species observed within the Action Area during the July 2024, October 2024, and February 2025 biological surveys were used to define habitat types based on composition, abundance, and cover (Table 5. Plant Species Observed; Table 6. Wildlife Species Observed).

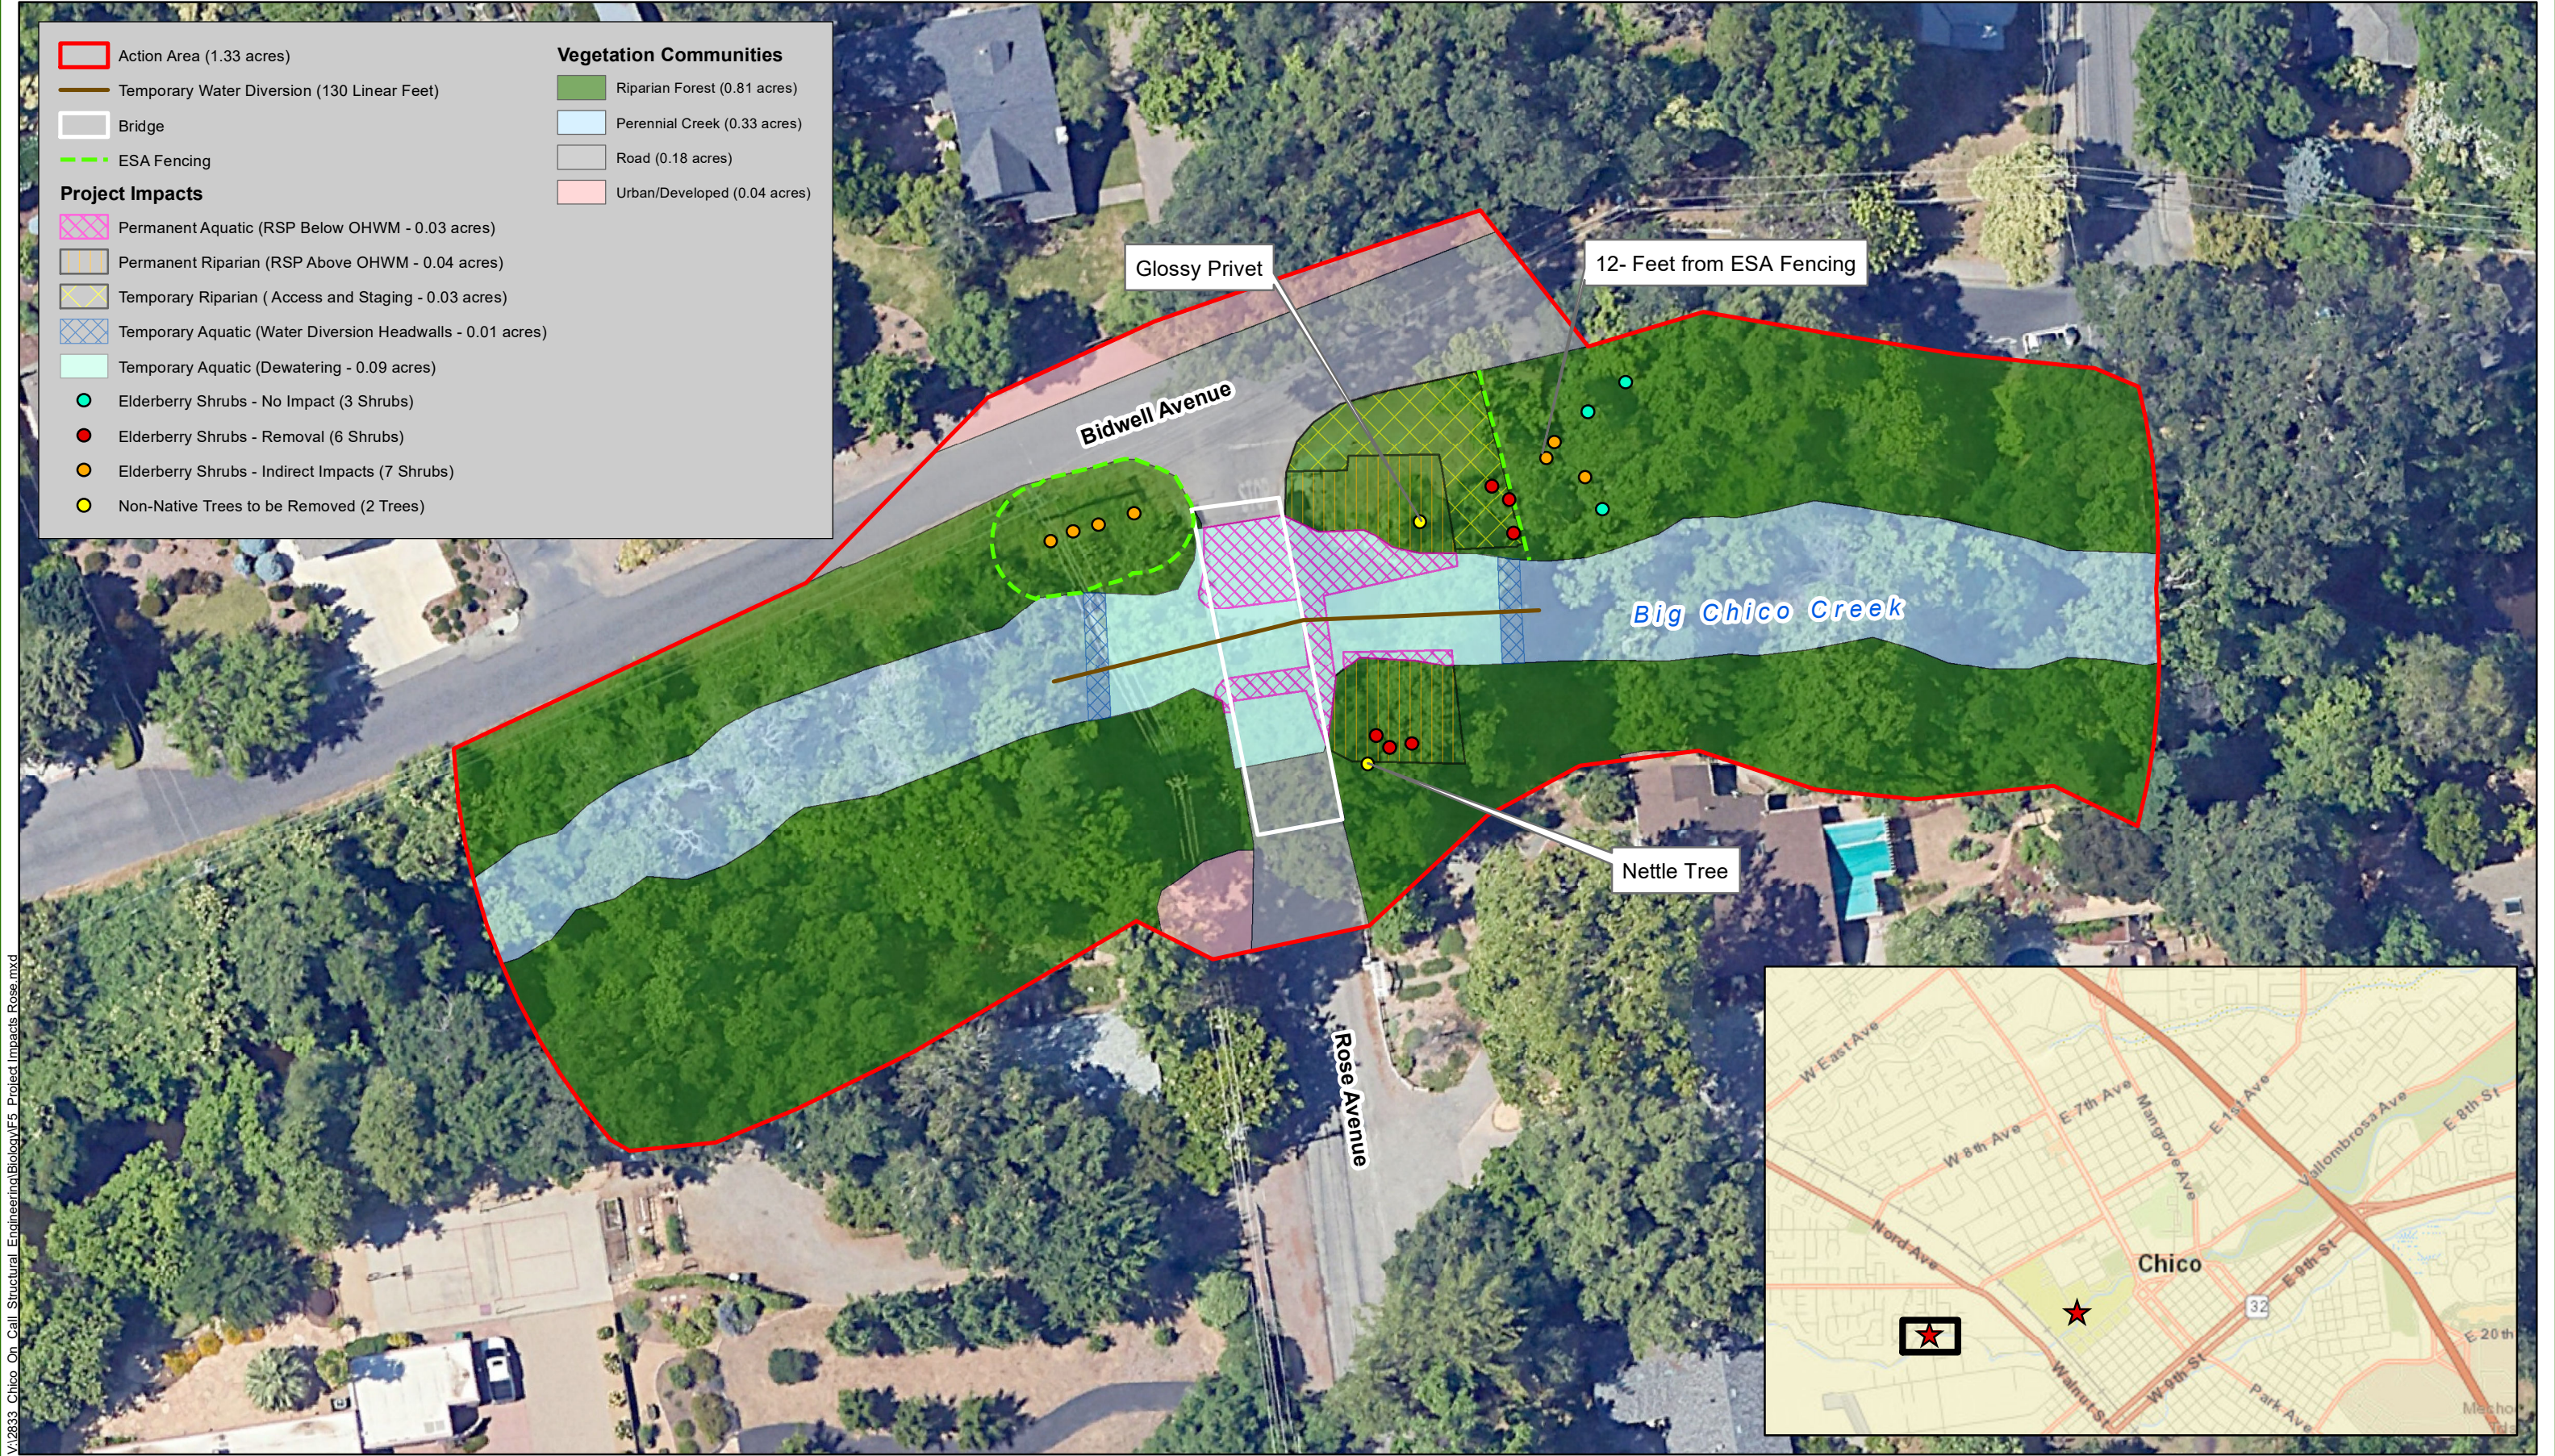
Figure 5
Project Impacts
Page 1 of 4

Construction activities east of the Rose Avenue Bridge will result in the removal of six elderberry shrubs identified within the Action Area (Figure 5. Project Impacts). No shrubs will be removed at the Warner Street Bridge or Vallombrosa Avenue sites. All 3 sites are presumed occupied by VELB and any VELB within the six shrubs to be removed at the Rose Avenue Bridge site would be exposed to this stressor.

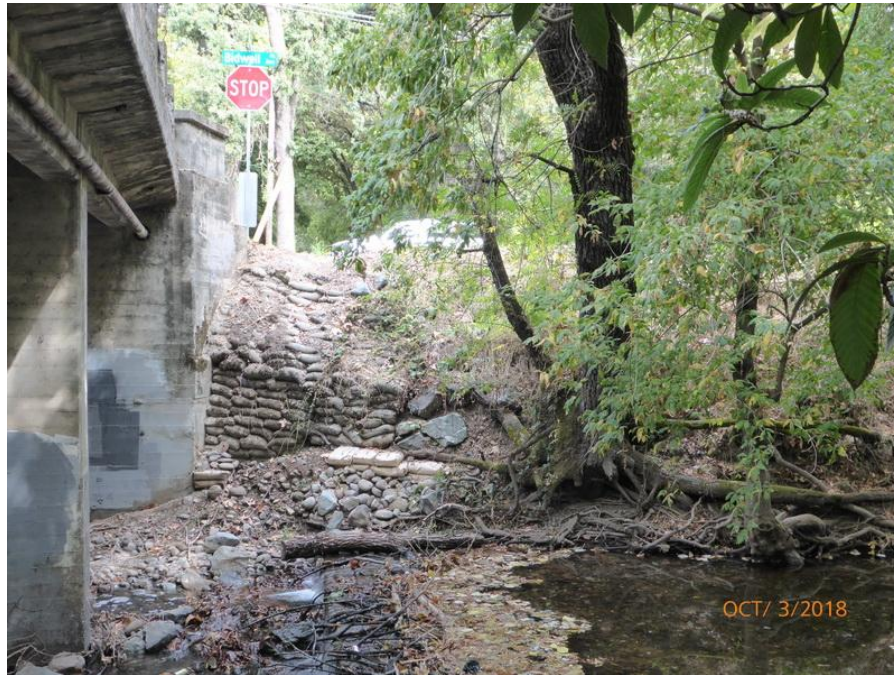
Photo 1. Representative photo of Big Chico Creek at the Rose Avenue Bridge, taken during a period of low flow, facing north. Note bank protection on steep slope. The large tree right of center was lost during the 2023 storms. Photo taken October 2018.

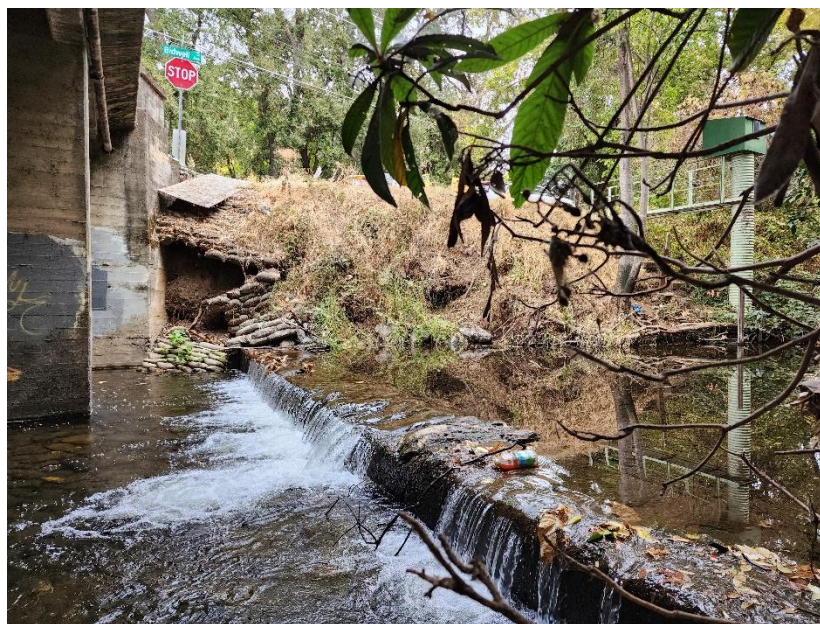
Photo 2. Representative photo of the 2023 storm damage along the northeast abutment and wingwall of the Rose Avenue Bridge. In 2024, some of the bank protection was lost, and the slope in front of the armoring eroded after a tree fell. Photo taken October 2024.

The Rose Avenue Bridge experienced damage during two federally declared disasters in January and February 2023. The damage in January (4683DR) occurred when torrential rainfall in the Big Chico Watershed raised creek levels and washed out the roots of trees on the north and south sides of the creek. The trees fell into the creek on the upstream (or east) side of the Bridge, directing the high, fast-moving water towards both banks scouring the banks from the bridge abutments to 35 feet upstream. The scouring caused the loss of approximately 466 cubic yards of soil from both banks. The dimensions of the areas affected by the January 2024 event are 35 feet long, 20 feet wide, and 18 feet deep. Then, storms from January 21 to February 9, 2024, in the watershed caused additional damage and resulted in a second federal disaster declaration (4769DR). Heavy rainfall and stormwater overtopped the road and swelled the waterway under the bridge. As a result, the embankment at the northeast bridge abutment was scoured and slope armoring failed.

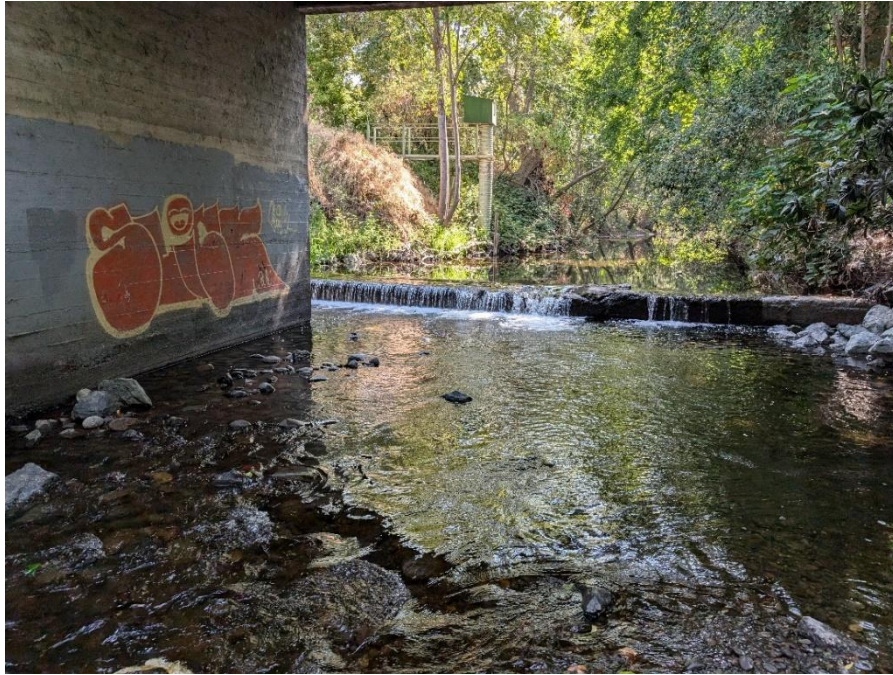
Photo 3. Representative photo of Big Chico Creek and its associated riparian forest at the Rose Avenue Bridge location, taken facing east, looking upstream. A 21" sewer line, encased in concrete, functions as a low weir across the creek. Photo taken July 2024.

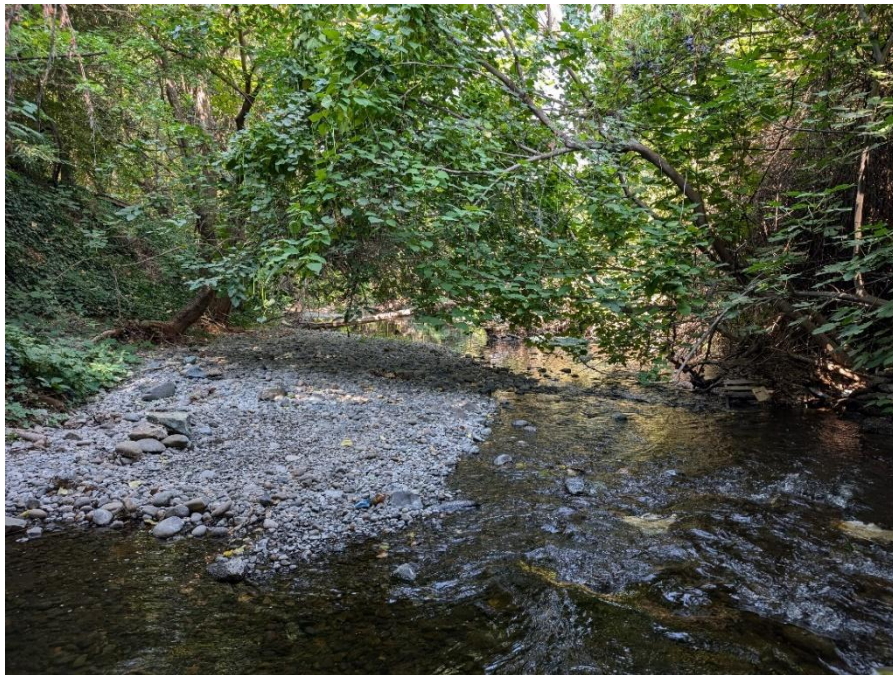
Photo 4. Representative photo of Big Chico Creek at the Rose Avenue Bridge, taken facing west, looking downstream. Photo taken July 2024.

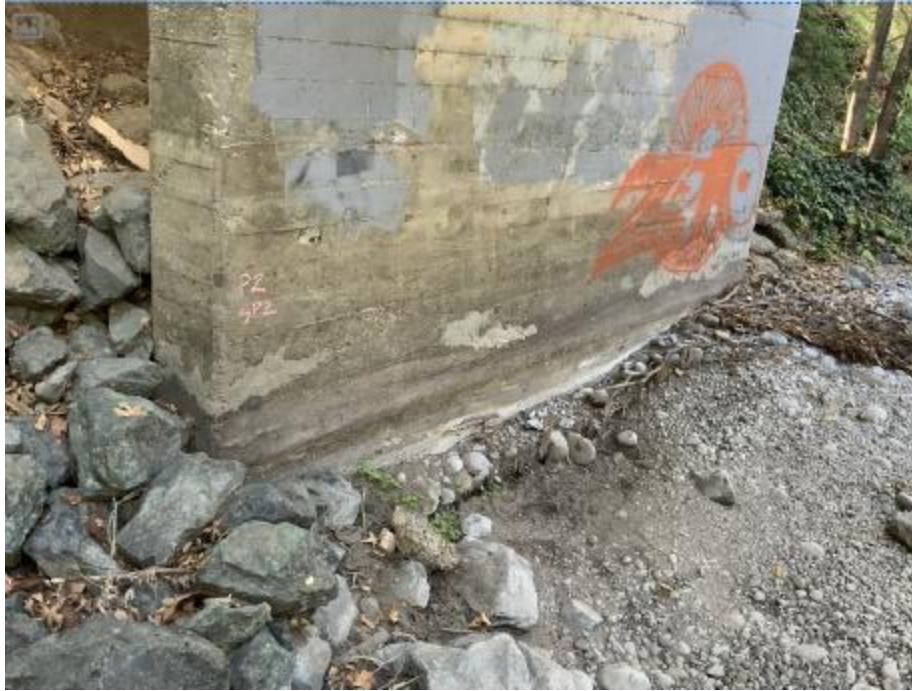
Photo 5. Representative photo of the exposed footing of Pier 2 and a lack of flowing water at the Rose Avenue Bridge site. Taken September 2016.

The bridge was constructed in 1925. It is a three-span reinforced concrete T-girder bridge on reinforced concrete pier walls and open reinforced concrete diaphragm/wall abutments at are all founded on spread foundations. Approximate 10-feet upstream of the bridge, there is a 21-inch gravity sewer pipe in the bed of the creek. The pipe, constructed in 1929, is encased in concrete. The pipe functions as a check dam or weir where, upstream, creek bed is full of cobbles to the height of the concrete encasement.

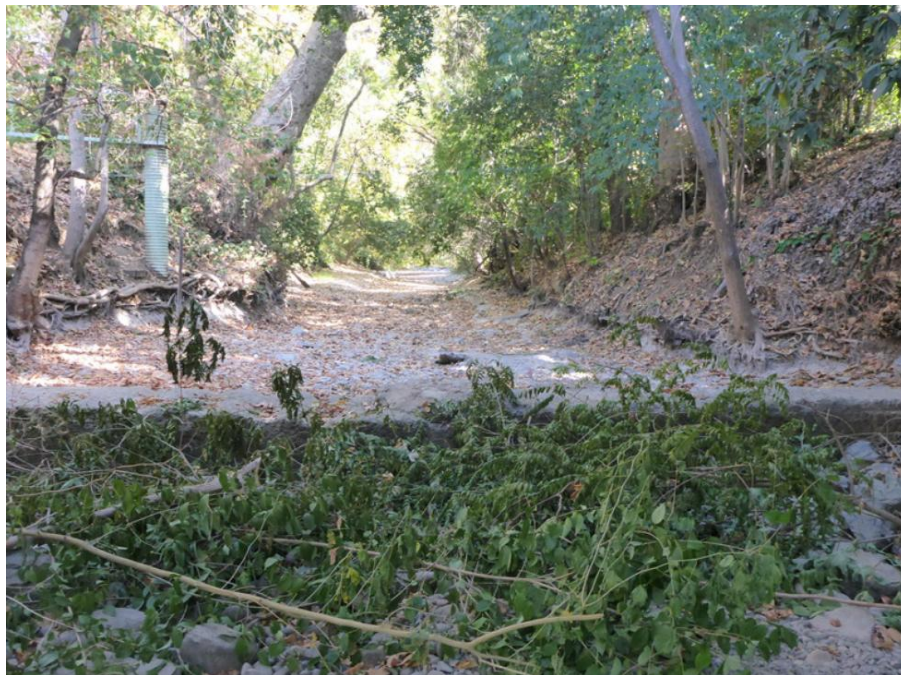
Photo 6. Representative photo of the concrete encased utility at the Rose Avenue Bridge site when Big Chico Creek is not flowing. Taken October 2016.

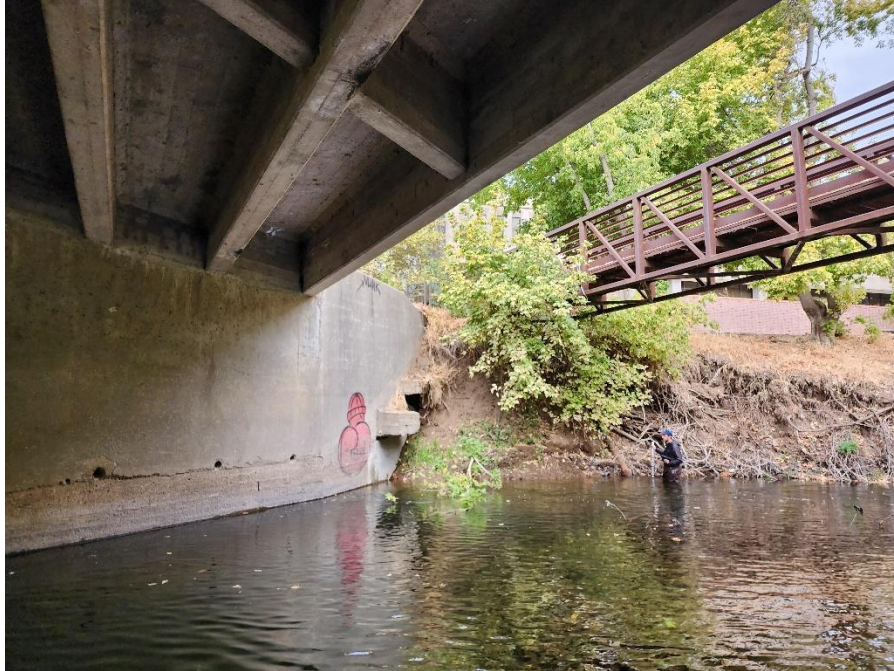
Photo 7. Representative photo of the scour at the northern abutment. Scour has caused the creek bank to retreat, exposing the concrete wingwall footings. A pedestrian bridge that spans the creek is visible upstream of the Warner Street Bridge Taken October 2024

The Report details the changes to the north abutment: “The right side of the Abutment 3 footing is exposed up to 1 foot vertically for approximately 5 feet in length. No undermining was noted when probed with an extension pole. This exposure was not noted in the 2018 and 2020 routine inspection reports, however the 9/14/2017 Hydraulic

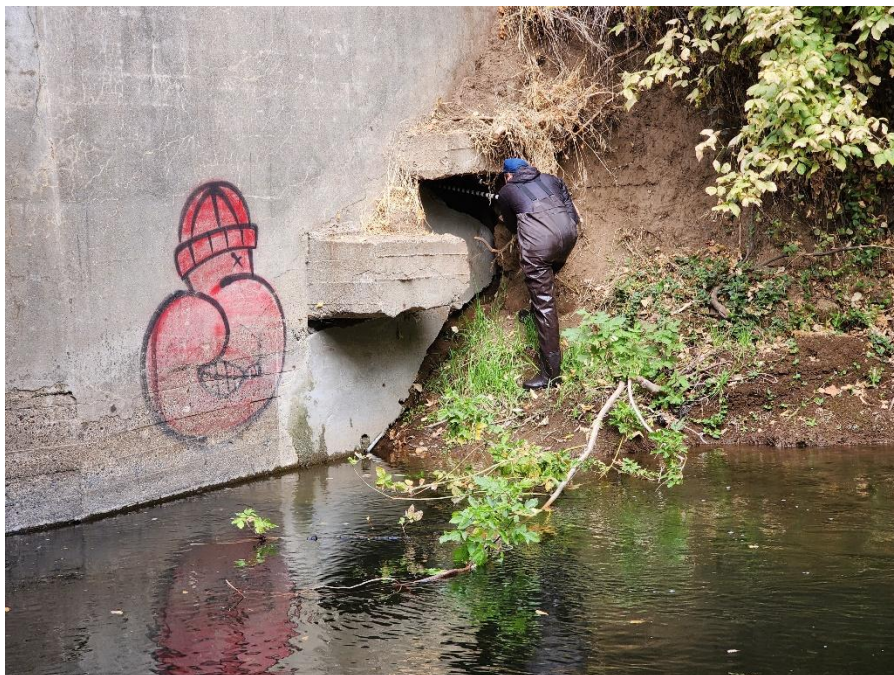
Photo 8. Representative photo of right wing wall step #2 footing that is completely undermined. Taken October 2024.

The Caltrans Bridge Inspection Report from October 2022 notes that “The stepped wingwall foundations on the right wingwall at Abutment 3 are exposed and undermined. There is an existing work recommendation to mitigate the scour at the right wingwall of Abutment 3 in accordance with HEC-23 procedures.”

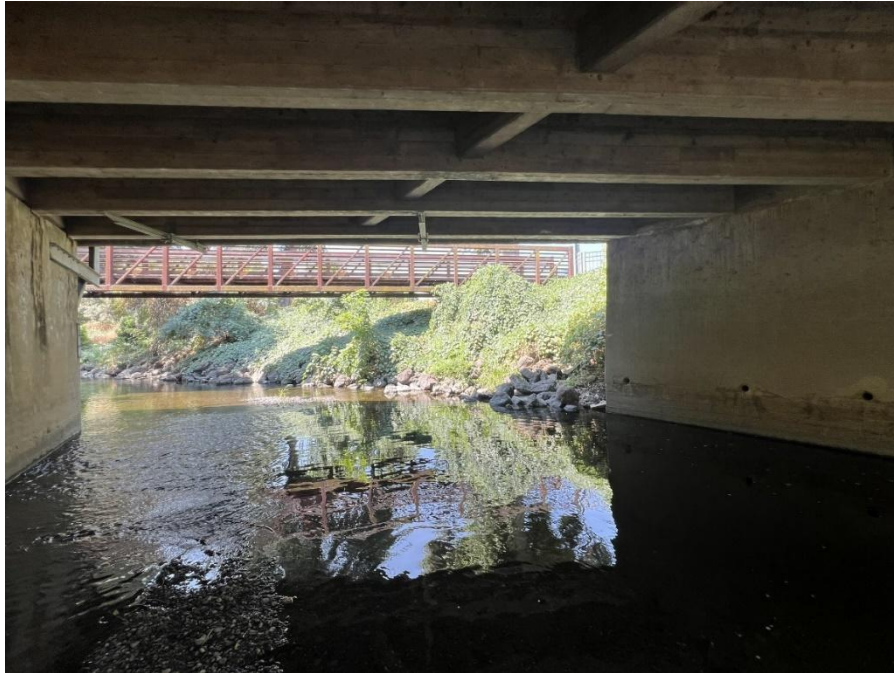
Photo 8. Representative photo of Big Chico Creek at the Warner Street Bridge location , taken facing west, looking downstream. Pedestrian bridges occur on both sides of Warner Street bridge. Note existing RSP on north creek bank downstream of the bridge abutment. Photo taken July 2024.

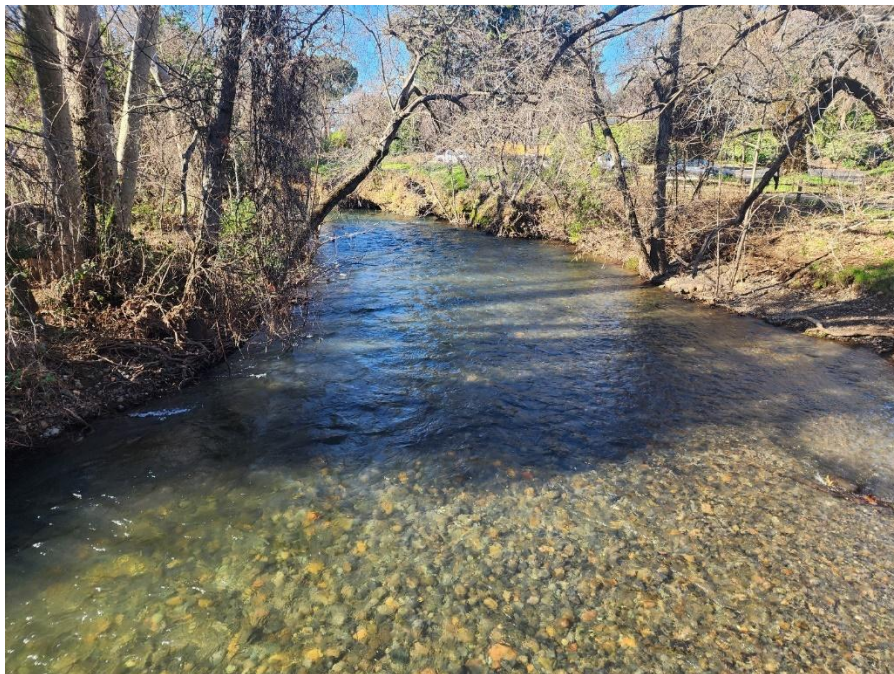
Photo 9. Representative photo of Big Chico Creek and its riparian forest, taken facing west from the pedestrian path on the Manzanita Pedestrian Bridge—approximately 100 feet south of the Manzanita Avenue and Vallombrosa Avenue intersection—looking downstream. Photo taken February 2025.

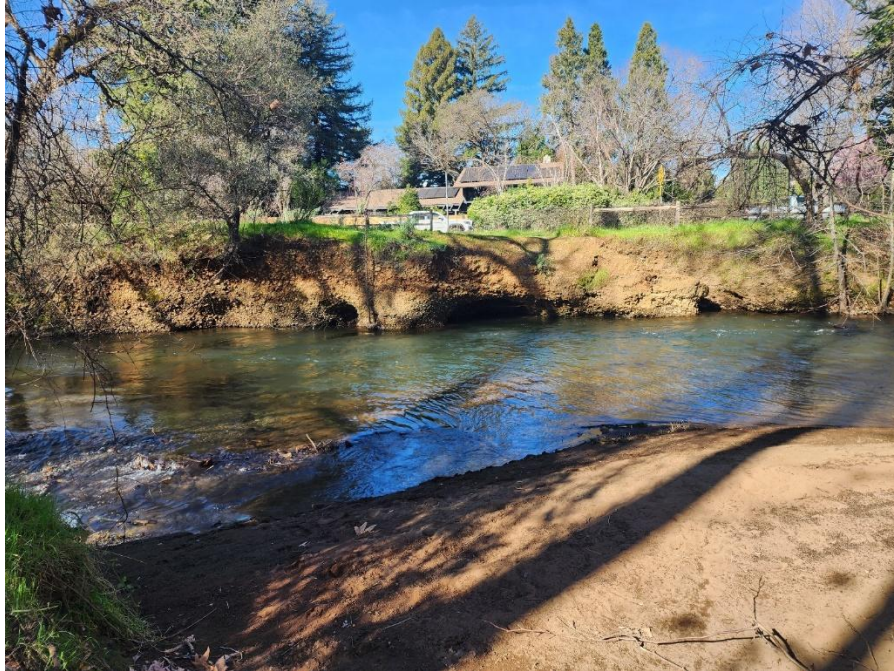
Photo 10. Representative photo of the erosion feature along the west bank of Big Chico Creek , taken facing west from the east bank. Photo taken February 2025.

This erosion site is located just downstream of the intersection of Manzanita Avenue and Vallombrosa Avenue. The west bank of the creek has significant erosion at the base. This location is a common recreation area during summertime where the public jumps off the top of bank into the creek. The scour has undercut the west bank, creating a "cave" that is exposed during normal flows. The recreation activity at this location could also be a contributing factor to the erosion at that site. The erosion damage is approximately 80 feet in length, 8 feet in width, and 15 feet high.

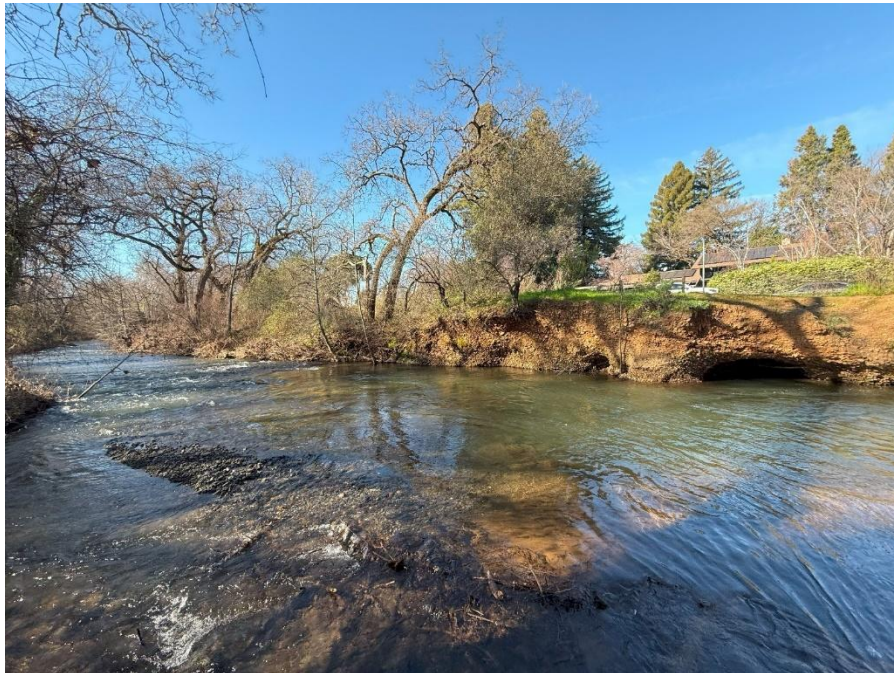
Photo 11. Representative photo of Big Chico Creek, showing conditions downstream of the erosion feature. Photo taken February 2025, facing southwest.

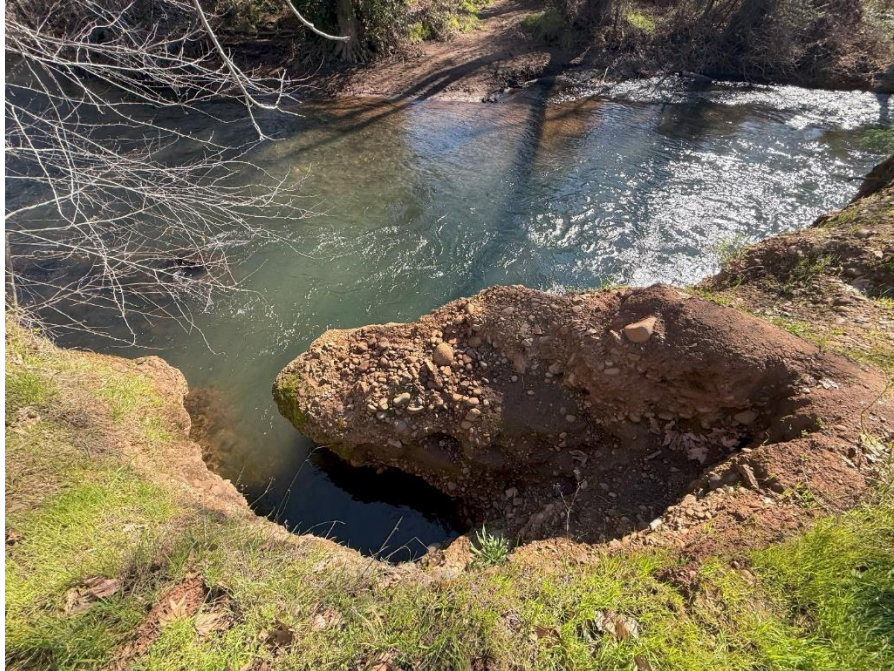
Photo 12. Representative photo of the erosion feature along the west bank of Big Chico Creek, taken facing east. Photo taken February 2025.

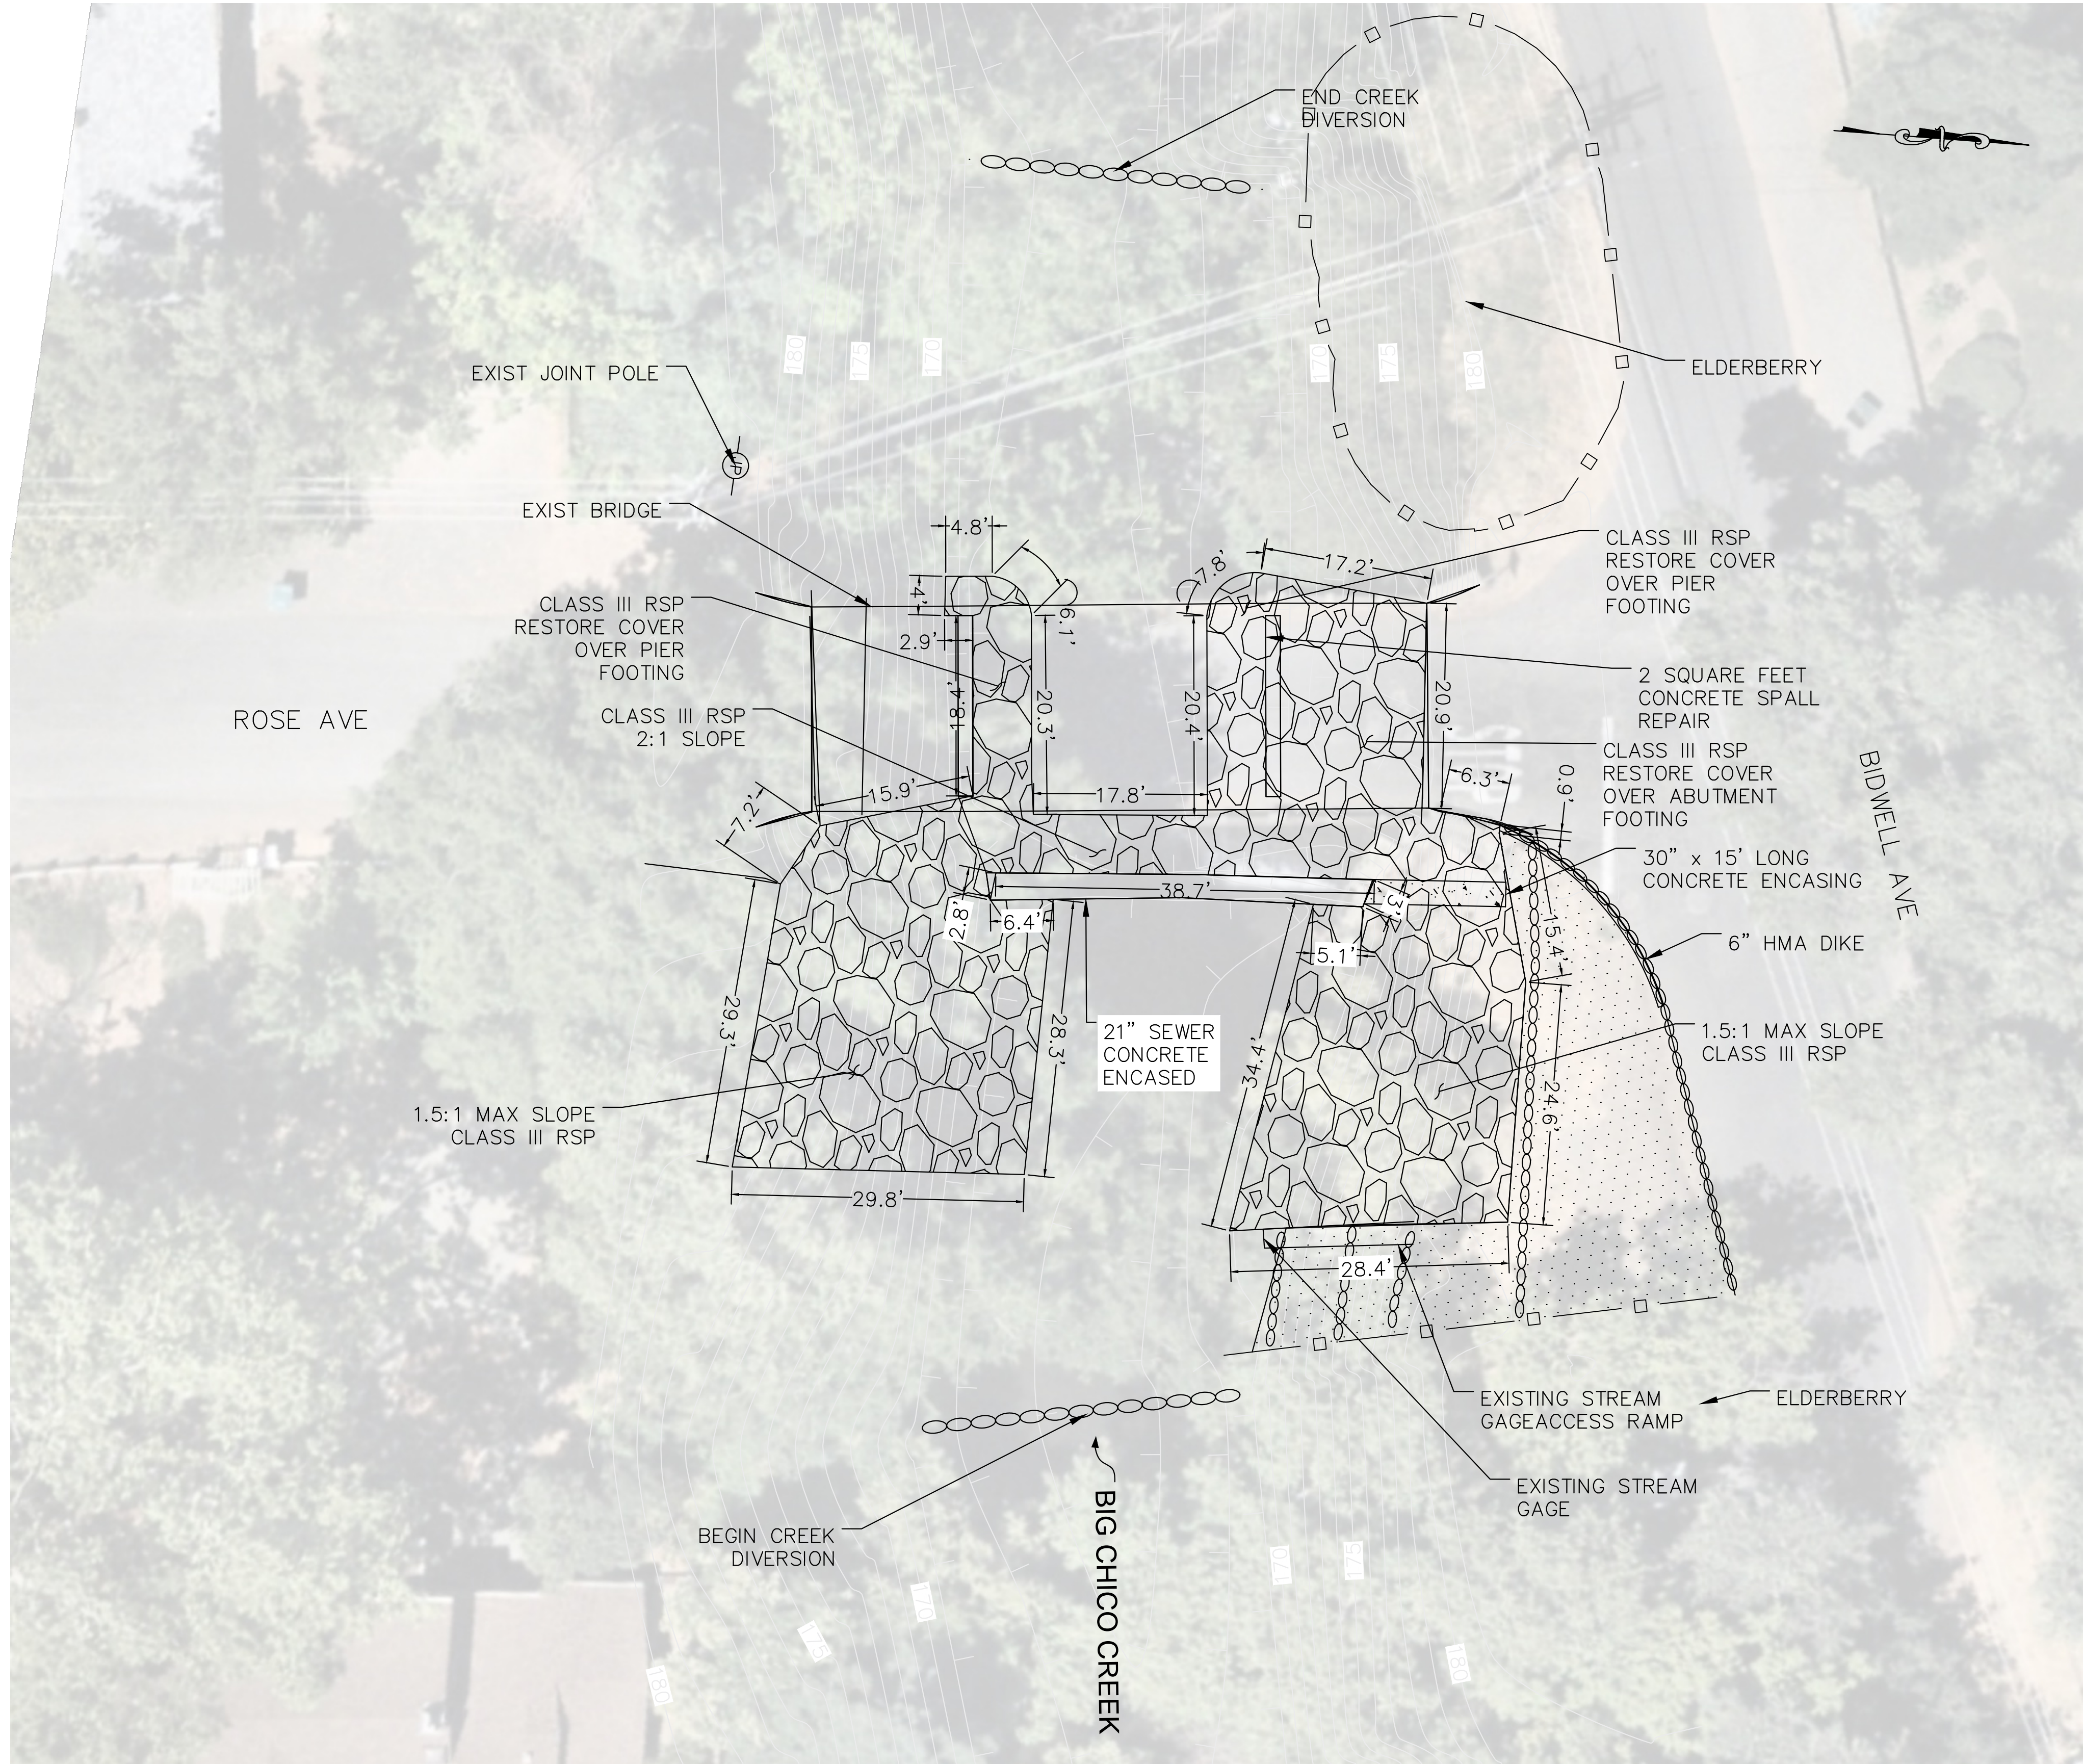
Sheet 02 of 10

PERMANENT REPAIR AREA
