# Cultural Resources Inventory Report for the Big Chico Creek Erosion Repair Project

City of Chico, Butte County, California

**Cultural Resources Inventory Report  
for the  
Big Chico Creek Erosion Repair Project  
City of Chico, Butte County, California**

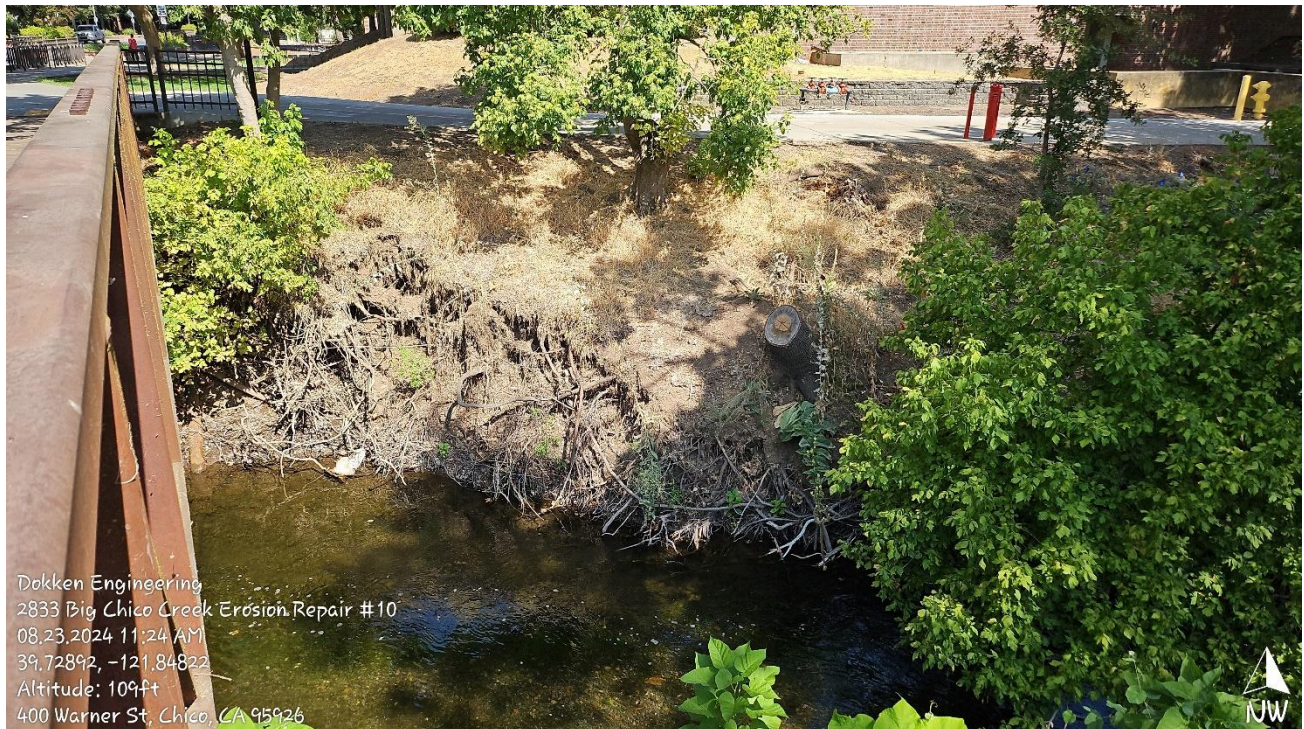
**Photograph 1.** Overview of north bank of Big Chico Creek along the east side of the pedestrian bridge adjacent to 12C-0276. View facing north.

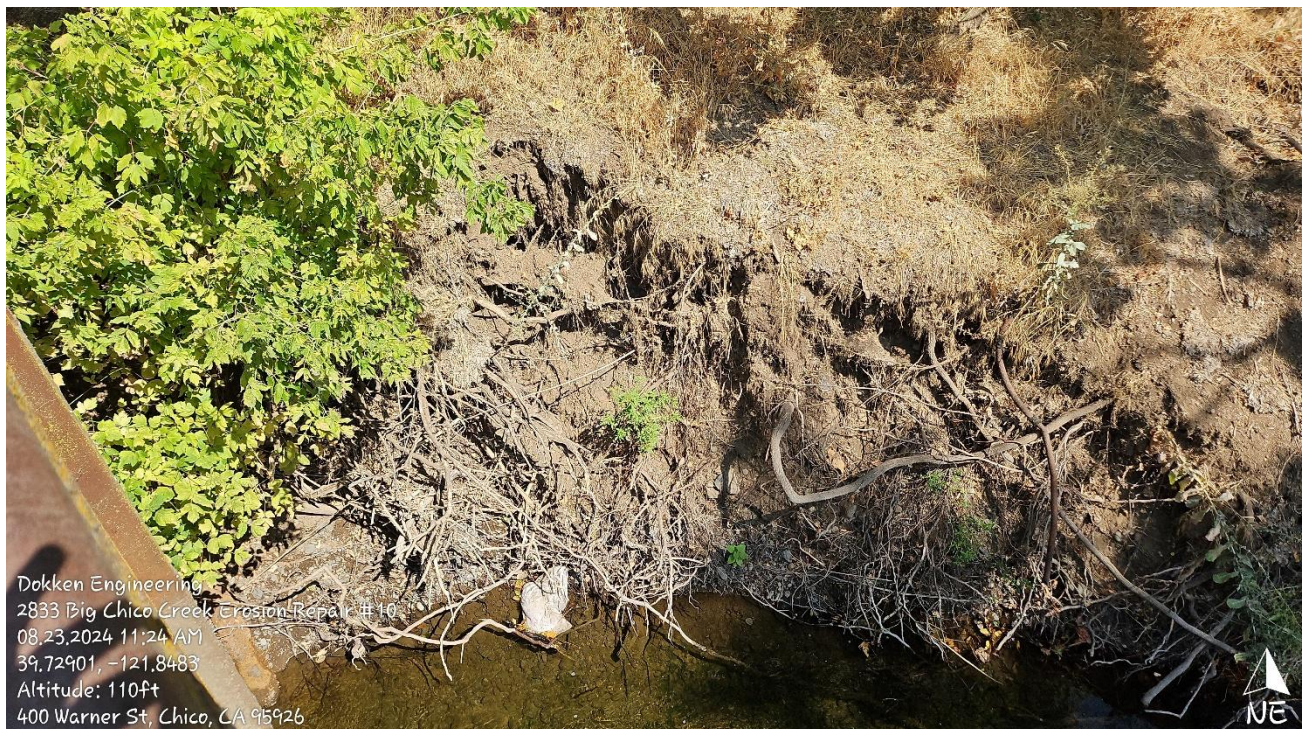
**Photograph 2.** Close-up of erosional damage along the north bank of Big Chico Creek. View facing north/northeast.

The City proposes to repair the erosion and address the scour issue on north bank of the creek using rock slope protection (RSP). RSP will reinforce the existing creek bank and protect the northern abutment from undermining and failure. The RSP on the creek banks will be based on the Caltrans' Mounded Toe RSP design as shown in Highway Design Manual Figure 873.3D with a 1.5:1 slope. The RSP will be underlain with a gravel filter.

A total of 90 linear feet of RSP will be installed along the north bank upstream of the bridge, 40 linear feet of RSP along the north bridge abutment, and 50 linear feet of RSP will be placed along the north bank downstream of the bridge.

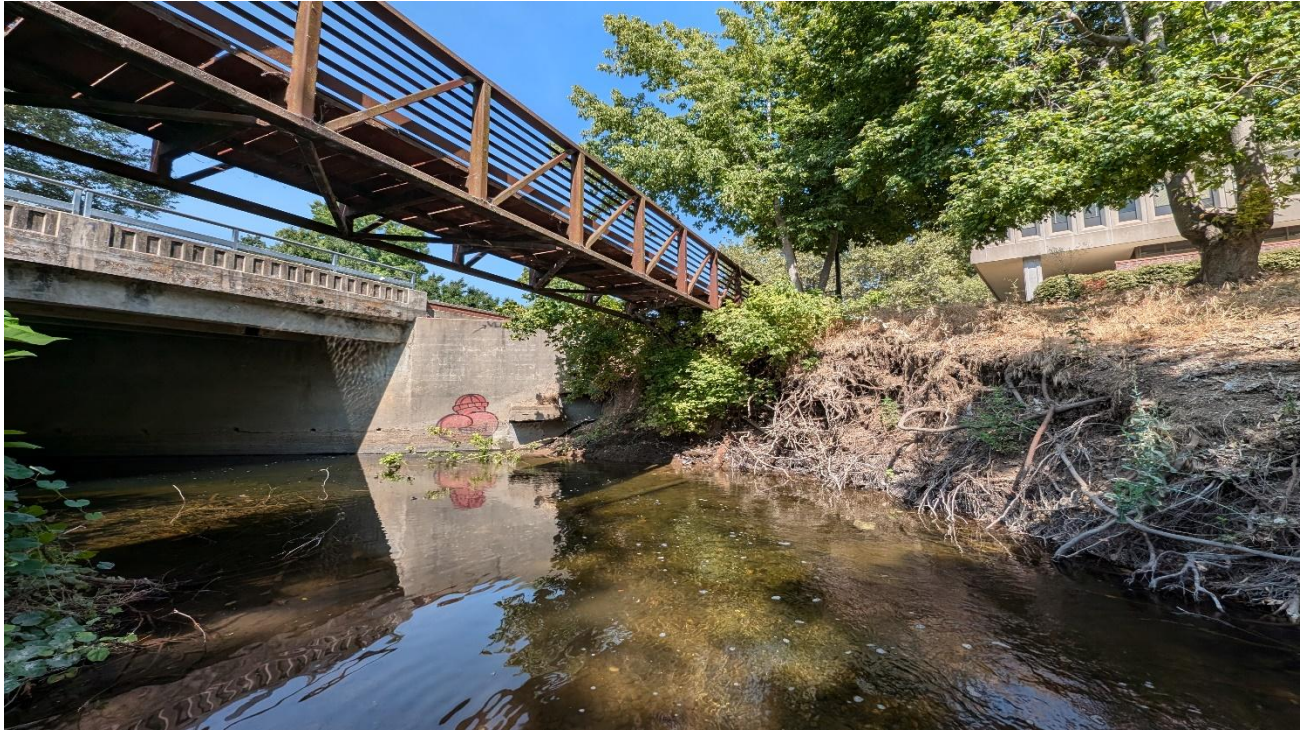
**Photograph 3.** Overview of the north bank of Big Chico Creek and along the western edge of Bridge 12C-0276. View facing northwest.

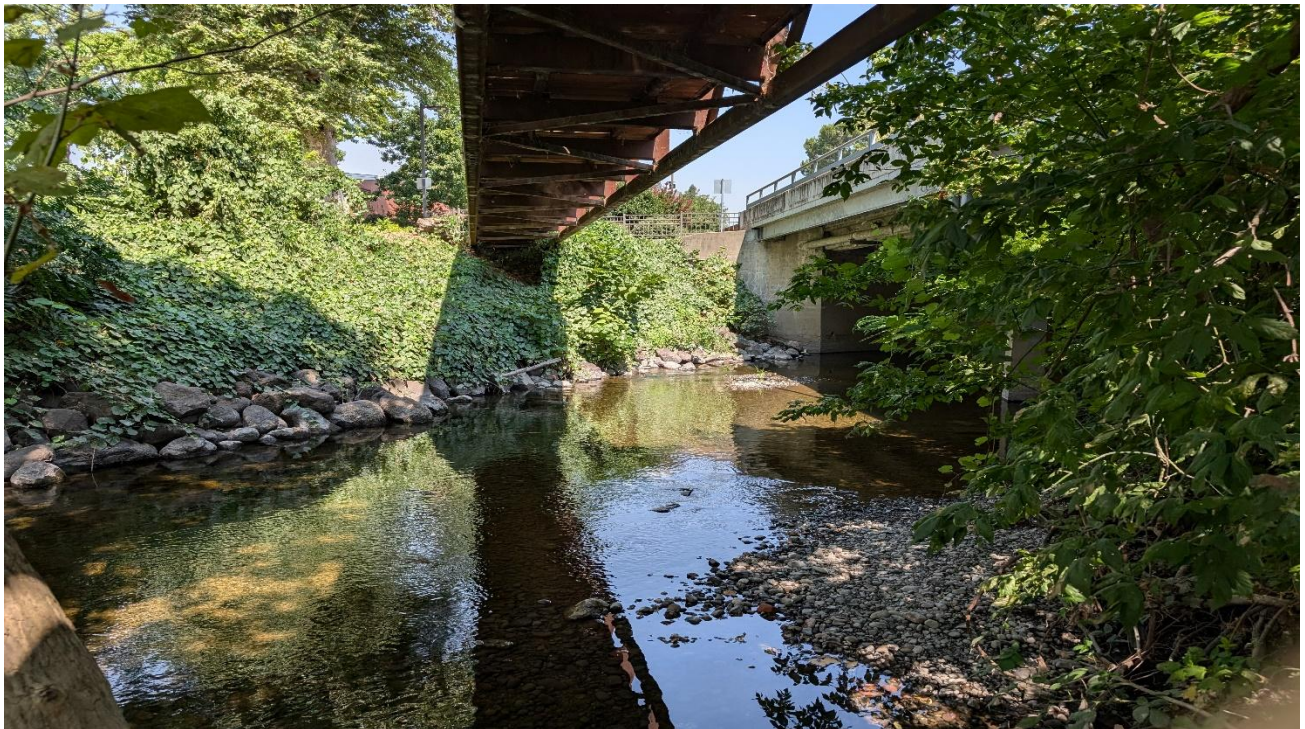
**Photograph 4.** View of the north bank of Big Chico Creek west of Bridge 12C-0276. View facing north/northeast.

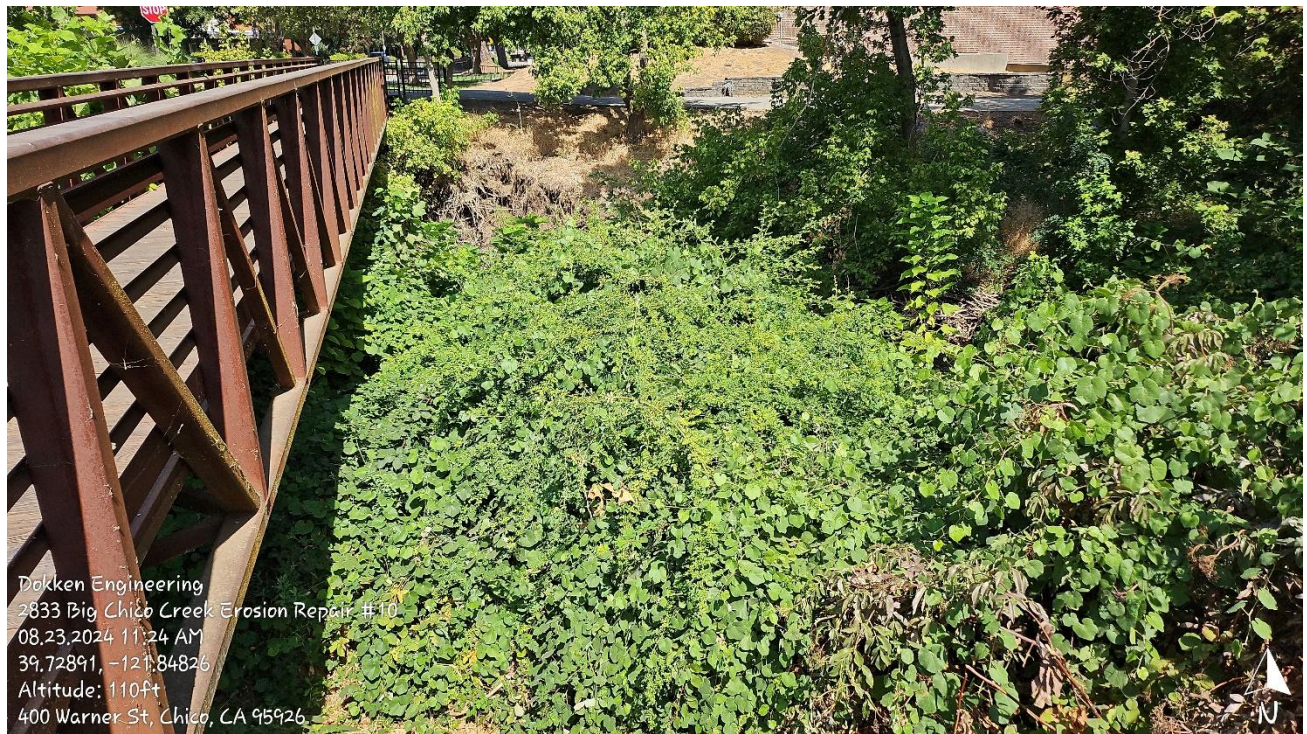
**Photograph 5.** Overview of dense vegetation throughout the Creek. View facing north.

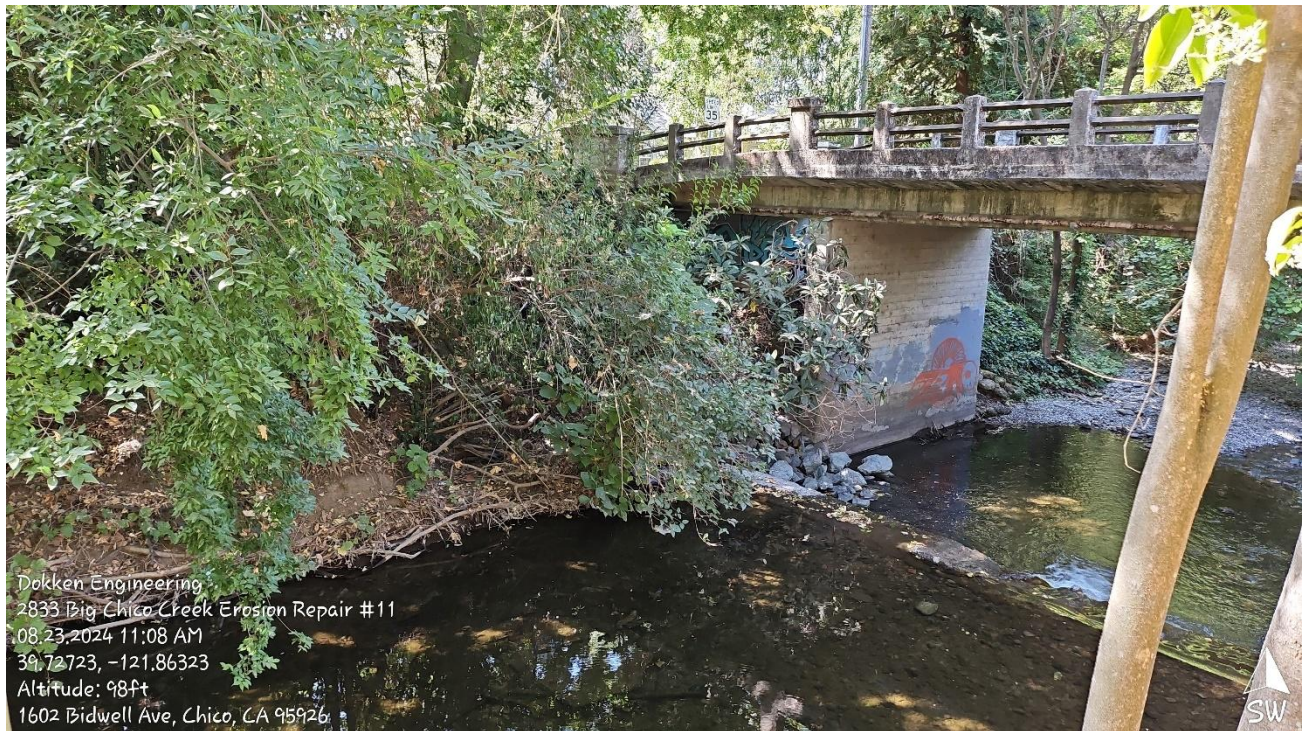
**Photograph 6.** Overview of the Rose Avenue Bridge location. View facing southwest.

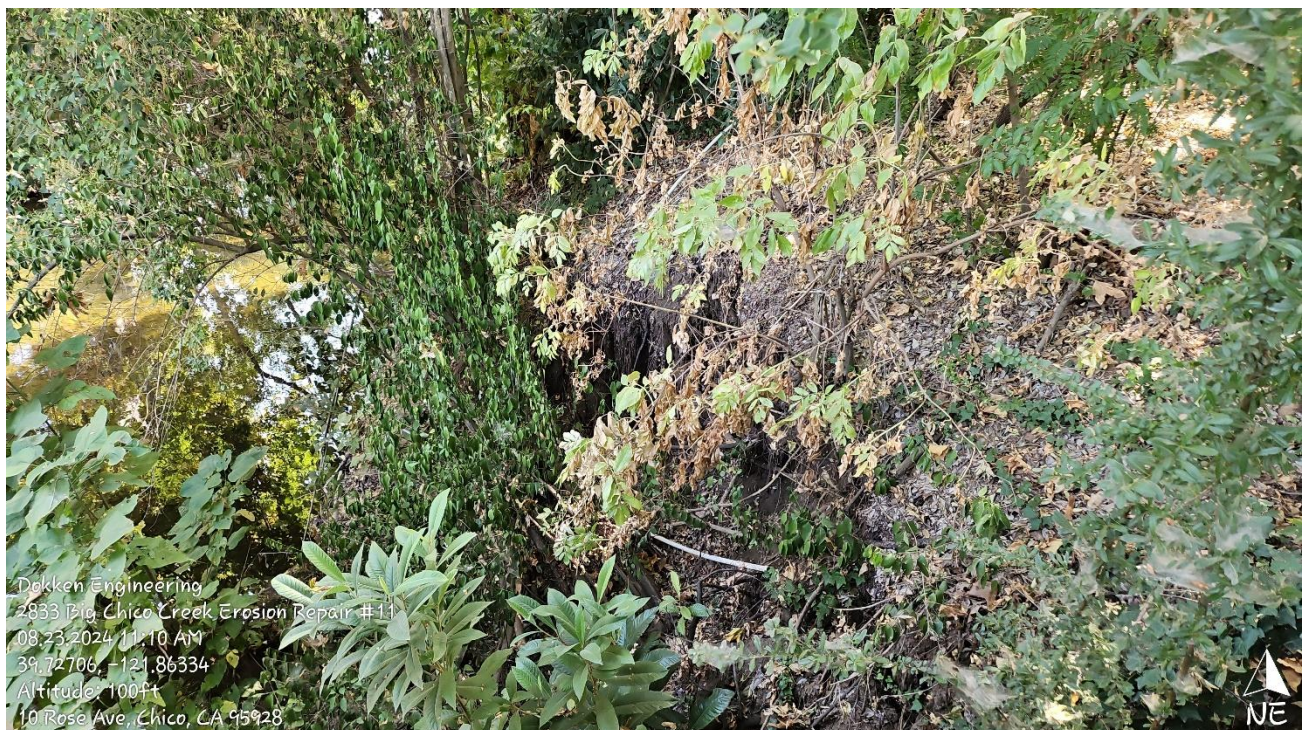
**Photograph 7.** Overview of significant erosional damage somewhat obscured by dense vegetation near the southeast corner of the bridge. View facing east.

The City proposes to repair the erosion on both banks and the scour around the piers, north abutment footing, and the sewer pipe using a combination of RSP. RSP will reinforce the existing creek banks and a concrete-encased sewer pipe. The RSP on the creek banks will be based on the Caltrans' Mounded Toe RSP design as shown in Highway Design Manual Figure 873.3D with a 1.5:1 slope. The RSP will be underlain with a gravel filter.

A total of 46 linear feet of RSP will be installed along the north creek bank upstream of the bridge, 20 linear feet of RSP along the base of the north bridge abutment, and 50 linear feet of RSP will be placed along the south creek bank upstream of the bridge. The RSP will extend upstream to protect an existing stream gage. RSP will be placed on the downstream side of the concrete encased sewer pipe to prevent additional scour.

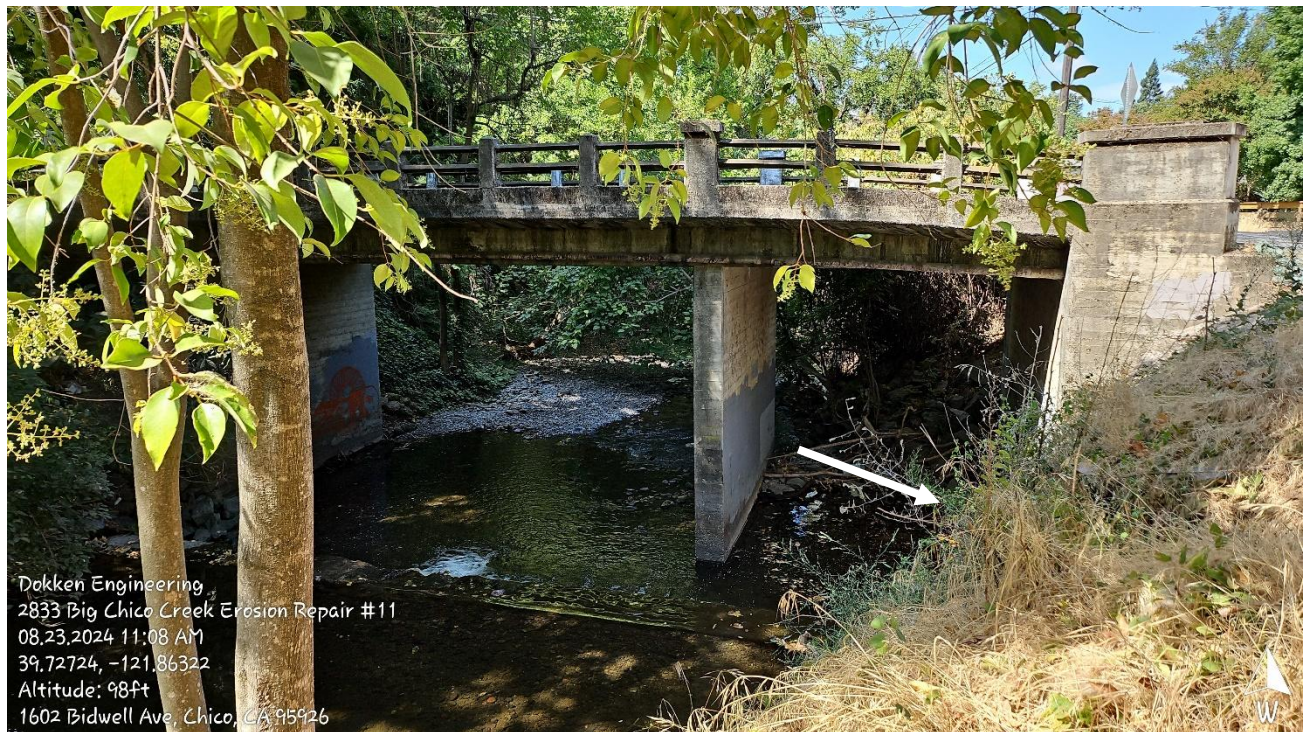
**Photograph 8.** Overview of the Bridge and the location of the proposed concrete ultra block (white arrow). View facing west.

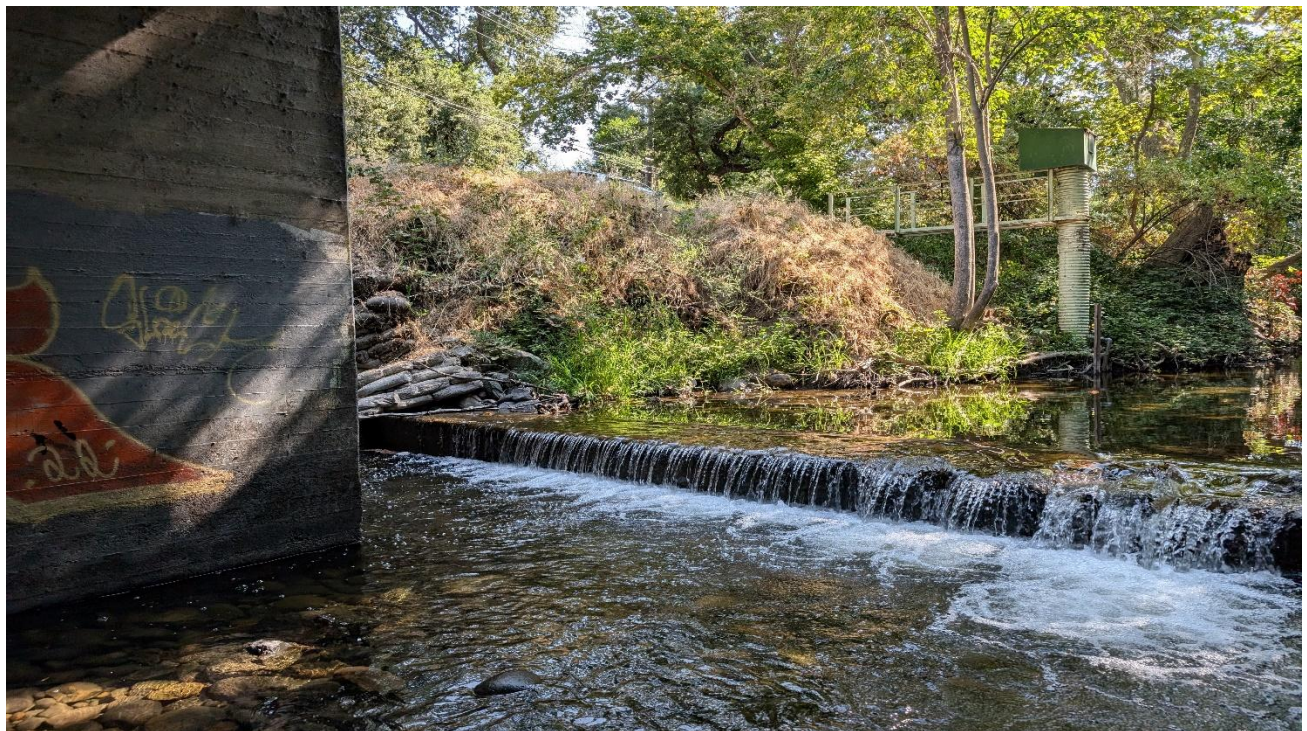
**Photograph 9.** Overview of the northeast bank of Big Chico Creek. View facing northeast.

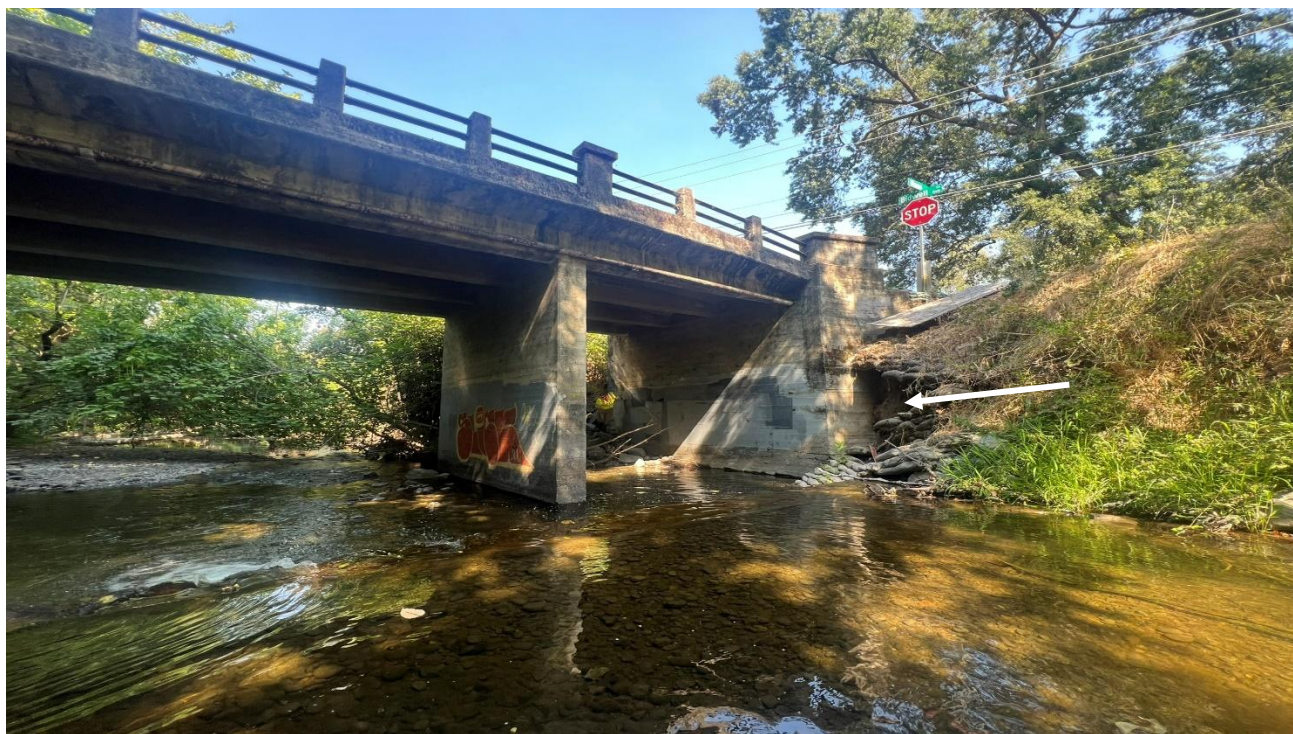
**Photograph 10.** Overview of the northern bank where erosion damage is occurring (white arrow). View facing northwest.
