AQUATIC RESOURCE DELINEATION REPORT

Rose Avenue Bridge Big Chico Creek Erosion Repair Project Butte County, California

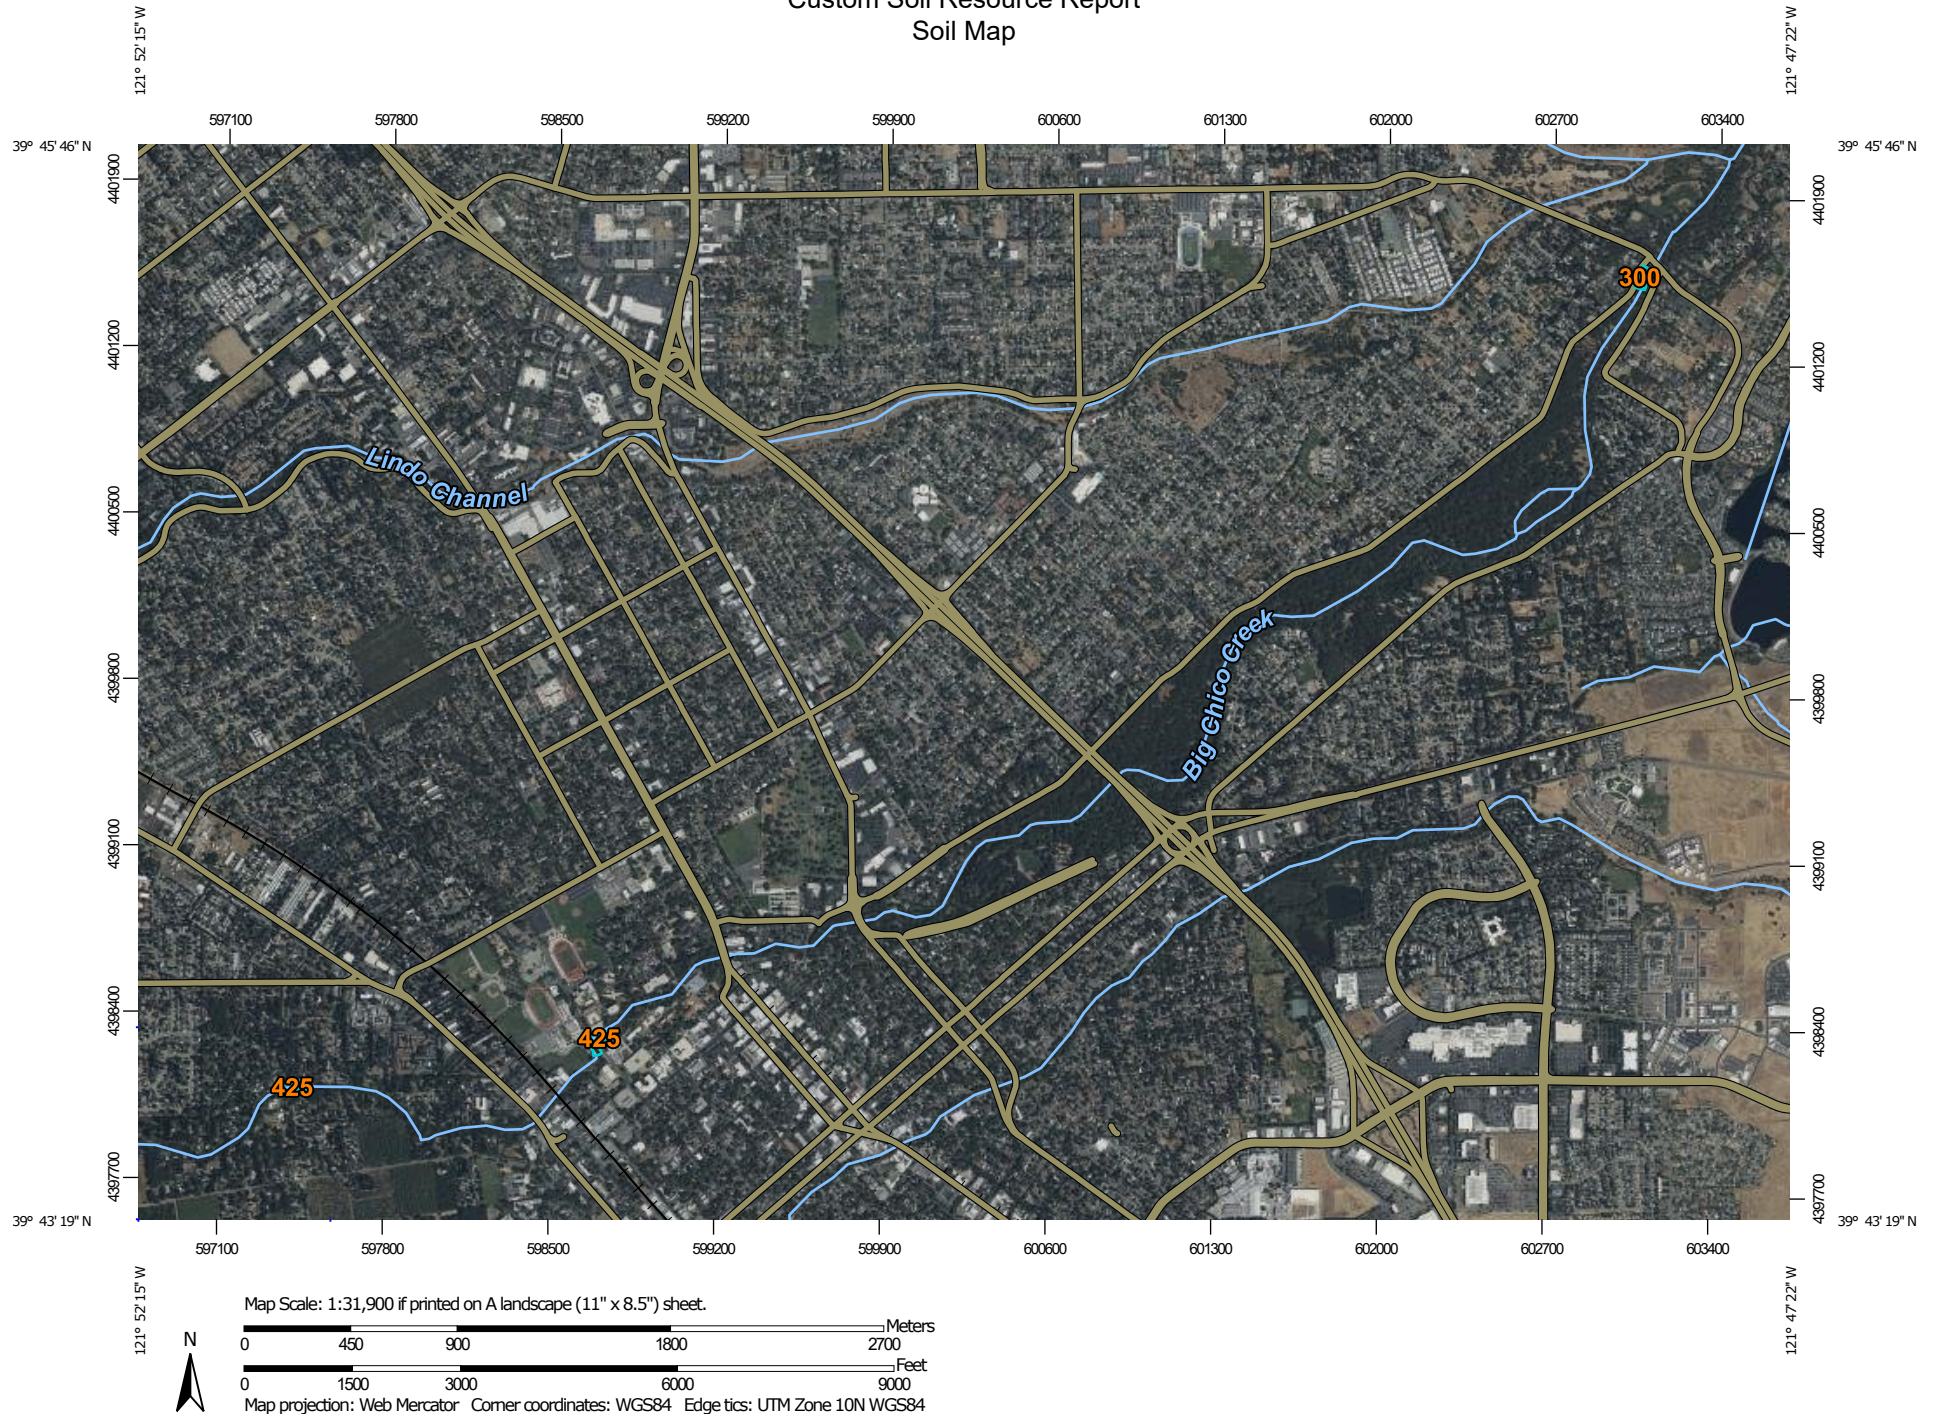
Custom Soil Resource Report Soil Map

The soil map section includes the soil map for the defined area of interest, a list of soil map units on the map and extent of each map unit, and cartographic symbols displayed on the map. Also presented are various metadata about data used to produce the map, and a description of each soil map unit.

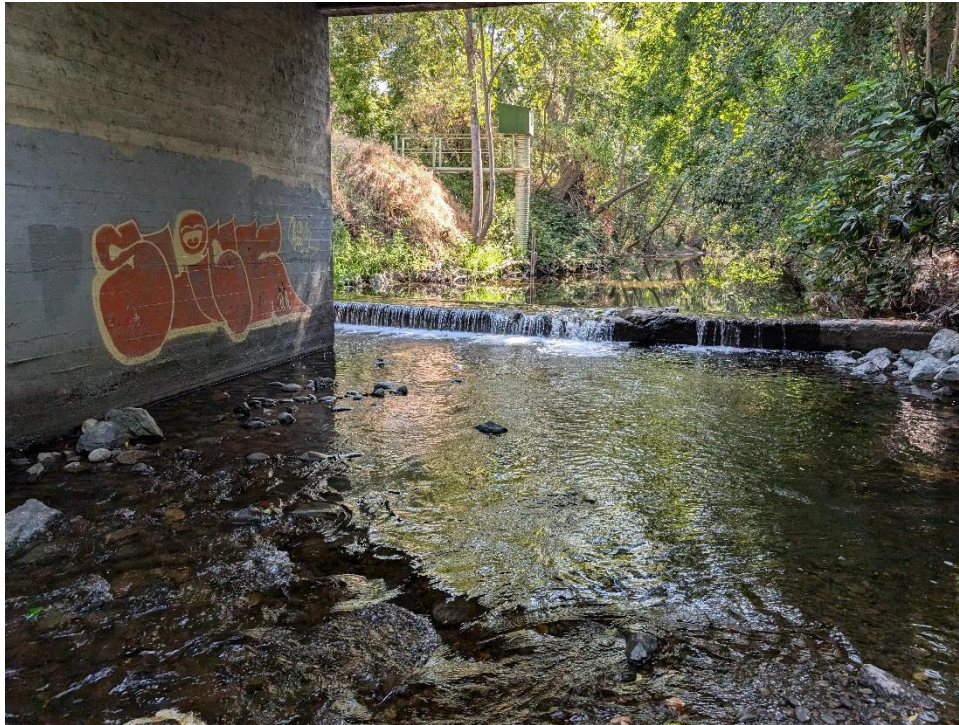
The riverbed beneath the Rose Avenue bridge is predominantly shaded by the surrounding riparian forest, with incised channel banks shaped by erosion resulting from urban development and heavy creek flows from atmospheric river events in Winter 2023/Spring 2024.

Photo 1. Representative photo of Big Chico Creek and its associated riparian forest at the Rose Avenue Bridge (SC-1) location , taken facing east, looking upstream. Photo taken July 2024.

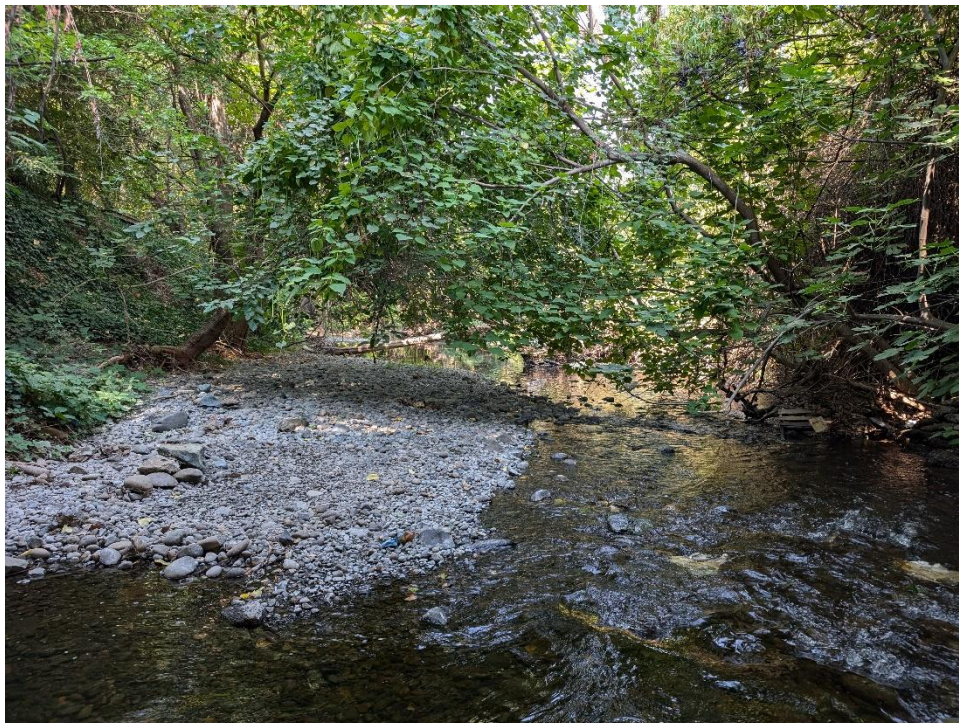
Photo 2. Representative photo of Big Chico Creek at the Rose Avenue Bridge (SC-1) , taken facing west, looking downstream. Photo taken July 2024.
