FACILITIES MASTER PLAN

2025

Persinger Architects

Grass Valley School District Master Plan 2025

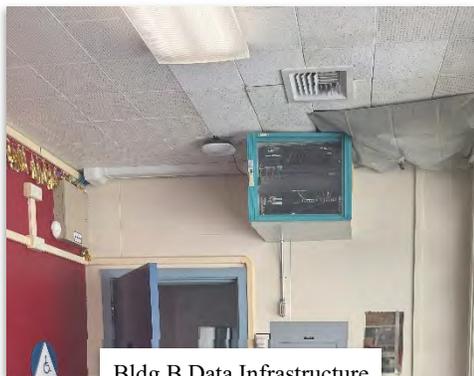
Bldg B Data Infrastructure

Fire alarm, low voltage, and data infrastructure are surface mounted in hallways and classrooms, and in fair condition.

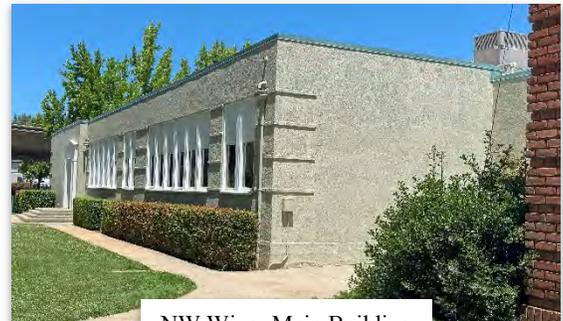
NW Wing, Main Building

Comp shingle roofs and flat roofs are in fair condition.

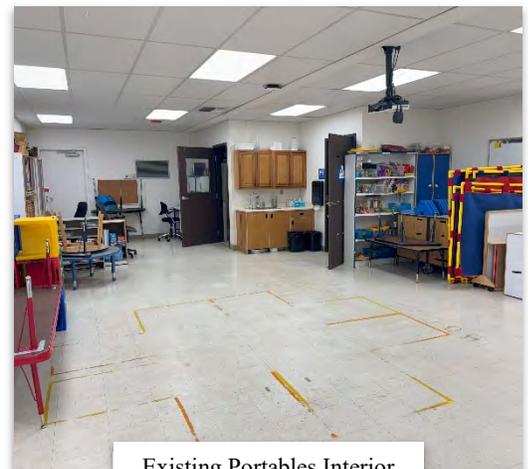
Existing Portables Interior

Suspended ceilings have been provided and are in fair condition, with some stained and broken tiles.

Floors consist of original vinyl tile in worn condition.

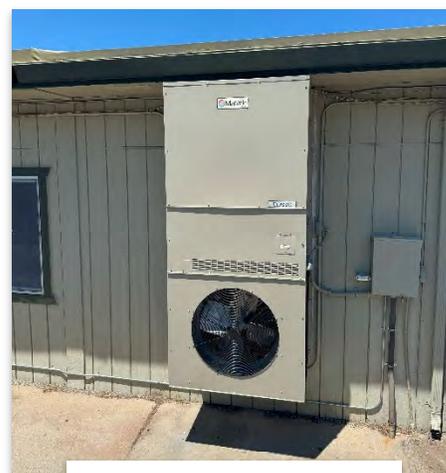
Existing Portables HVAC

Heating and cooling is provided by wall mounted mechanical units in fair condition.

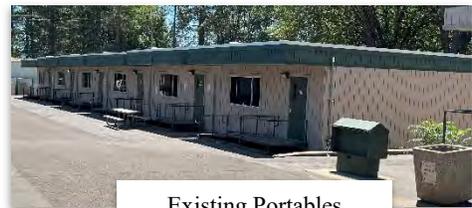
Existing Portables

Portable buildings were all placed per the same DSA application in 1990. Portable buildings are set on temporary wood foundations, have ramps at exterior entrances and use more temporary materials such as plywood siding.

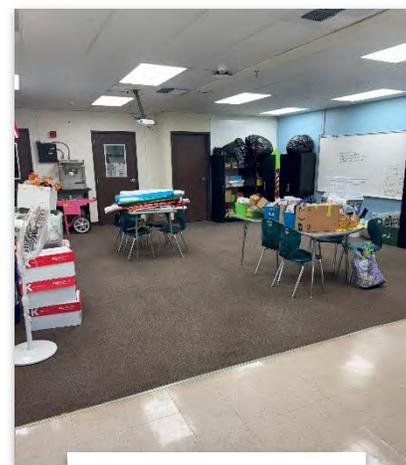
Existing Portable Interior

Floors consist of original mix of VCT and carpet, in fair condition.

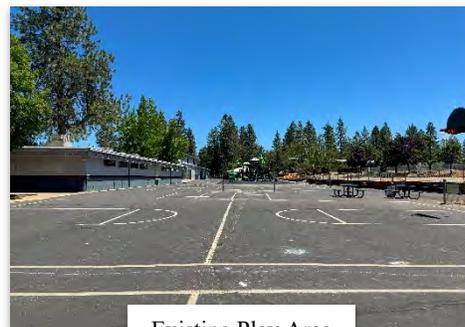
Existing Play Area

Staff and student restroom access is adequate, and restroom quality is good and recently modernized. Drinking fountains are lacking in quantity on site. The playground is new and in good condition. The blacktop area is in aged condition with no major issues, but would benefit from resurfacing. The sports fields are new and in good condition, but lacks seating for teams or spectators. There is an fair amount of simple landscaping throughout

campus, but the condition varies and is patchy in places. The site appears to drain adequately. Underground utilities appear to be functioning adequately with no significant issues noted. Power on campus is supported by a photovoltaic system and backup natural gas generator installed in recent years.

Landscaping should be maintained and expanded, patchy areas should have irrigation system serviced and grass reseeded

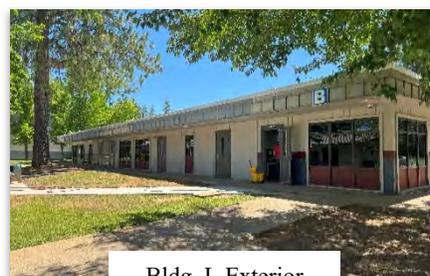
Bldg. L Exterior

Many of the buildings on this site were constructed or placed between the years of 1987 and 1999 and have been maintained well. The campus consists of three site-built buildings, L, M, and N, which serve as a mix library/classroom building, administration building, and the multi-purpose building. The site-built buildings are in good condition. Three modular classroom wings, A, B, and C, were also constructed during this period of time. These modular wings are in fair condition. Between 1990 and 1999 portable classrooms were brought in and serve as the D wing. The portable wings are in fair condition and regular maintenance keeps ahead of major decline due to age.

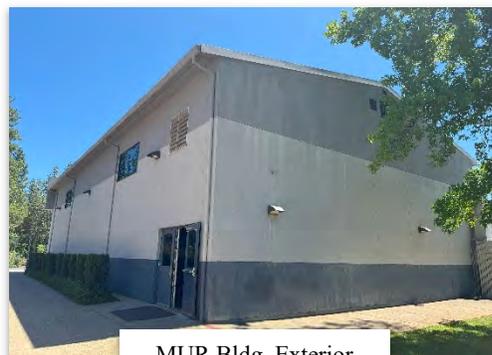
MUR Bldg. Exterior

The roof of the site-builts is low slope, not currently leaking, and has been replaced in recent years.

Heating and cooling is provided by package systems, generally located on the roofs. Units and controls have been replaced in recent years and are in fair condition.

Exterior plaster siding is in fair condition. Paint is in fair condition but would benefit from being touched up.

Exterior siding should continue to receive regular maintenance and periodic repainting.

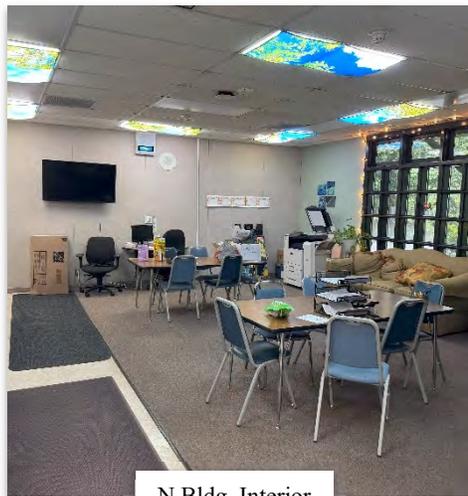
N Bldg. Interior

Data system has been retrofit installed and is functional. Wireless access points have been provided.

Fire alarm, low voltage, and data infrastructure are surface mounted or concealed in suspended ceiling and in fair condition.

The ceiling is generally suspended acoustic ceiling tile system or acoustic tiles adhered to hard lid in the MUR. Ceiling systems have been replaced in recent years and is in good condition.

Wall and floor finishes in many all spaces have been refinished recently. Casework in many spaces have been replaced recently. Finishes not included are in fair condition.

HVAC, fire alarm, data, low voltage, and lighting systems and infrastructure should continue to be maintained.

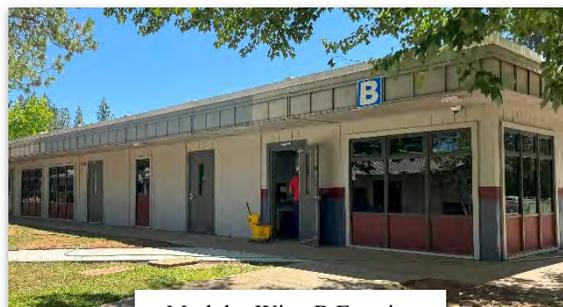
Modular Wing B Exterior

Modular wings A-C were all placed in the same timeframe as the site-built. The D wing was placed in phases between 1990 and 1999. Modular buildings are set on concrete and wood foundations, set at grade, and use more temporary materials such as plywood siding.

The roofs of the modulares are in fair condition and have been redone in recent years.

Heating and cooling is provided by roof mounted package units at the A, B, and C wing, and wall mounted units at the D wing. Units and controls have been replaced in recent years and are in fair condition.

In general, portable buildings should be replaced with new site built buildings, or at very least, newer quality modular buildings. Although they have a low initial cost, portable buildings are prone to long term maintenance issues as a function of the poorer quality of materials used. Wholesale replacement is often financially unfeasible and so phased

replacement based on the age of buildings should be planned and the buildings maintained as well as possible in the meantime.

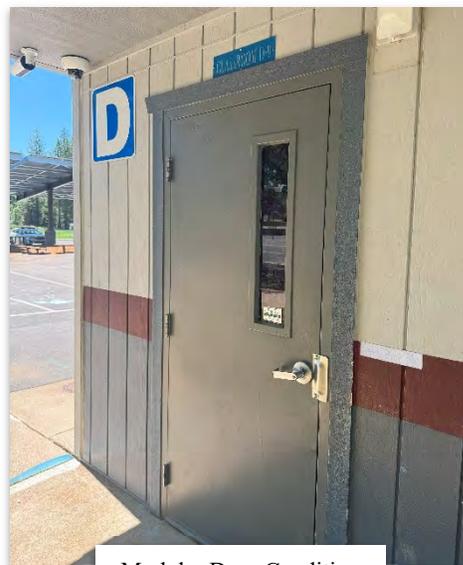
Modular Door Condition

The doors and door hardware appear to be original and in generally fair condition, but hardware may be out of code.

Doors and door hardware should be maintained and wholesale replacement should be considered. Card readers or other keyless entry systems should be considered.

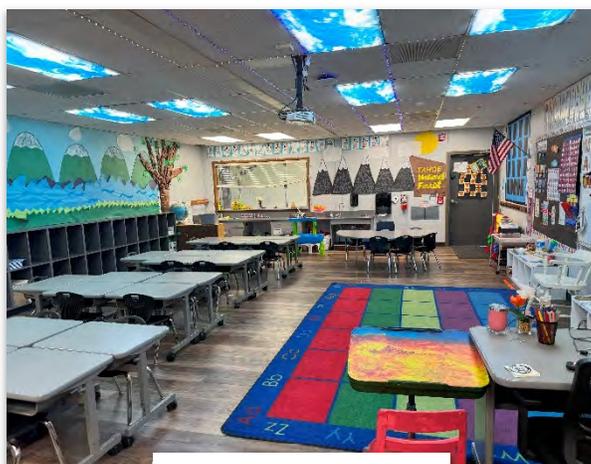
C Wing Classroom Interior

Fire alarm, low voltage, power, and data infrastructure are concealed in walls and suspended ceiling and in fair condition.

Suspended ceiling tile system has been replaced in recent years and is in good condition.

Wall and floor finishes have been refinished recently. Casework has been replaced recently.

Original windows should be replaced with new units that incorporate dual glazing. Operable windows should be provided wherever possible to provide better opportunities for cross ventilation. Sola-tubes should also be considered for areas where new windows are impractical.

Ceiling, wall, and floor finishes and casework should continue to be maintained.

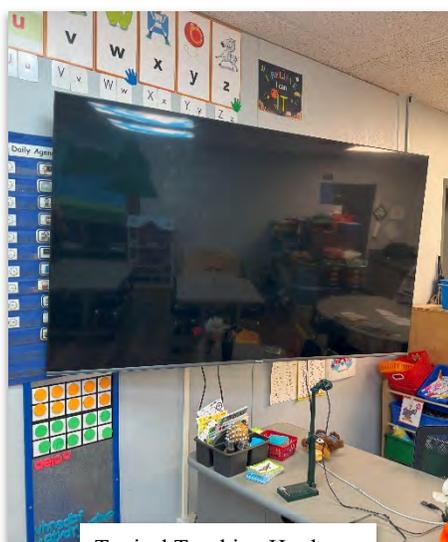
Typical Teaching Hardware

Teaching hardware has been updated in recent years with large televisions to support projector system.

Teaching hardware upgrade to smartboards should be considered

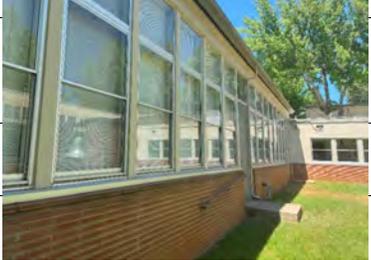
09.1402.091	Siding	Brick and plaster siding is in fair condition with minor cracking.	Maintain regularly and repaint periodically.

09.8002.191	Paint	Paint is in fair condition with minor cracking.	Maintain regularly and repaint periodically.

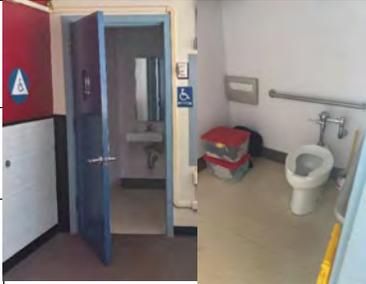
CSI#	ITEM	CONDITION	RECOMMENDATION	COST			PHOTOS
					Bronze	SILVER	GOLD	
Restroom	15.1201 201 15.1201 181	Fixtures	Water closet original, lavatory replaced in 2019. Both in fair condition.	Maintain.

06.2101 101	Restroom accessories	Accessories replaced in 2019 and in fair condition.	Maintain.				
	09.3003 061	Finishes	Wall finishes in fair condition, flooring is original in worn condition.	Bronze: Repair damage. Gold: Complete restroom remodel w/ finishes.	\$3,875		\$49,430

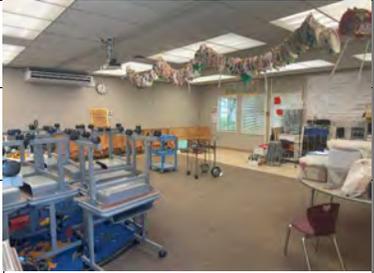
CSI#	ITEM	CONDITION	RECOMMENDATION	COST			PHOTOS
					Bronze	SILVER	GOLD	
BUILDING C - INTERIOR	09.1403.00	Wall Finishes	Wall finishes are in classrooms original in fair condition.	Maintain.

09.5002.021	Ceilings	Suspended acoustic ceiling tiles replaced in 2025.	Maintain.				
	09.6001.121	Flooring	Original carpet in fair condition. Vinyl flooring replaced in 2025.	Maintain.

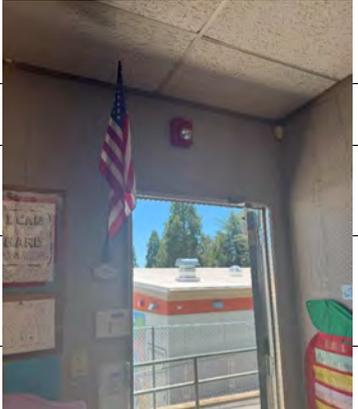
09.8003.151	Paint	Interior repainted in 2025.	Maintain.				
	15.3401.041	HVAC Controls	Programmable thermostat controls the HVAC.	Silver: Install lighting and HVAC control systems.		\$4,000

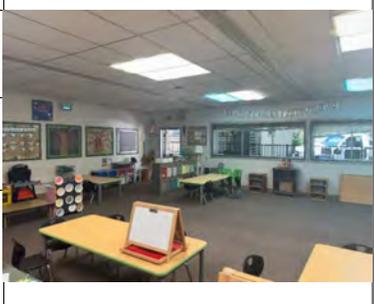
CSI#	ITEM	CONDITION	RECOMMENDATION	COST			PHOTOS
					Bronze	SILVER	GOLD	
BUILDING D - INTERIOR	09.1403.00	Wall Finishes	Wall finishes are in classrooms original in fair condition.	Maintain.

09.5002.021	Ceilings	Suspended acoustic ceiling tiles replaced in 2025.	Maintain.				
	09.6001.121	Flooring	Original carpet in fair condition. Vinyl flooring replaced in 2025.	Maintain.

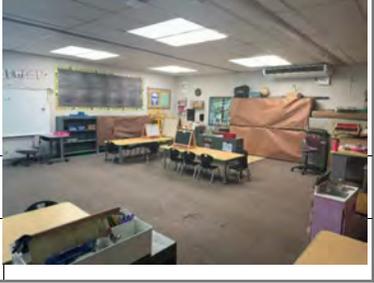
16.7209.11	Data Infrastructure	Retrofit installed and functional, with wireless access points. Surface mounted units w/ surface mounted wiring.	Maintain.

Casework	Casework replaced in 2025.	Maintain.				
		Teaching hardware	Whiteboards and TVs in classroom.	Gold: Upgrade technology to smart boards.			\$8,000	
SUMMARY					Bronze	\$0		
				SILVER		\$4,000		
				GOLD			\$12,000

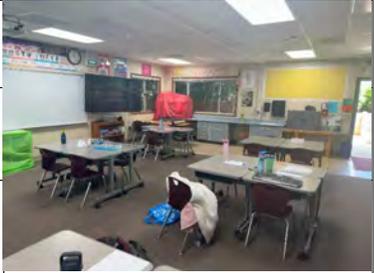
CSI#	ITEM	CONDITION	RECOMMENDATION	COST			PHOTOS
					Bronze	SILVER	GOLD	
BUILDING E - INTERIOR	09.1403.00	Wall Finishes	Wall finishes are in classrooms replaced in 2025.	Maintain.

09.5002.021	Ceilings	Suspended acoustic ceiling tiles replaced in 2025.	Maintain.				
	09.6001.121	Flooring	Original carpet in fair condition. Vinyl flooring replaced in 2025.	Maintain.

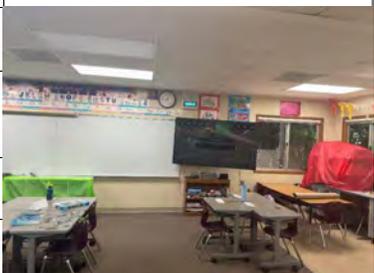
09.8003.151	Paint	Interior repainted in 2025.	Maintain.

15.3401.041	HVAC Controls	Programmable thermostat controls the HVAC.	Silver: Install lighting and HVAC control systems.		\$4,000

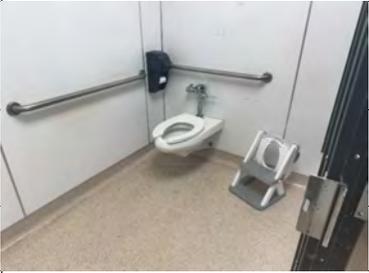
CSI#	ITEM	CONDITION	RECOMMENDATION	COST			PHOTOS
					Bronze	SILVER	GOLD	
BUILDING F - INTERIOR	09.1403.00	Wall Finishes	Wall finishes replaced in 2025.	Maintain.

09.5002.021	Ceilings	The ceiling is suspended acoustic ceiling tiles replaced in 2025.	Maintain.				
	09.6001.121	Flooring	Sheet vinyl flooring replaced in 2025.	Maintain.

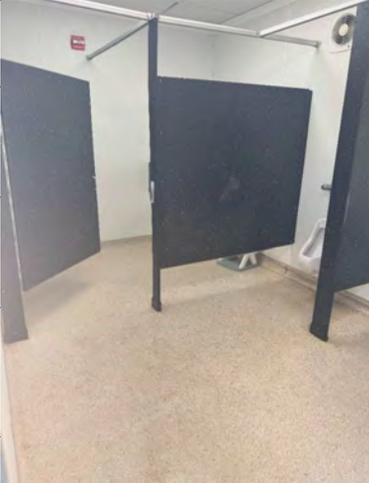
09.8003.151	Paint	Paint redone in 2025.	Maintain.

15.3401.041	HVAC Controls	Programmable thermostat controls the HVAC.	Maintain.				
	16.5703.021	Power Systems	Outlets quantity and quality are acceptable.	Maintain.

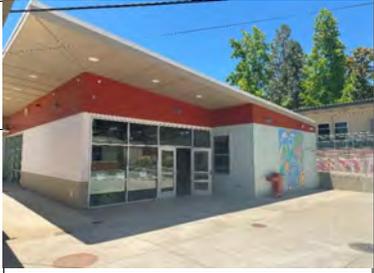
SITE	CSI#	ITEM	CONDITION	RECOMMENDATION	COST			PHOTOS
					Bronze	SILVER	GOLD	
	02.6006.101	Sidewalks	Some sidewalks are in fair conditions.	Maintain.

02.7605.011	Landscape	Landscaping is minimal, little room for expansion.	Maintain.

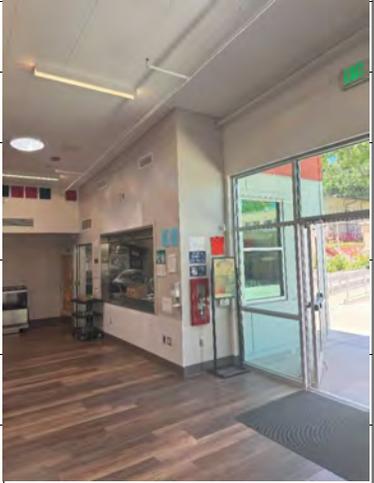
CSI#	ITEM	CONDITION	RECOMMENDATION	COST			PHOTOS
					Bronze	SILVER	GOLD	
MULTI-PURPOSE BUILDING - INTERIOR	08.9003.031	Interior Doors	Doors are original in good condition.	Silver: Install keyless entry.		\$11,184

09.1403.00	Wall finishes	Finishes are original in good condition.	Maintain.				
	09.5002.021	Ceilings	Ceilings is original hard lid with acoustic tiles fastened directly, in good condition.	Maintain.

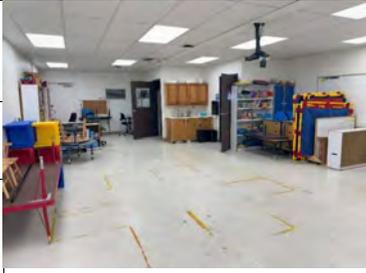
CSI#	ITEM	CONDITION	RECOMMENDATION	COST			PHOTOS
				Bronze	SILVER	GOLD	
09.1403.00	Wall Finishes	Wall finishes replaced in recent years and are in fair condition.	Maintain.

09.8003.151	Paint	Paint is in fair condition.	Maintain.				
09.5002.021	Ceilings	The ceiling is suspended acoustic ceiling tiles, replaced in recent years and in fair condition.	Maintain.

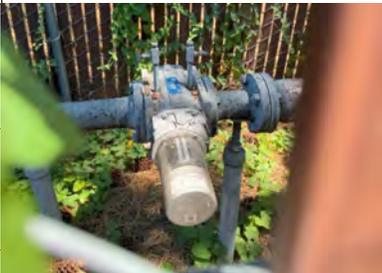
Site Fencing	Fencing is in fair condition with some gaps in security.	Silver: Install additional fencing and gates along N and E of campus. (350 LF)		\$23,625

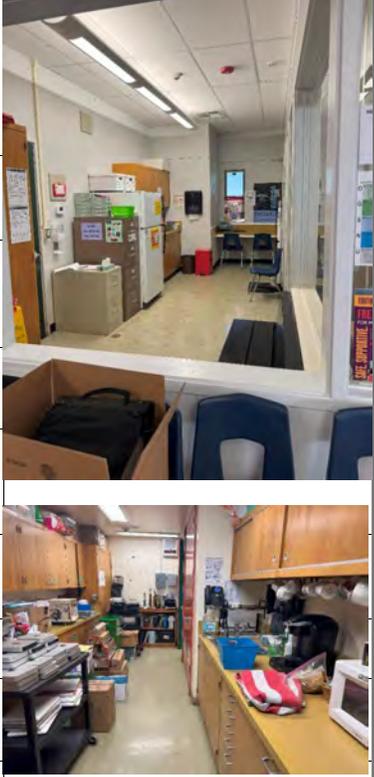
CSI#	ITEM	CONDITION	RECOMMENDATION	COST			PHOTOS
				Bronze	SILVER	GOLD	
08.9003.031	Interior Doors	Doors are in fair condition, but closers and hardware need upgrades.	Bronze: Replace door hardware where needed for code. Silver: Replace select doors. Gold: Incorporate keyless entry where appropriate.	\$5,359	\$23,717	\$22,369

09.1403.00	Wall Finishes	Walls finishes included in recent or upcoming projects.	Maintain.				
09.5002.021	Ceilings	Suspended ceilings replacement included in recent or upcoming projects.	Maintain.

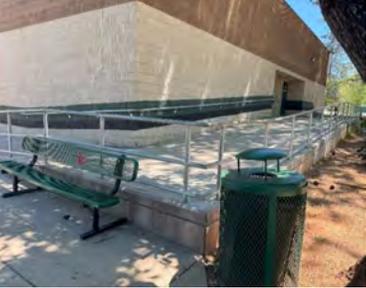
08.9106.181	Windows	Windows original and low in quantity, but in fair condition.	Maintain.

09.1402.091	Siding	Cement plaster is in fair condition.	Maintain.

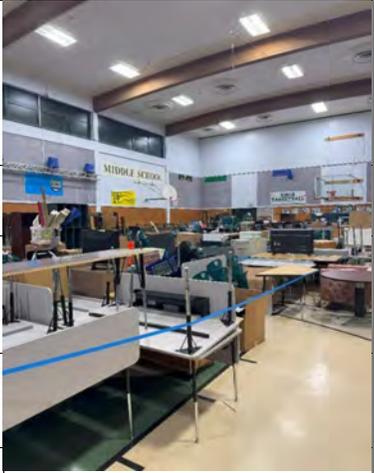
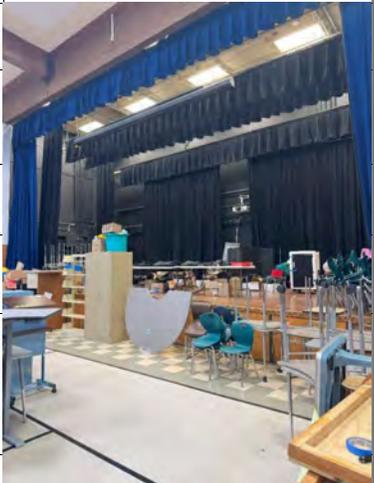
CSI#	ITEM	CONDITION	RECOMMENDATION	COST			PHOTOS
				Bronze	SILVER	GOLD	
08.9003.031	Interior Doors	Doors are in fair condition, but closers and hardware need upgrades.	Bronze: Replace door hardware where needed for code. Silver: Replace select doors. Gold: Incorporate keyless entry where appropriate.	\$5,359	\$11,826	\$16,776

09.1403.00	Wall finishes	Finishes are original in fair condition.	Maintain.				
09.5002.021	Ceilings	Ceilings is original hard lid with acoustic tiles fastened directly, in good condition.	Maintain.

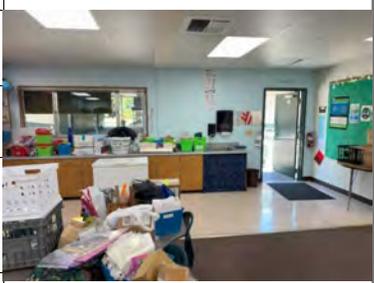
CSI#	ITEM	CONDITION	RECOMMENDATION	COST			PHOTOS
				Bronze	SILVER	GOLD	
09.1403.00	Wall Finishes	Wall finishes in fair condition.	Maintain.

09.8003.151	Paint	Paint is in fair condition.	Maintain.

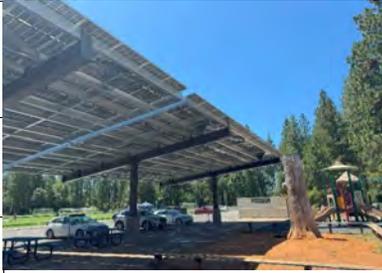
ITEM	CONDITION	RECOMMENDATION	COST			PHOTOS
				Bronze	SILVER	GOLD	
SITE	Delineation of Main Entrance	Clear entrance with indicators directing towards the main office, and close parking.	Gold: Additional coverings and student seating should be considered at pick-up and drop-off areas.			\$120,000

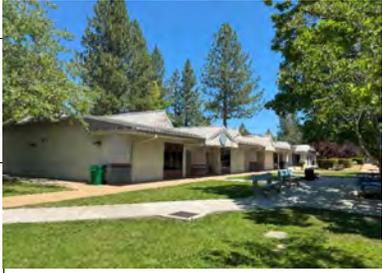
Site Fencing	Fencing is in fair condition with minimal gaps in security.	Maintain.		\$23,625		
	Closed Circuit Security Camera System	Closed circuit security system has been installed on campus.	Maintain.				
	Switchgear	Original switchgear for the site is interconnected with new PV system and backup generator.	Maintain.

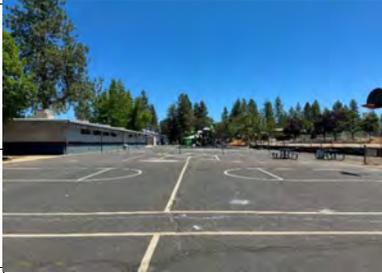
Underground Utilities	Underground utilities have been serviced and modernized in the past few decades.	Maintain and develop long term service plan.				
	Parking Lots	Parking lots are located far at the back of campus due to limited space, and would benefit from resurfacing.	Silver: Reseal entire existing parking lot and continue maintenance. (35,755 SF)		\$17,699

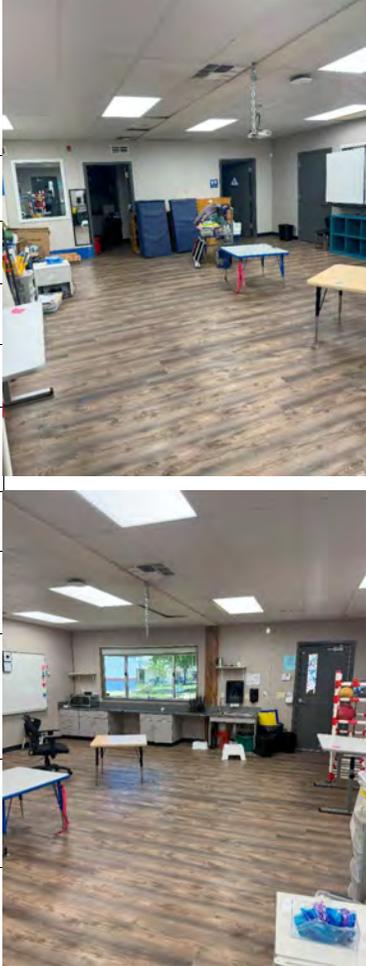
CSI#	ITEM	CONDITION	RECOMMENDATION	COST			PHOTOS
				Bronze	SILVER	GOLD	
08.9003.031	Interior Doors	Doors are in fair condition, but closers and hardware may need upgrades.	Bronze: Replace door hardware where needed for code. Silver: Replace select doors. Gold: Incorporate keyless entry where appropriate.	\$10,718	\$23,717	\$22,369

09.1403.00	Wall Finishes	Walls finishes in fair condition.	Maintain.				
09.5002.021	Ceilings	Suspended ceilings in fair condition.	Maintain.				
09.6001.121	Flooring	Flooring in fair condition.	Maintain.

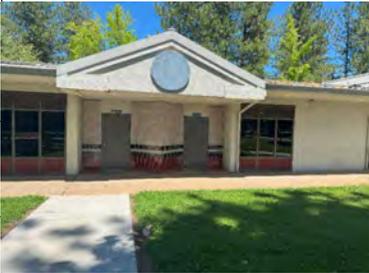
08.9106.181	Windows	Windows are original, low in quantity, single-glazed, and most are non-operable.	Silver: Replace classroom windows with new accessible operable, dual pane insulated units.		\$36,879

09.1402.091	Siding	Painted stucco and tile walls are in fair condition.	Maintain.				
	09.8002.191	Paint	Paint is in fair condition with minor cracking and peeling.	Maintain regularly and repaint periodically. Gold: Repaint exterior plaster.			\$73,280

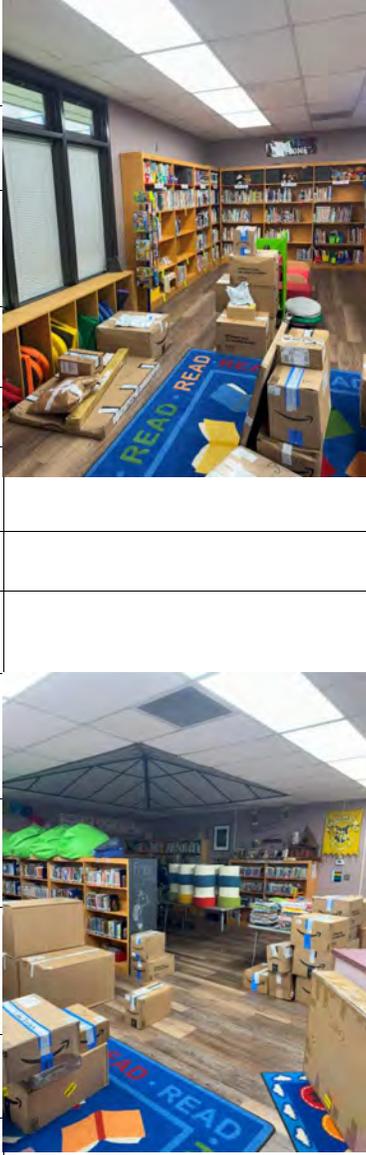
CSI#	ITEM	CONDITION	RECOMMENDATION	COST			PHOTOS
				Bronze	SILVER	GOLD	
08.9003.031	Interior Doors	Doors are in fair condition, but closers and hardware may need upgrades.	Gold: Incorporate keyless entry where appropriate.			\$16,776

09.1403.00	Wall Finishes	Walls finishes replaced recently and in good condition.	Maintain.				
09.5002.021	Ceilings	Suspended and painted hard lid ceilings replaced recently and in good condition.	Maintain.

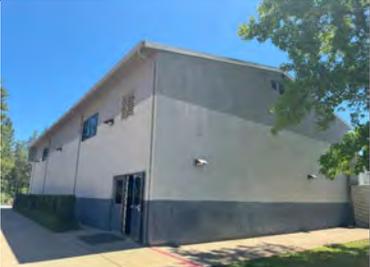
08.9010.021	Exterior Doors	Doors are in fair condition, but closers and hardware may need upgrades and limited replacement.	Gold: Incorporate keyless entry where appropriate.			\$16,776

08.9106.181	Windows	Windows are original, low in quantity, single-glazed, and most are non-operable.	Silver: Replace (30) classroom windows with new accessible operable, dual pane insulated units.		\$48,103

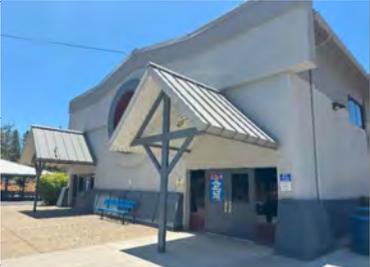
09.1402.091	Siding	Painted stucco walls are in fair condition.	Maintain.				
	09.8002.191	Paint	Paint is in fair condition with minor cracking and peeling.	Maintain regularly and repaint periodically. Gold: Repaint exterior plaster.			\$67,967

15.3401.041	HVAC	Ground mounted package systems have been replaced in recent years and are in fair condition.	Maintain.				
	16.6008.00	Exterior Lighting	Surface Mounted fixtures with LED bulbs retrofitted in recent years.	Maintain.

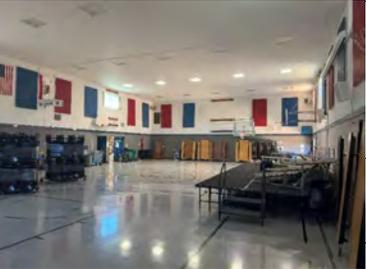
CSI#	ITEM	CONDITION	RECOMMENDATION	COST			PHOTOS
					Bronze	SILVER	GOLD	
BUILDING M - INTERIOR	08.9003.031	Interior Doors	Doors are in fair condition, but closers and hardware need upgrades.	Bronze: Replace door hardware where needed for code. Silver: Replace select doors. Gold: Incorporate keyless entry where appropriate.	\$8,932	\$14,230	\$27,961

09.1403.00	Wall Finishes	Walls finishes replaced recently and in good condition.	Maintain.				
	09.5002.021	Ceilings	Acoustic tiles fastened to hard lid replaced recently and in good condition.	Maintain.

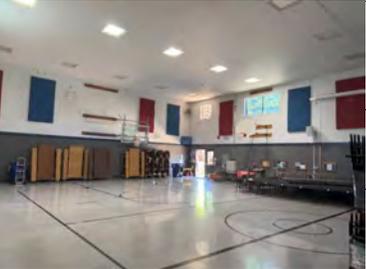
09.6001.121	Flooring	Rubber sports flooring replaced recently and in good condition.	Maintain.
