SIX-MONTH SURVEILLANCE AHERA REPORT

**LANEVIEW ELEMENTARY SCHOOL
2095 WARMWOOD LANE
SAN JOSE, CA 95132**

**INSPECTED ON:
MARCH 3, 2025**

HAZMAT DOC PROJECT #25-036

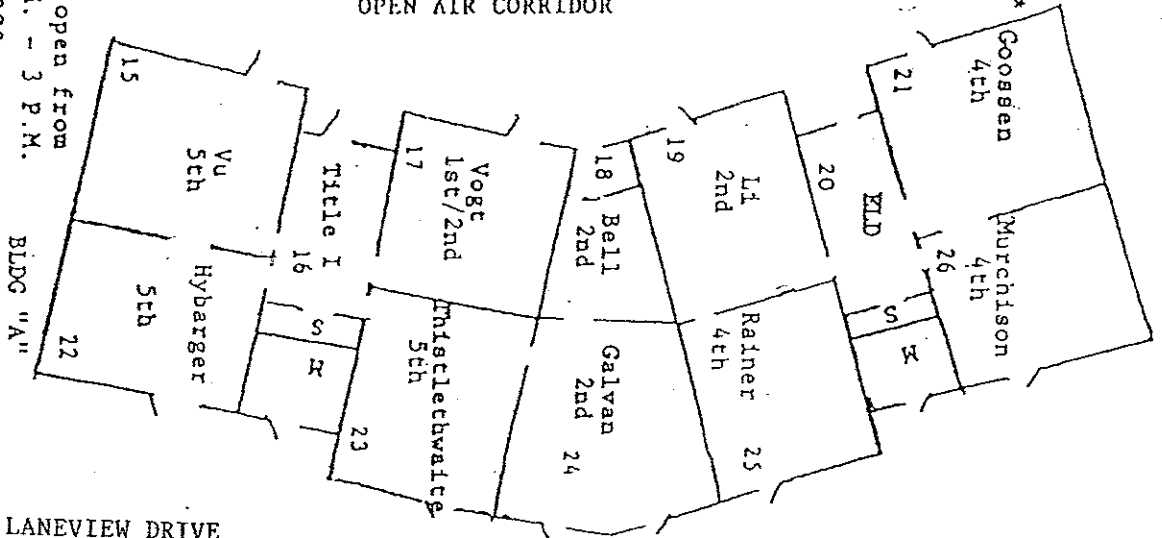
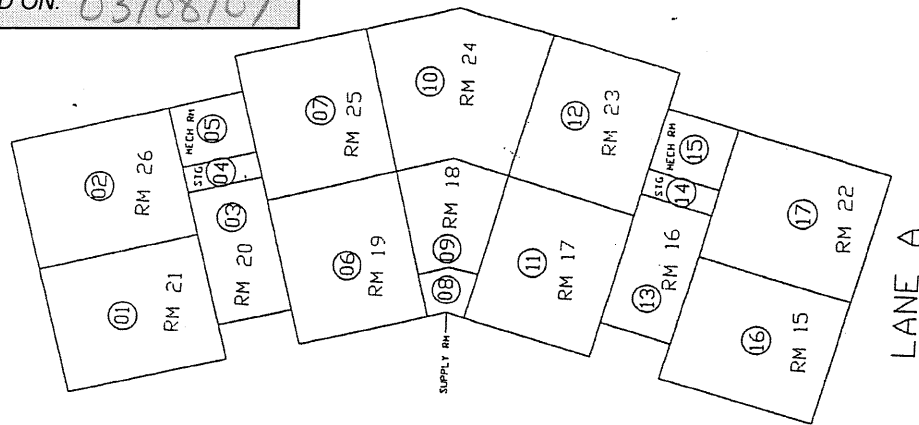
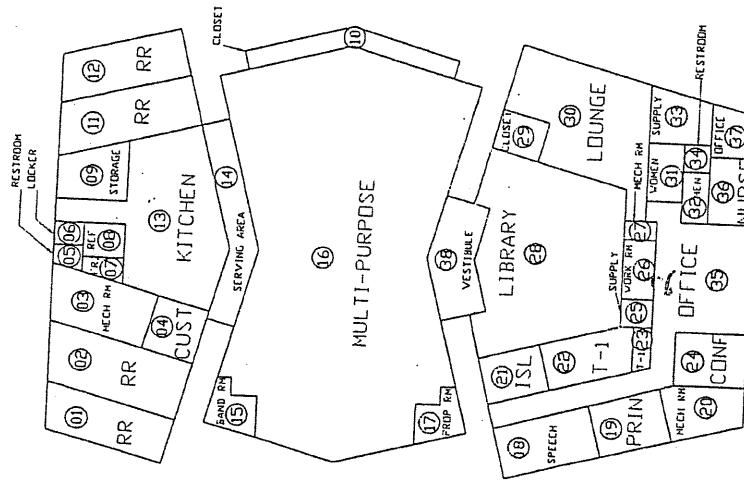
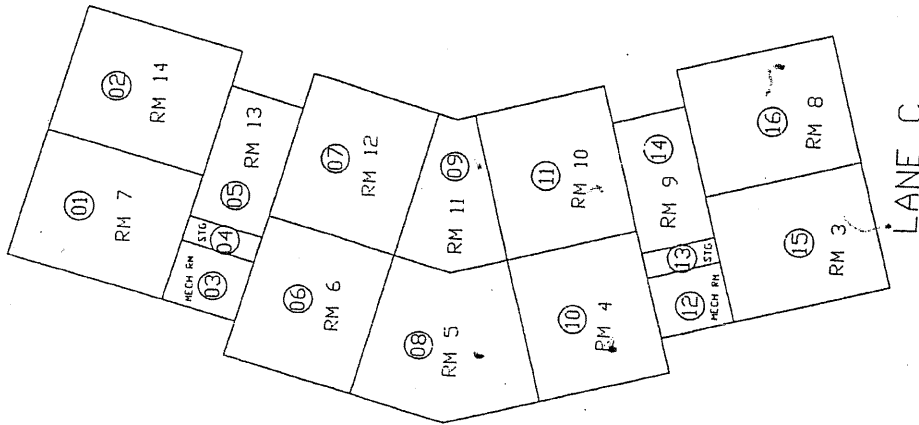
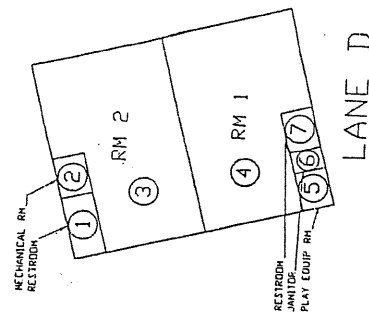
NAMING CONVENTION SITEPLAN

Gates*
*Gates open from 8 A.M. - 3 P.M.
S=Storage
P=Principal's Office
M=Mechanical room

NOT TO SCALE

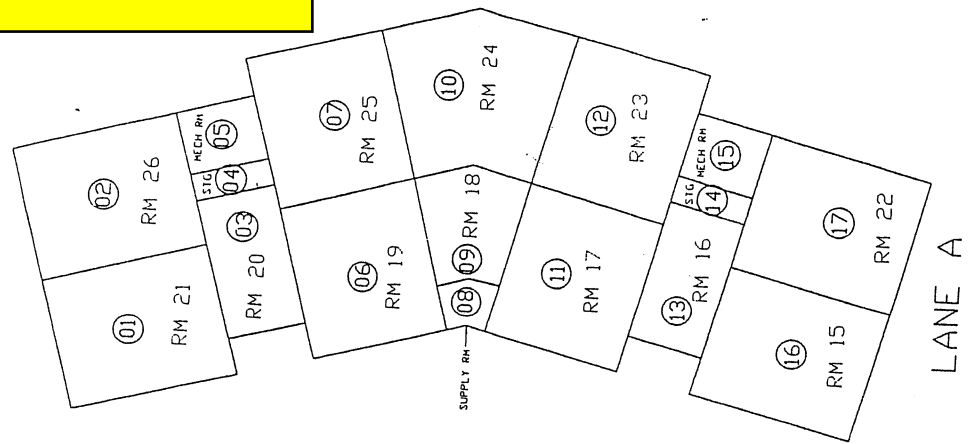
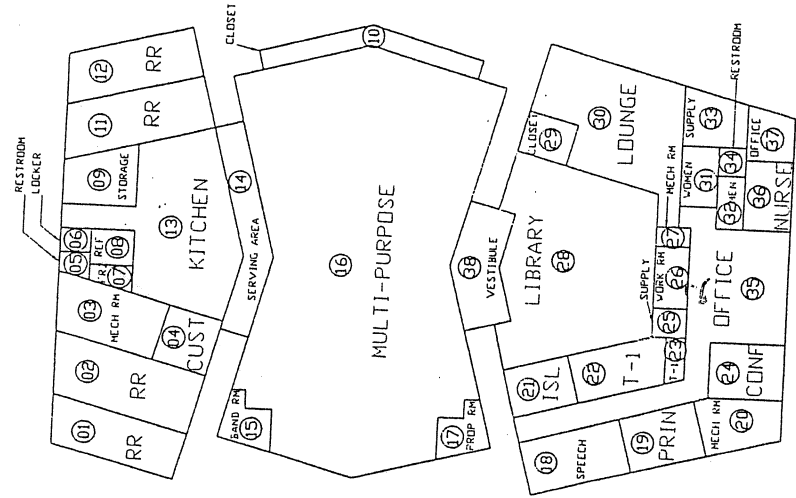
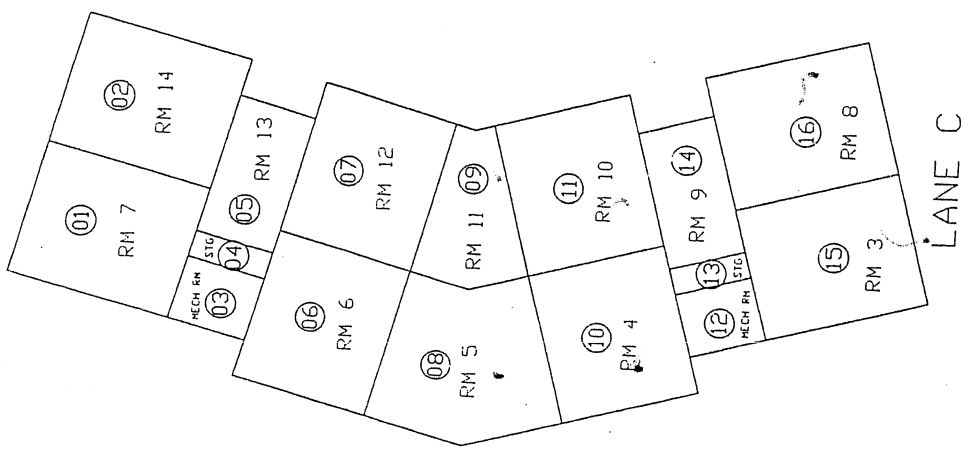
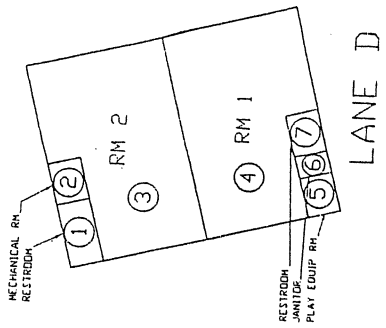
NAMING CONVENTION SITEPLAN

NOT TO SCALE

SCHOOL NAME: LANEVIEW ELEMENTARY
COUNTY: SANTA CLARA
ADDRESS: 2095 WARMWOOD LANE
ACREAGE: N/A
SCHOOL DISTRICT: BERRYESSA UNIFIED

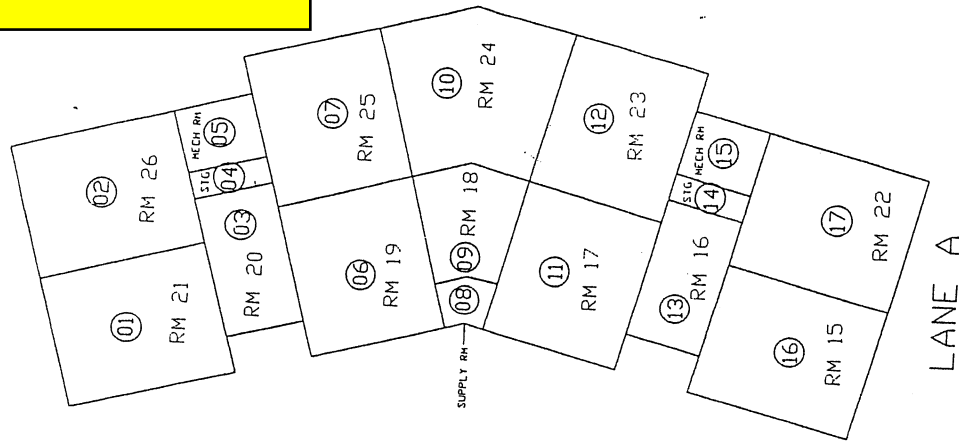
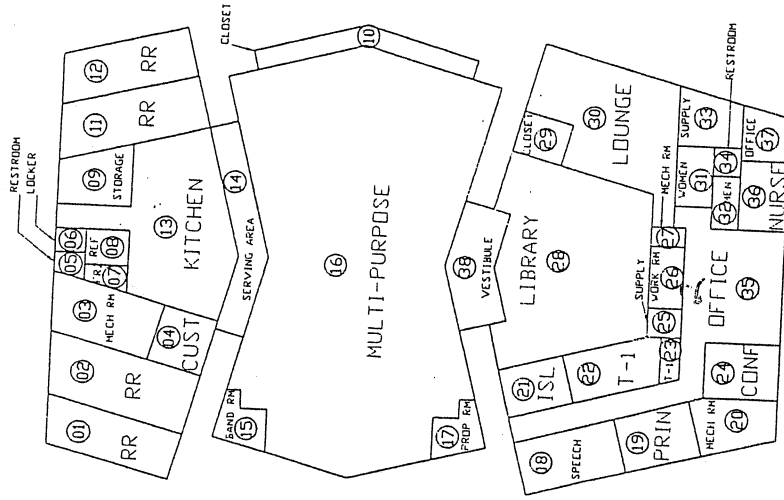
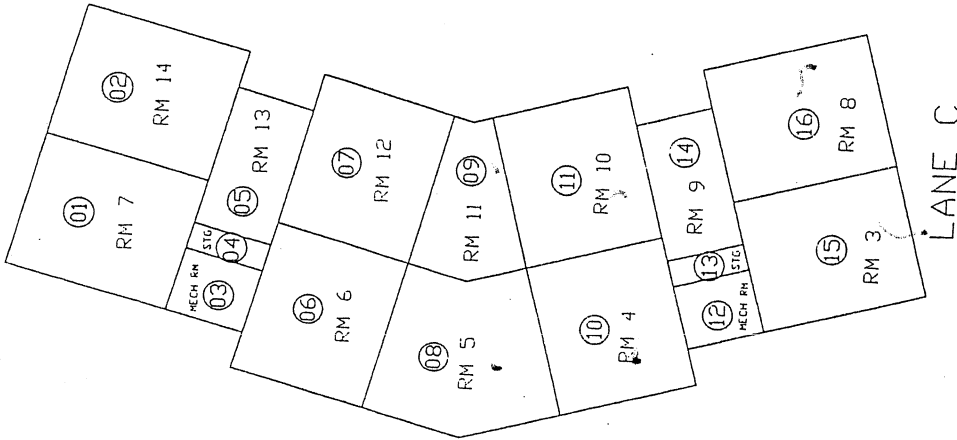
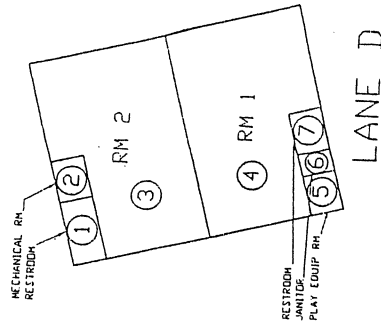
NAMING CONVENTION SITEPLAN

LANEVIEW ELEMENTARY SCHOOL
INSPECTED SEPTEMBER 2005

NOT TO SCALE
