## **SIX-MONTH SURVEILLANCE AHERA REPORT**

**VINCI PARK ELEMENTARY SCHOOL  
1311 VINCI PARK WAY  
SAN JOSE, CA 95131**

**INSPECTED ON:  
MARCH 3, 2025**

**HAZMAT DOC PROJECT #25-036**

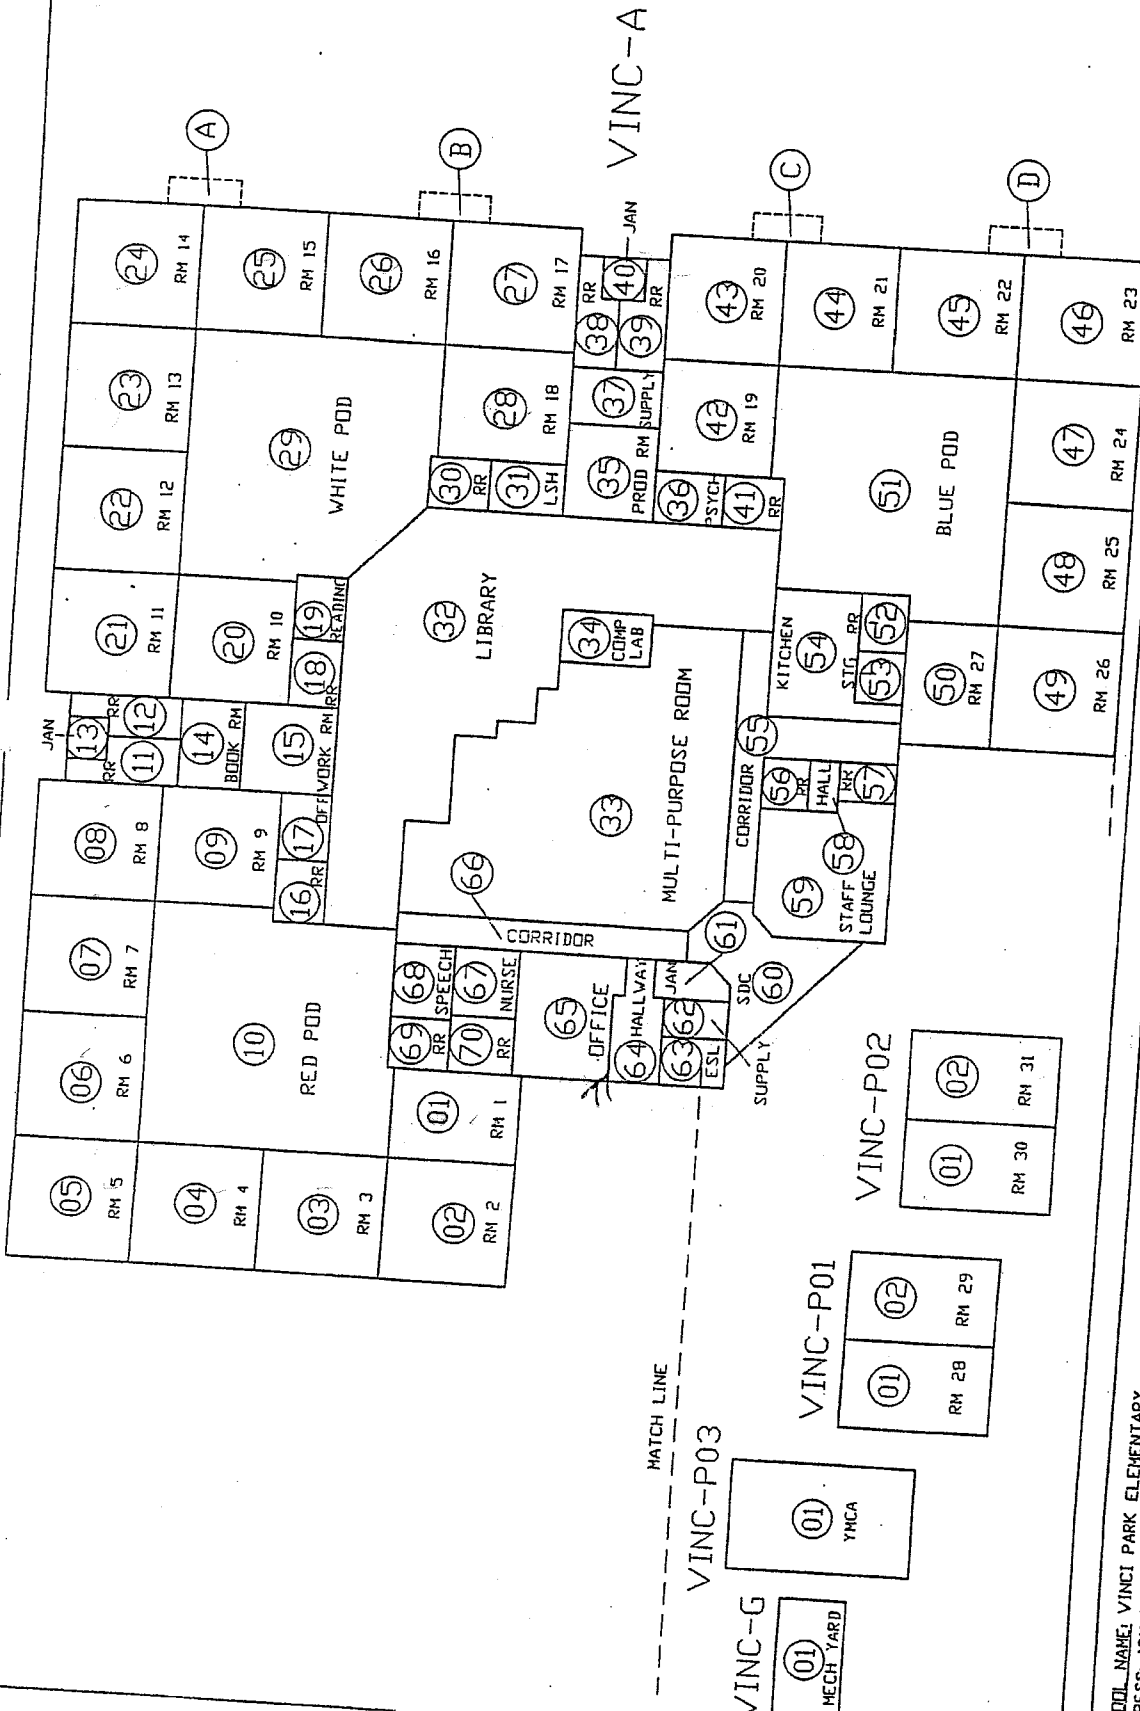
# NAMING CONVENTION SITEPLAN

VINCI PARK ELEMENTARY SCHOOL  
INSPECTED ON: 04/20/06
