## **SIX-MONTH SURVEILLANCE AHERA REPORT**

**BUESD MAINTENANCE AND TRANSPORTATION YARD  
945 PIEDMONT ROAD  
SAN JOSE, CA 95132**

**INSPECTED ON:  
FEBRUARY 12, 2024**

**HAZMAT DOC PROJECT #24-016**

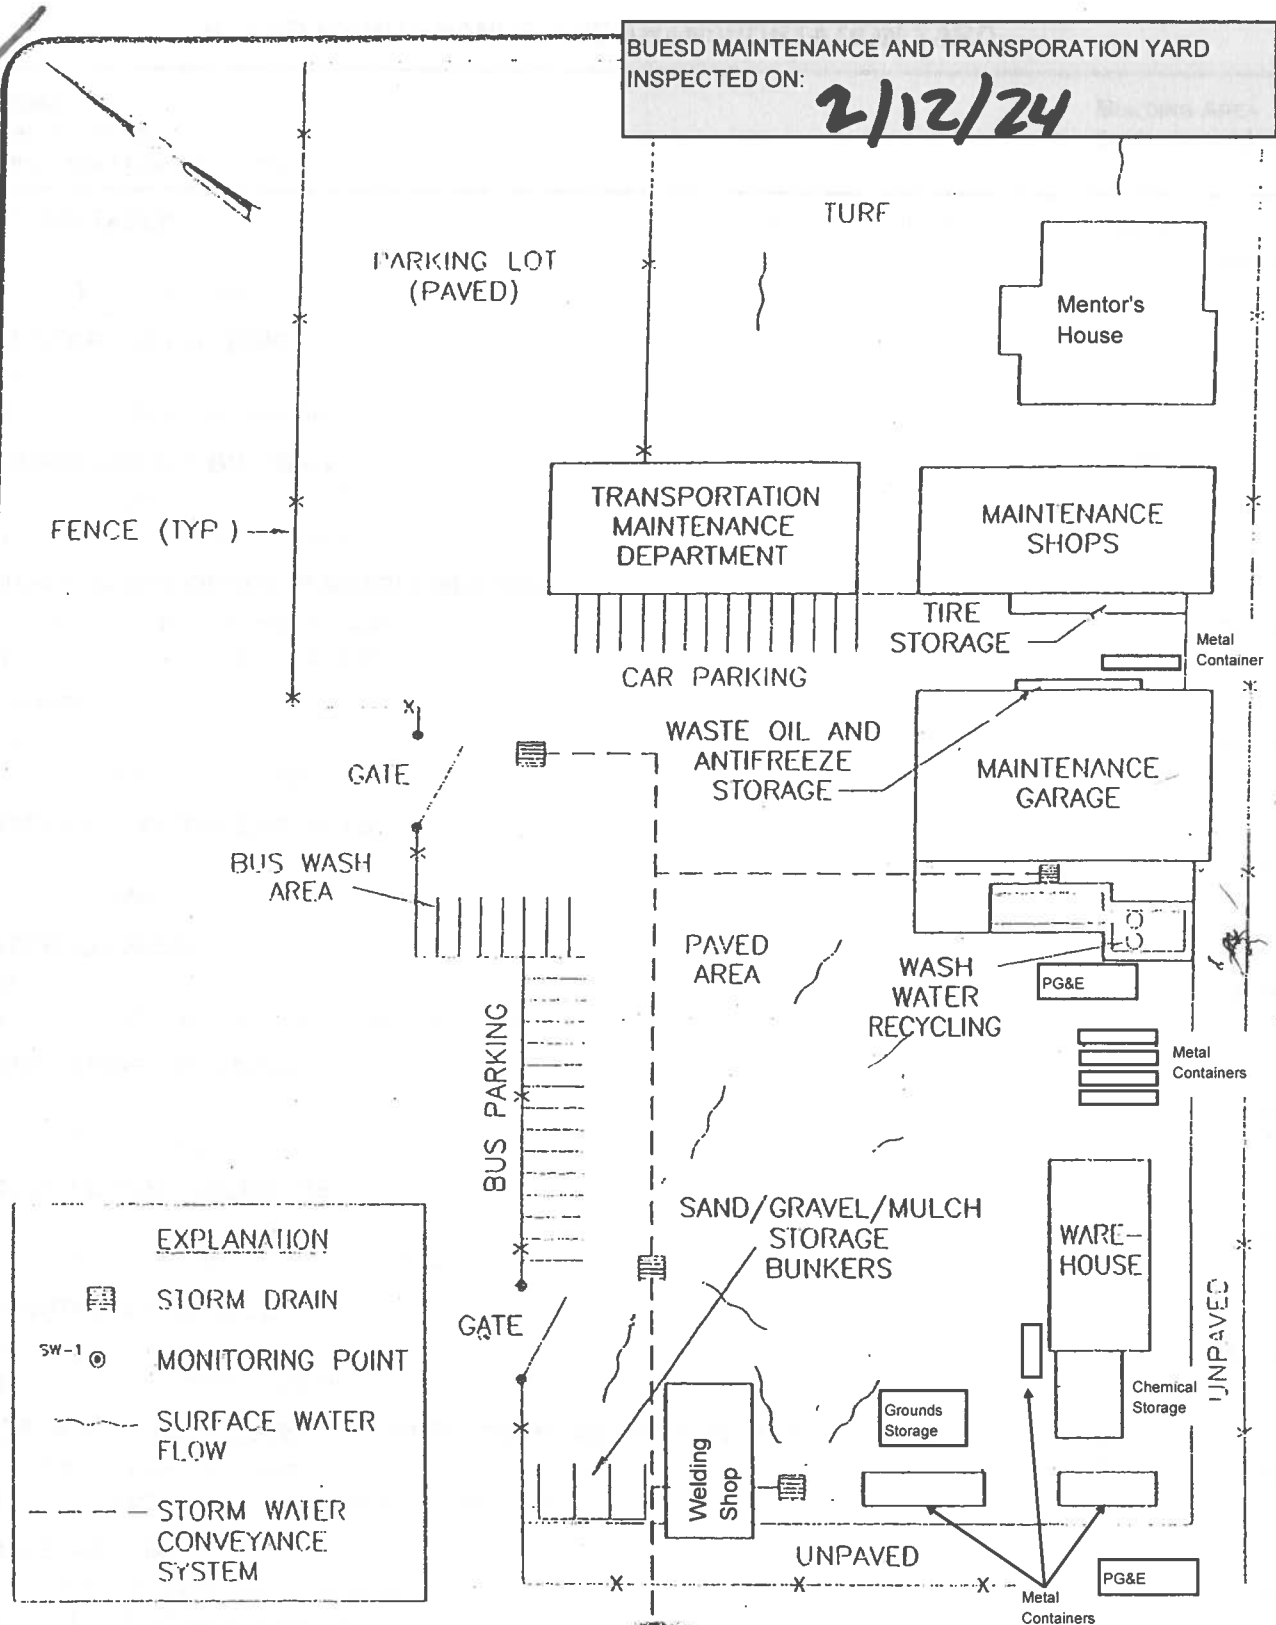
**FIGURE 2**  
**BERRYESSA UNION SCHOOL DISTRICT**  
945 PIEDMONT ROAD  
SAN JOSE, CALIFORNIA  
**CORPORATION YARD**  
**SITE PLAN**

# EXPLANATION

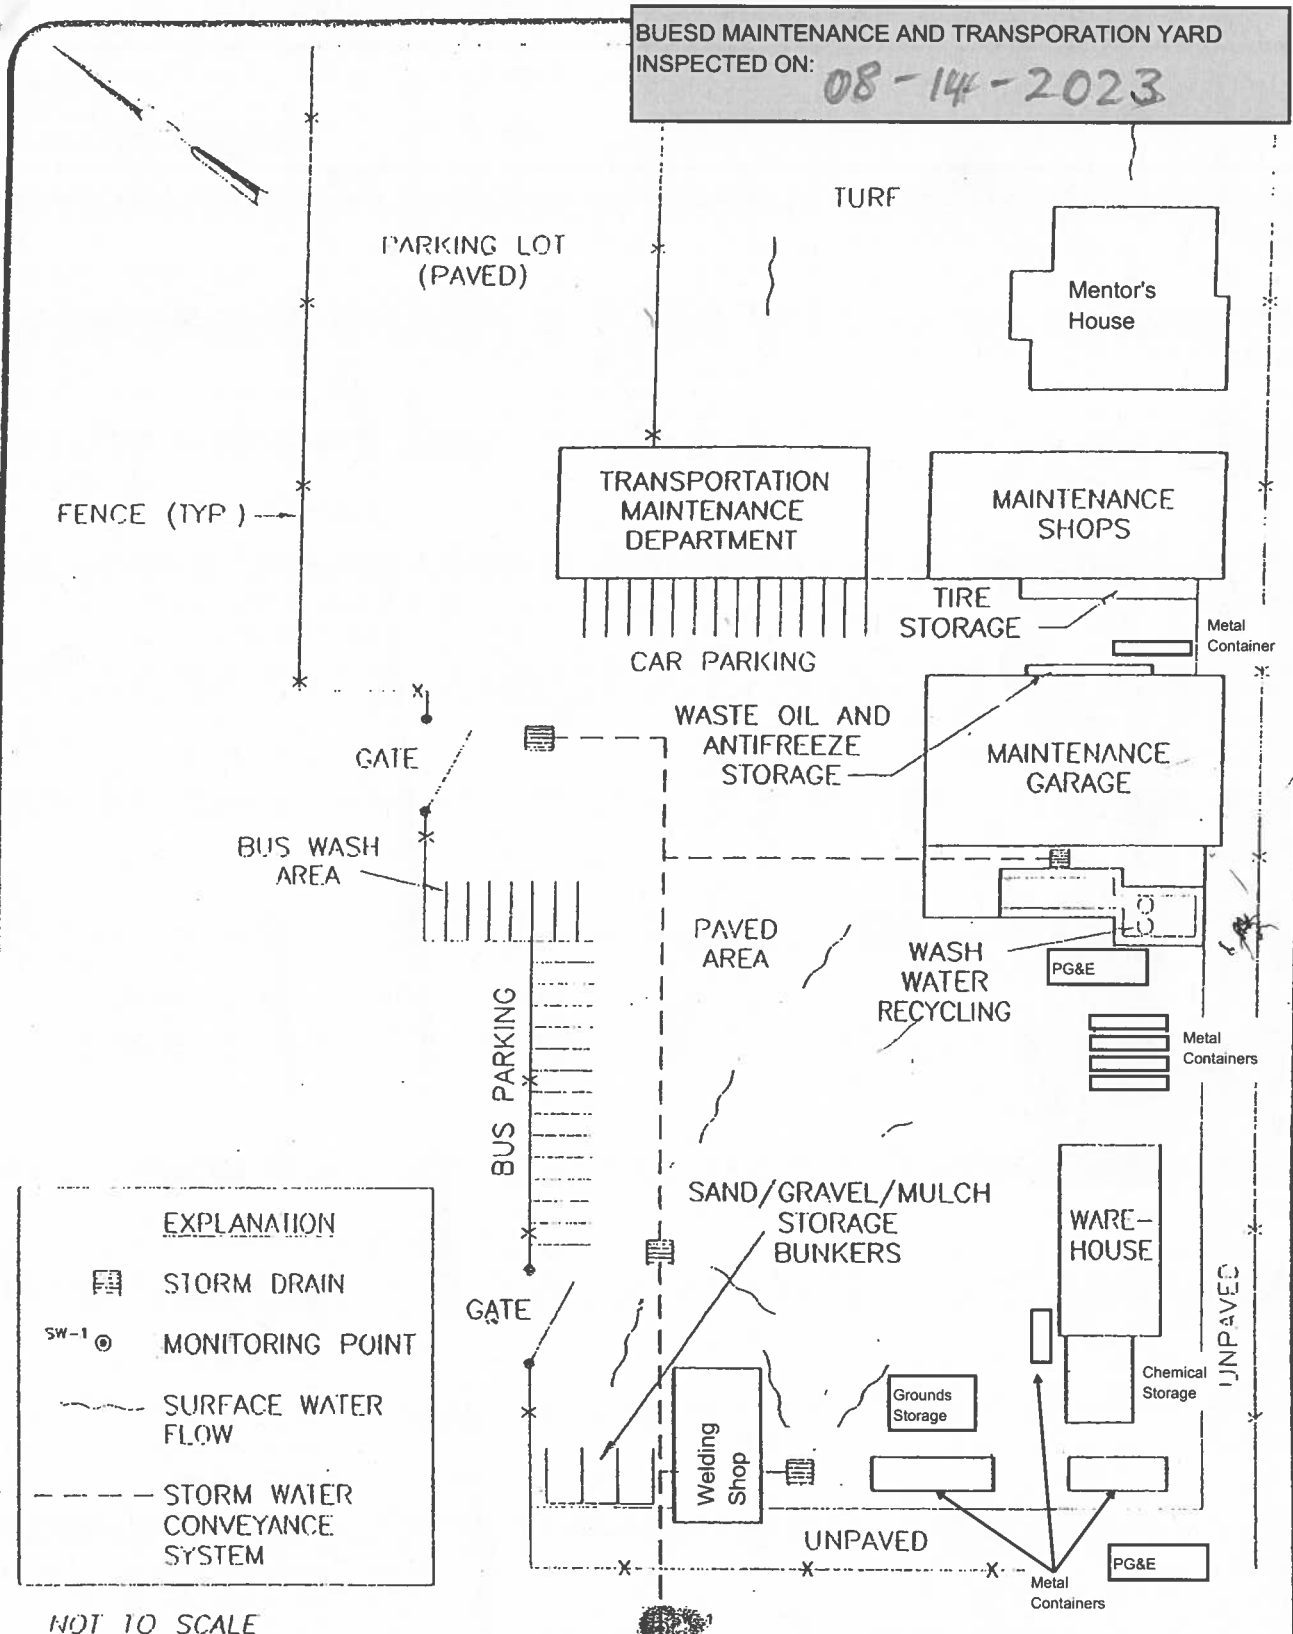
**FIGURE 2**  
BERRYESSA UNION SCHOOL DISTRICT  
945 PIEDMONT ROAD  
SAN JOSE, CALIFORNIA  
**CORPORATION YARD  
SITE PLAN**

- STORM DRAIN
- MONITORING POINT
- SURFACE WATER FLOW
- STORM WATER CONVEYANCE SYSTEM

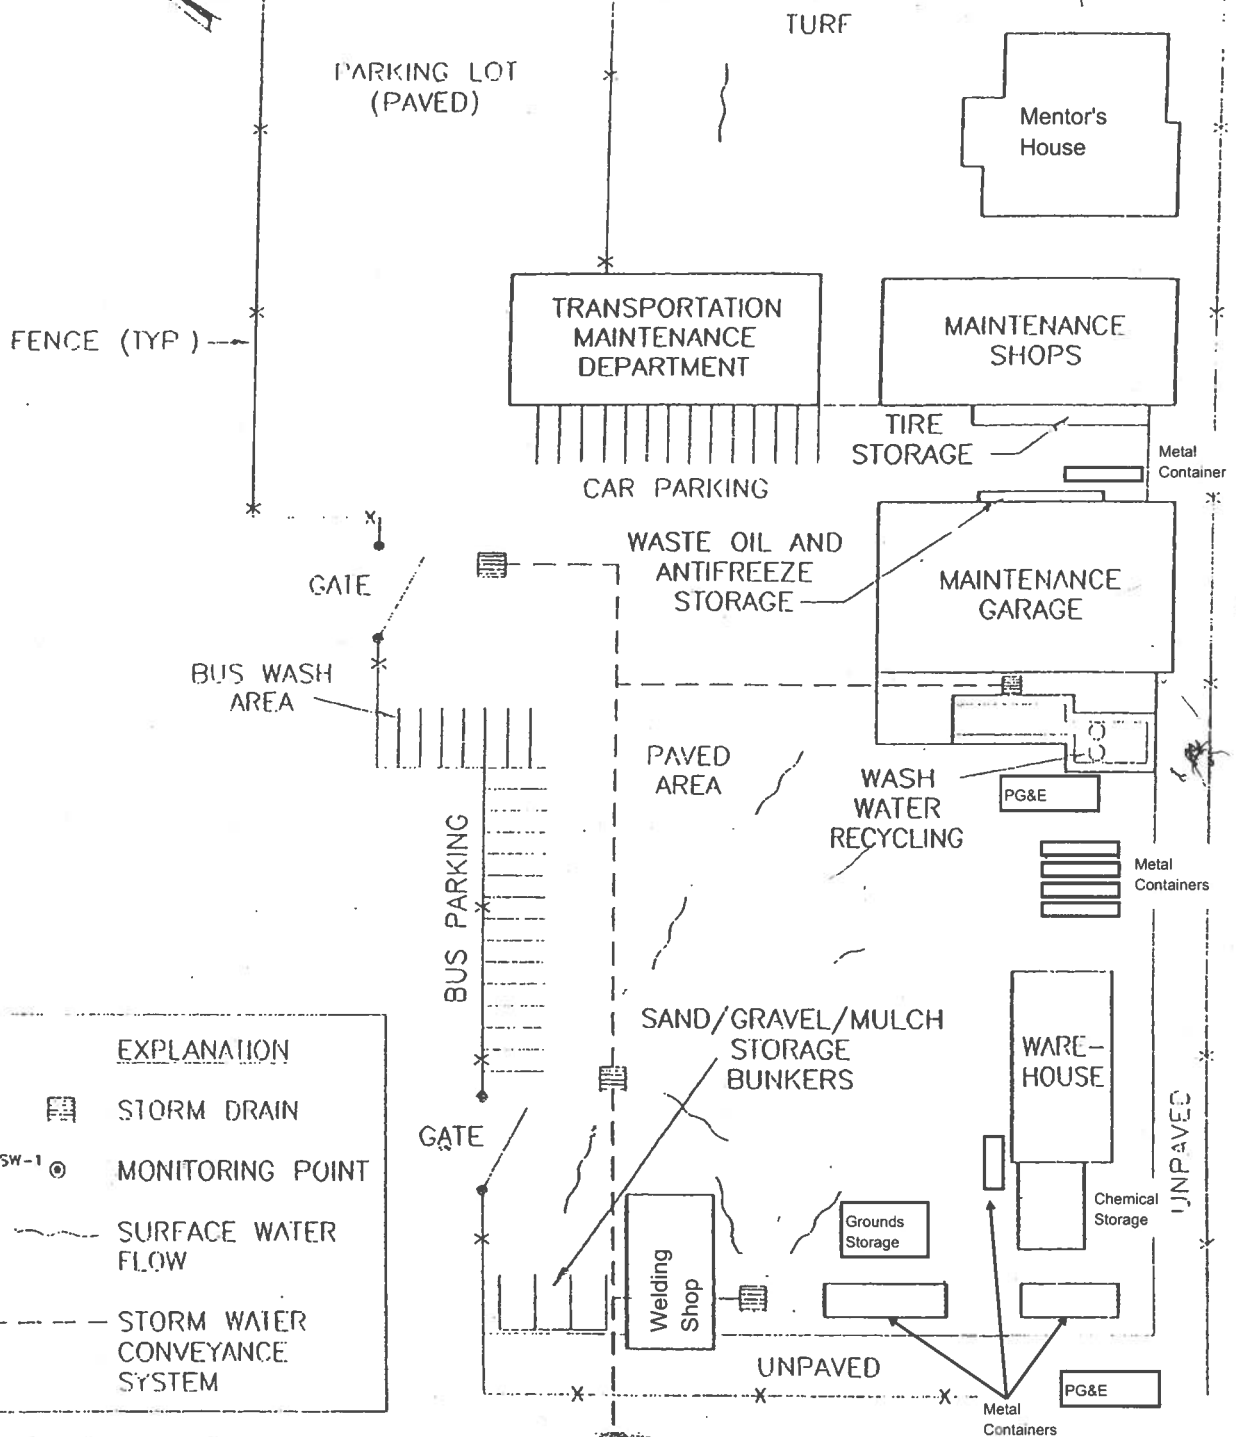
- STORM DRAIN
- MONITORING POINT
- SURFACE WATER FLOW
- STORM WATER CONVEYANCE SYSTEM
