## **SIX-MONTH SURVEILLANCE AHERA REPORT**

**MORRILL MIDDLE SCHOOL  
1970 MORRILL AVENUE  
SAN JOSE, CA 95132**

**PREPARED FOR:  
BERRYESSA UNION ELEMENTARY SCHOOL DISTRICT  
981 RIDDER PARK DRIVE  
SAN JOSE, CA 95131**

**HAZMAT DOC PROJECT #25-101**

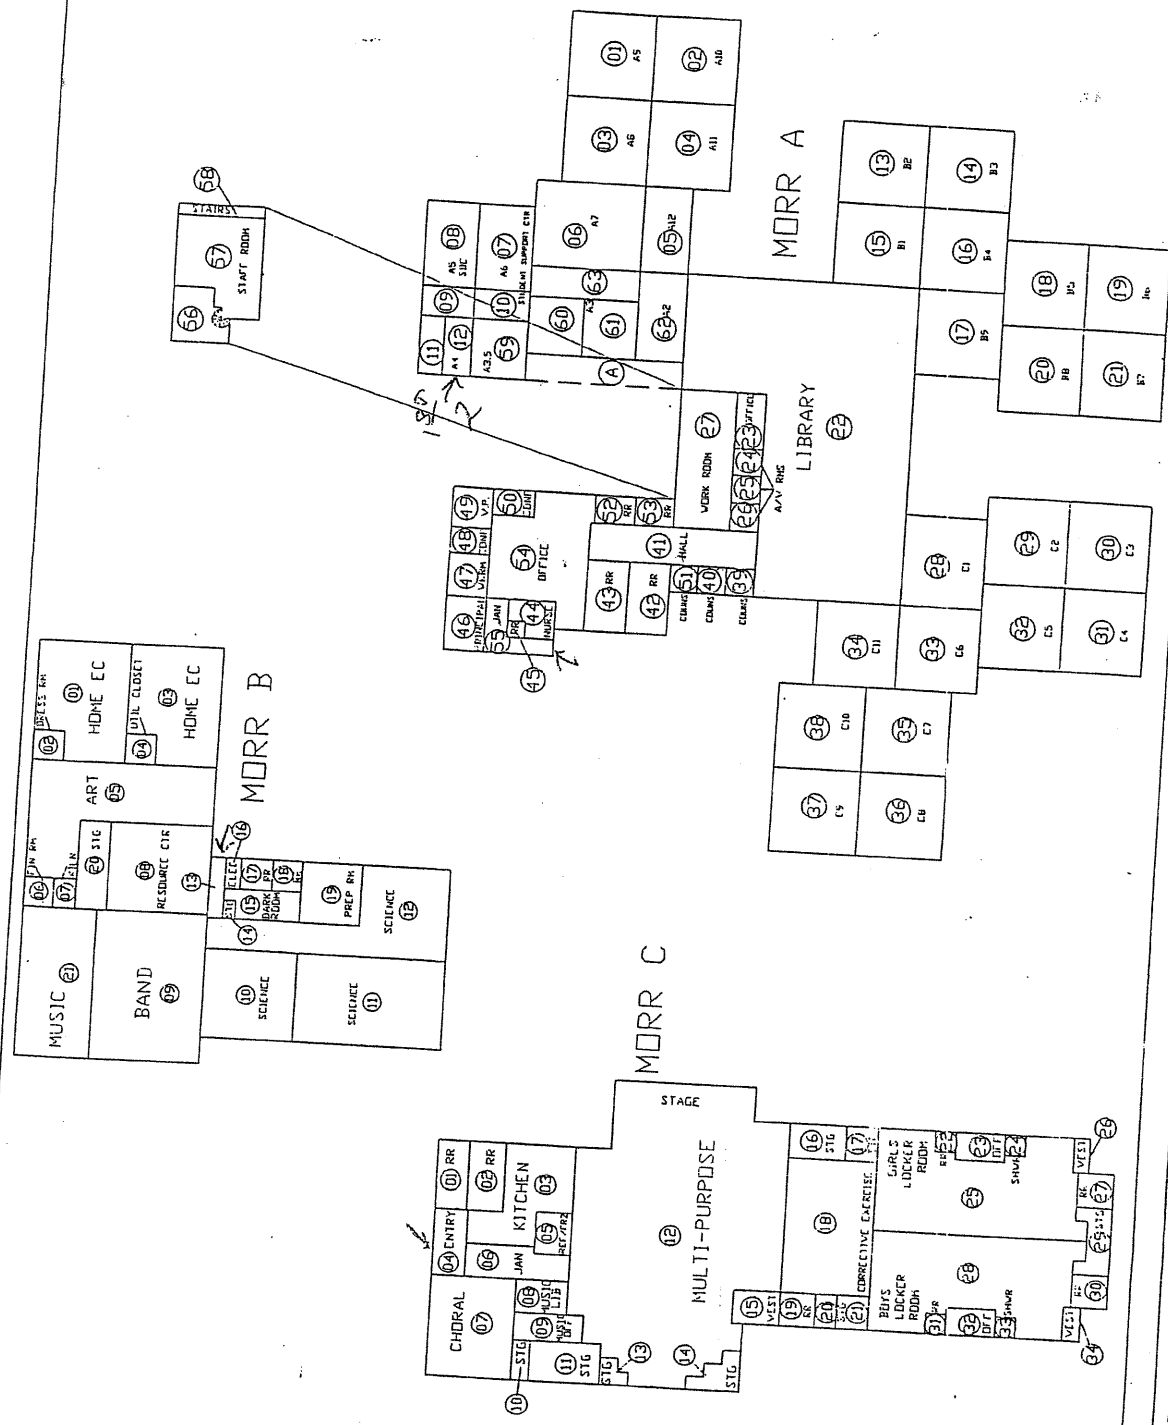
# NAMING CONVENTION SITEPLAN

SCHOOL NAME: MORRILL MIDDLE  
 ADDRESS: 1970 MORRILL AVENUE  
 COUNTY: SANTA CLARA  
 ACREAGE: N/A  
 REV. DATE: 01/25/99

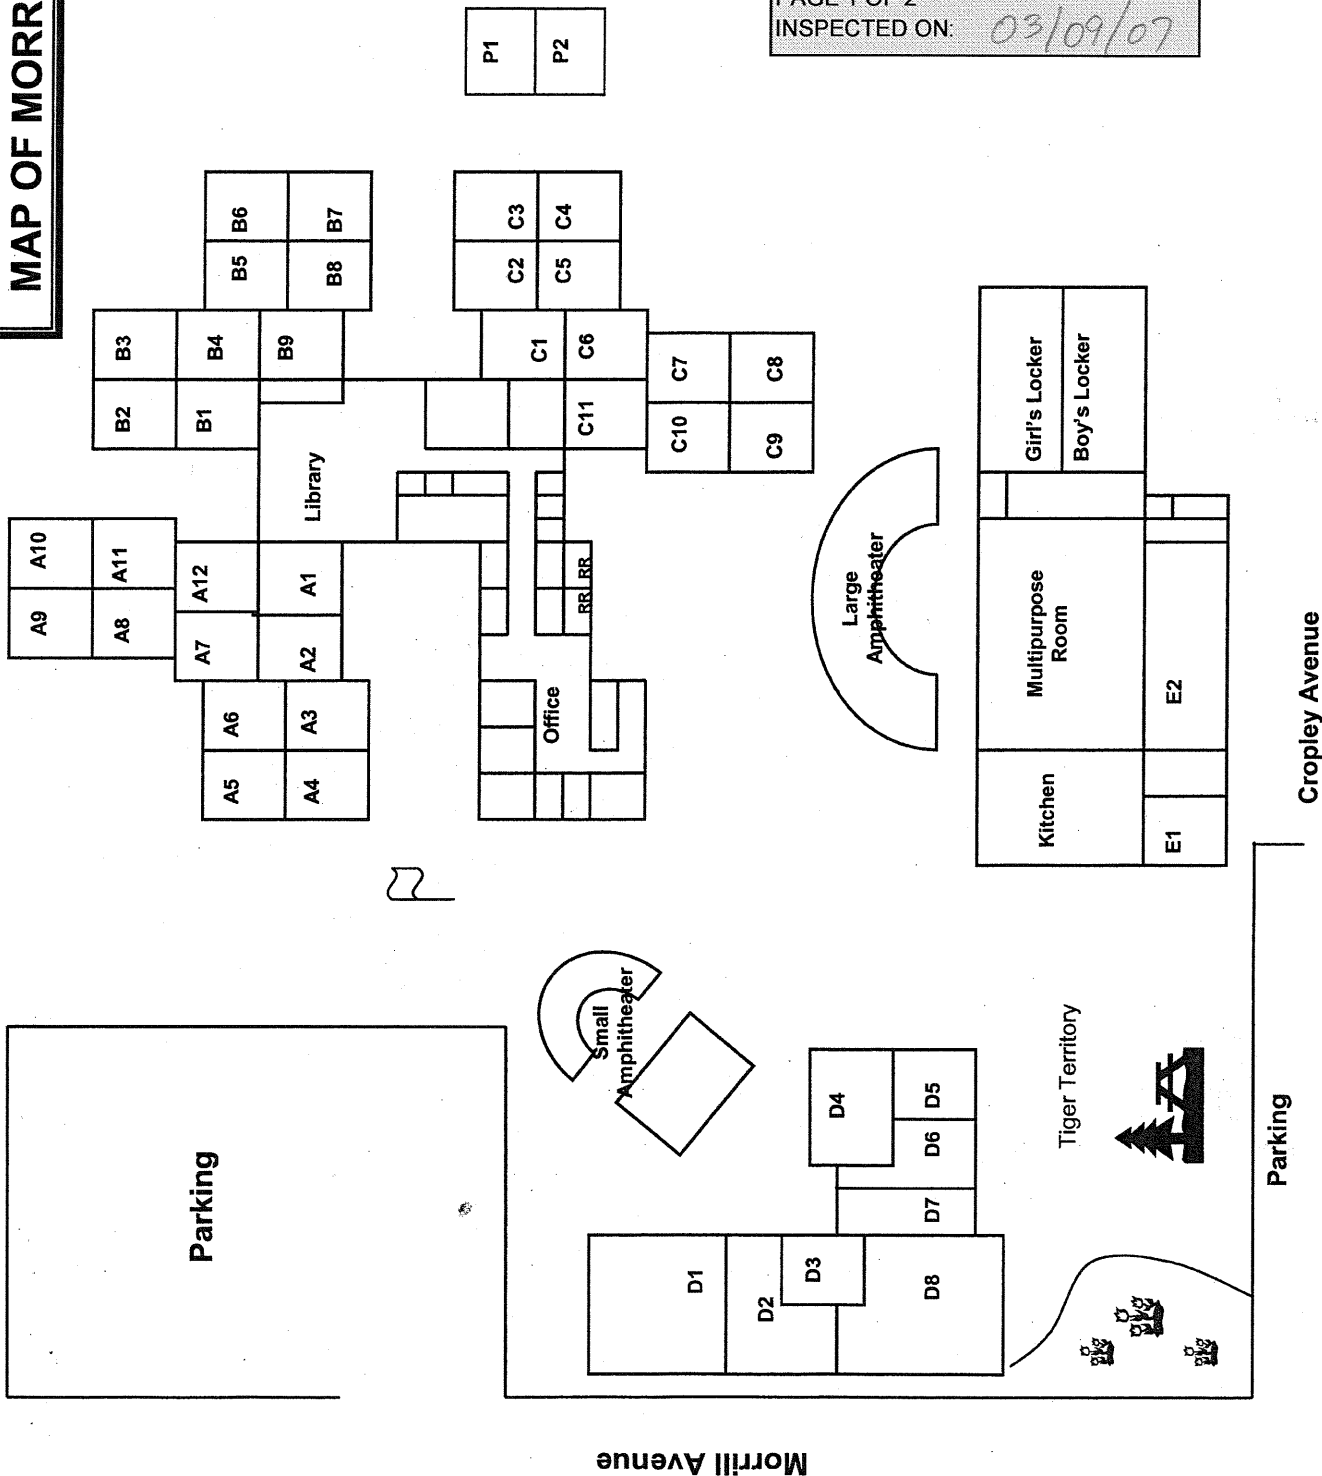
# MAP OF MORRILL

MORRILL MIDDLE SCHOOL  
PAGE 1 OF 2  
INSPECTED ON: 03/09/07

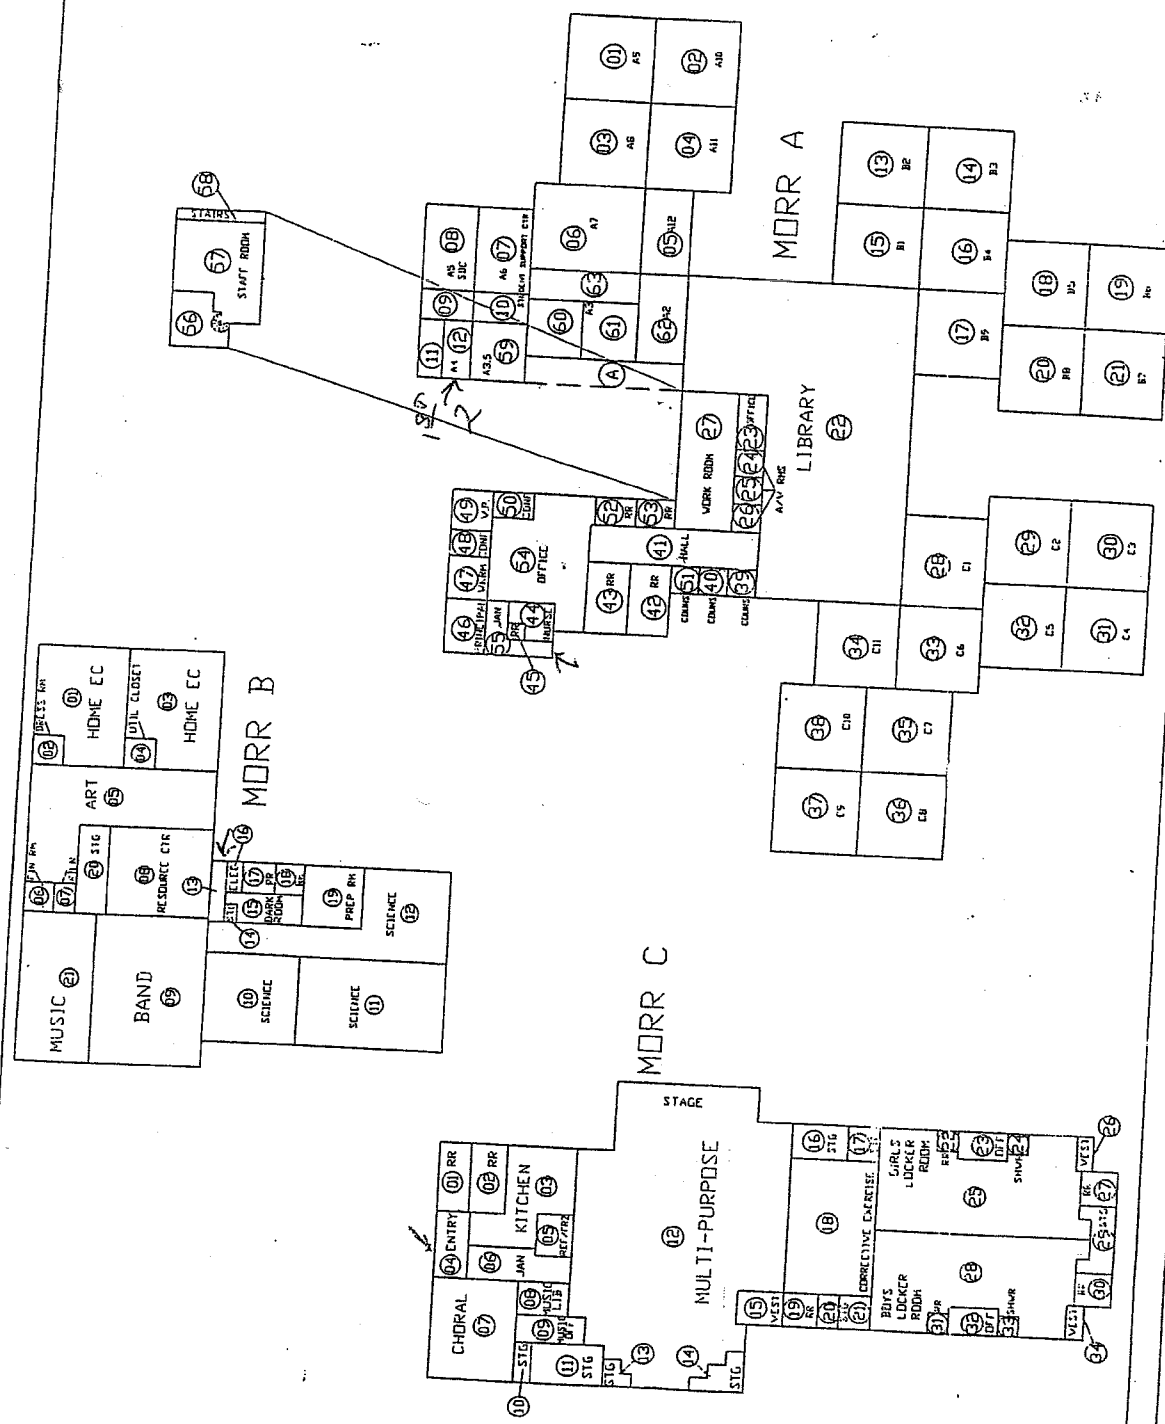
# NAMING CONVENTION SITEPLAN

BERRYESSA UNIFIED  
1376 PIEDMONT RD  
SAN JOSE, CA 95132

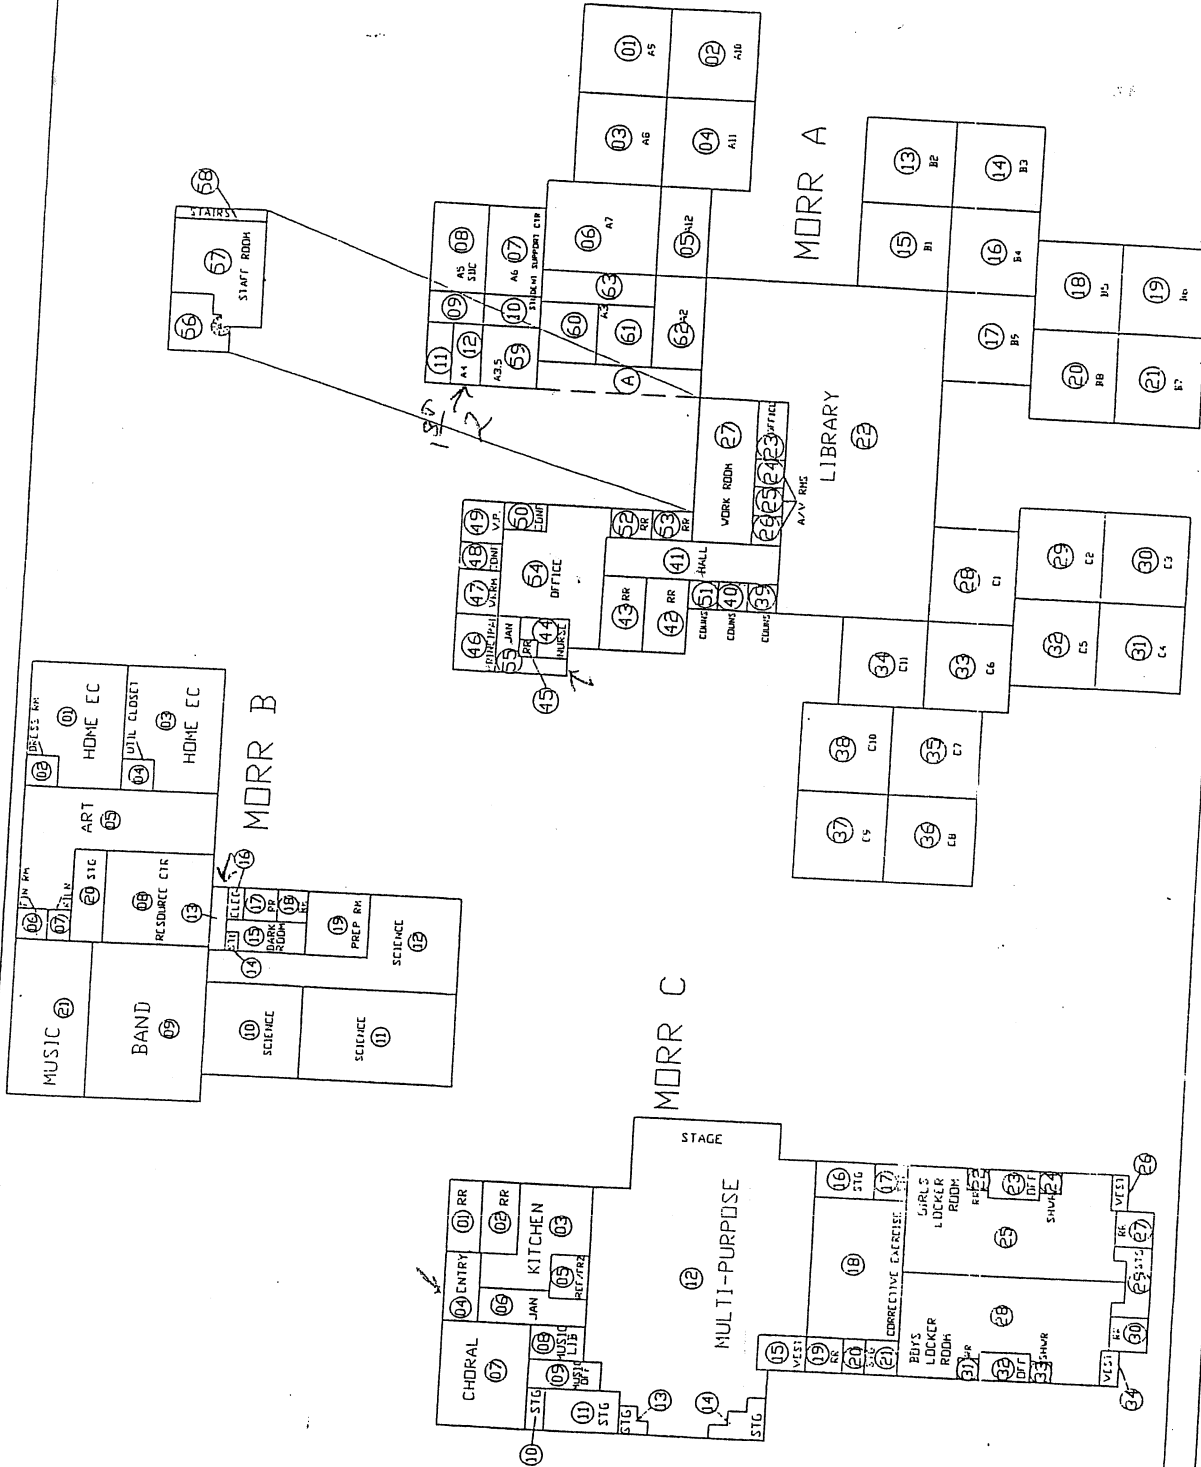
# NAMING CONVENTION SITEPLAN

SCHOOL NAME: MORRILL MIDDLE  
ADDRESS: 1970 MORRILL AVENUE  
SCHOOL DISTRICT: BERRYESSA UNIFIED  
COUNTY: SANTA CLARA  
ACREAGE: N/A  
REV. DATE: 01/25/99
