## **SIX-MONTH SURVEILLANCE AHERA REPORT**

**NOBLE ELEMENTARY SCHOOL  
3466 GROSSMONT DRIVE  
SAN JOSE, CA 95132**

**INSPECTED ON:  
FEBRUARY 25, 2025**

**HAZMAT DOC PROJECT #25-036**

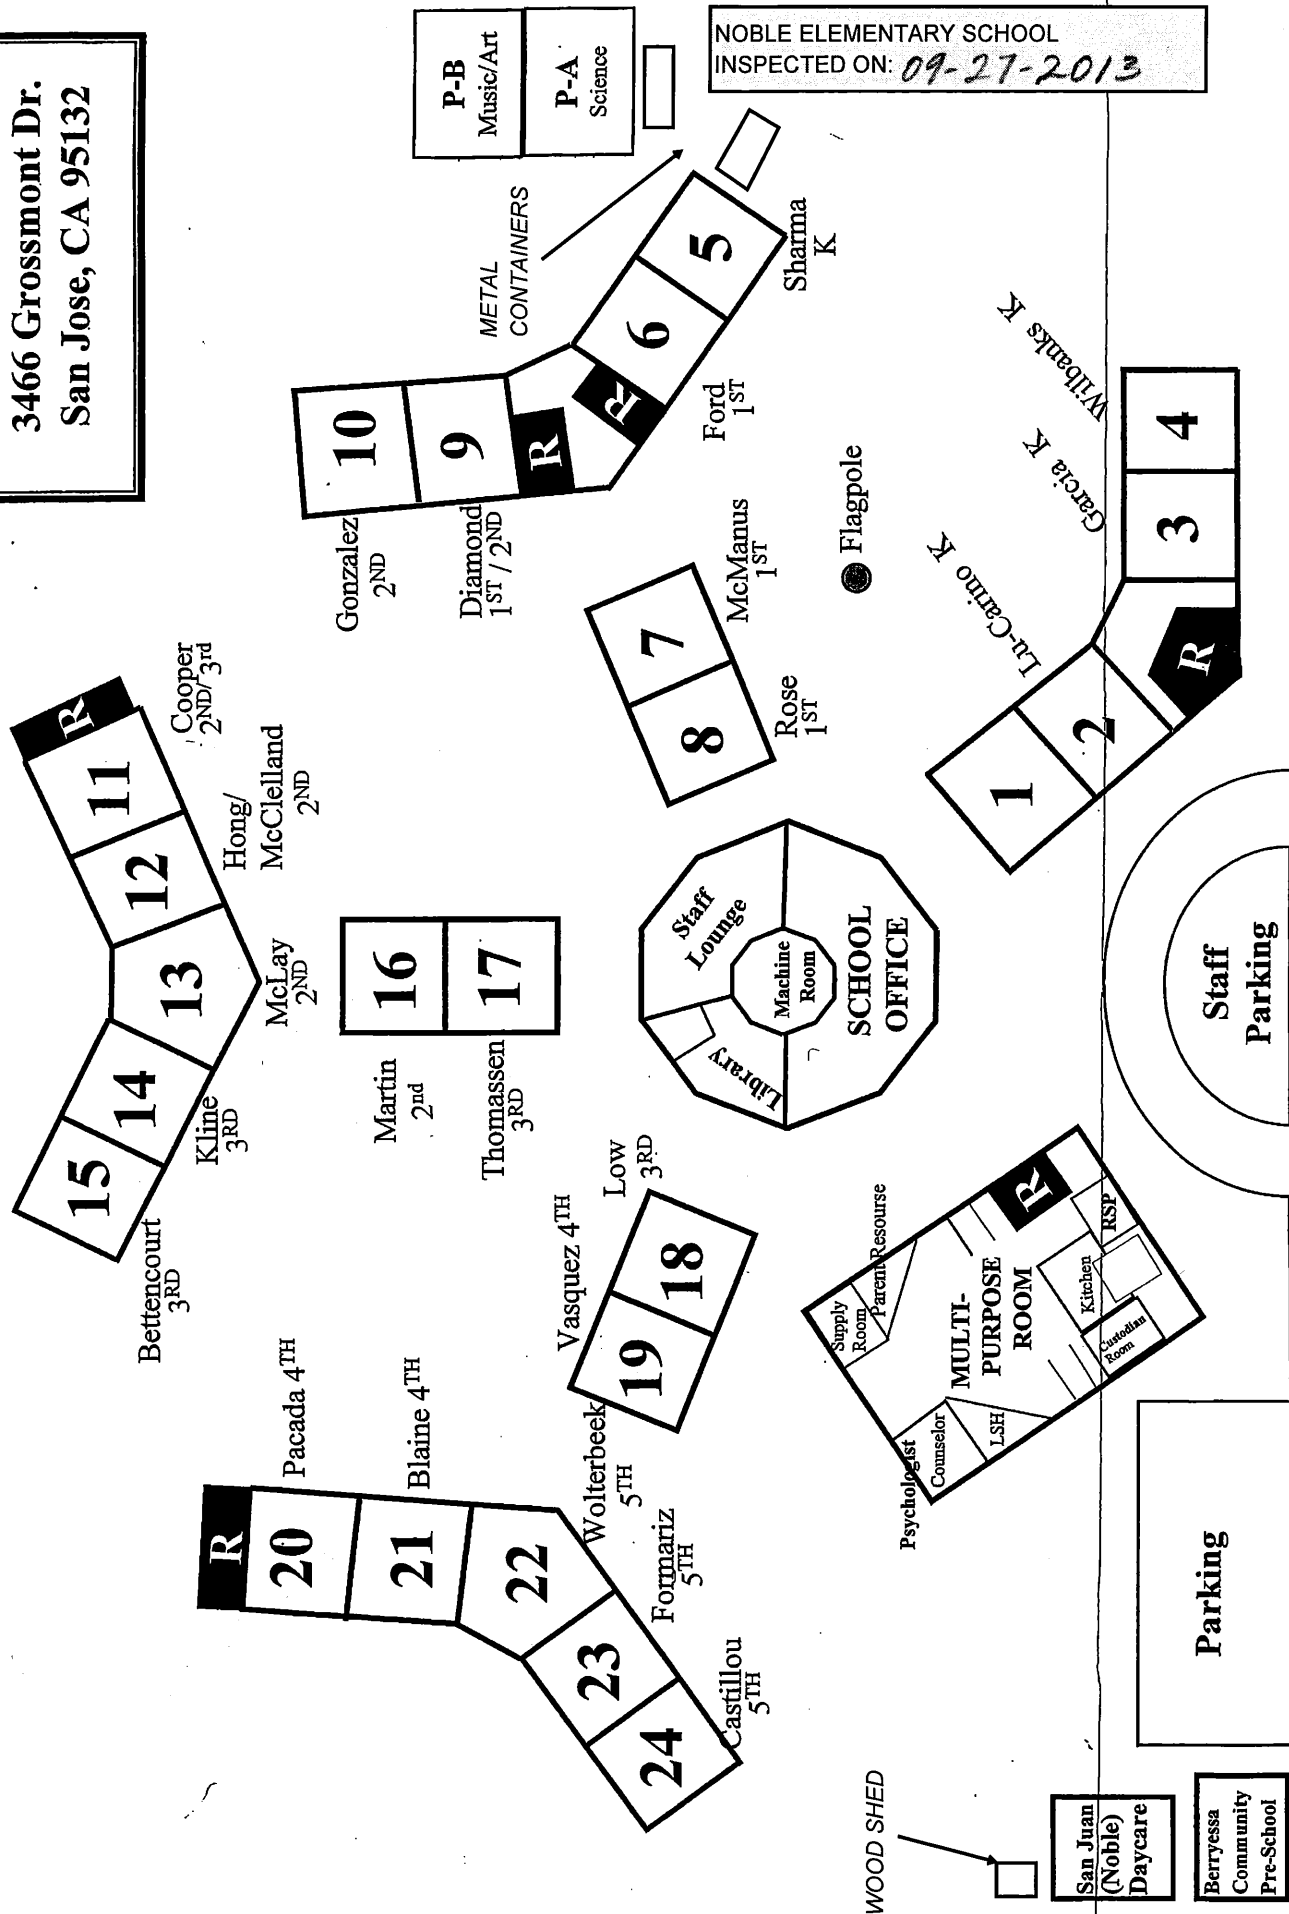
NOBLE ELEMENTARY SCHOOL  
 INSPECTED ON: **09-27-2013**

**R** = restroom

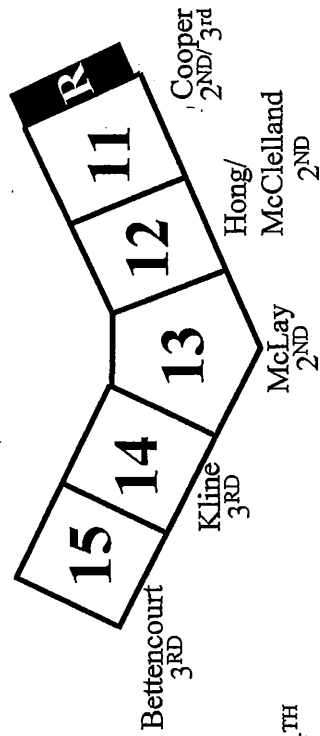
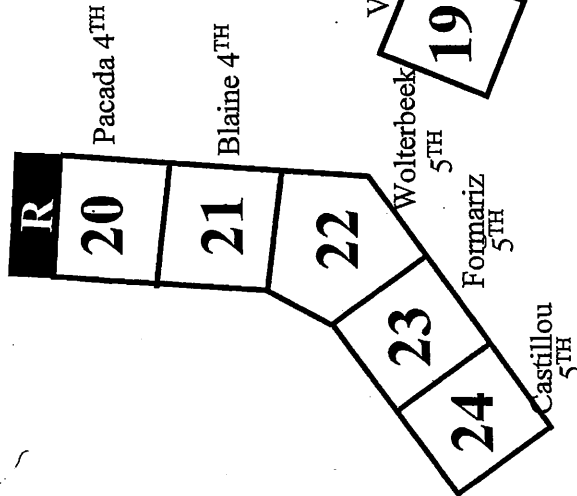
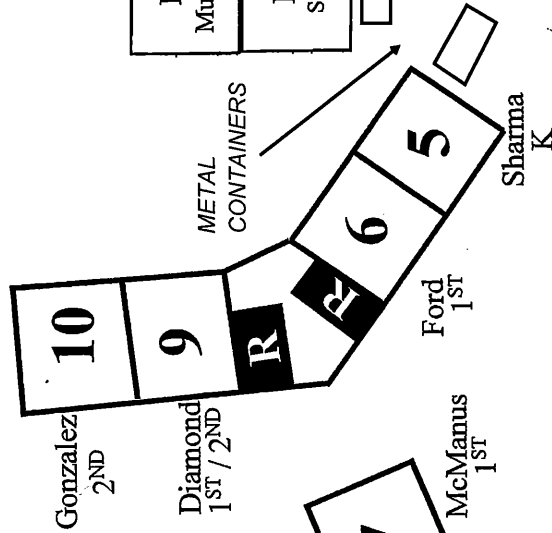
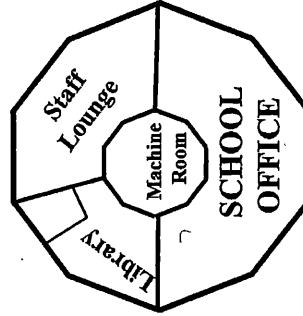
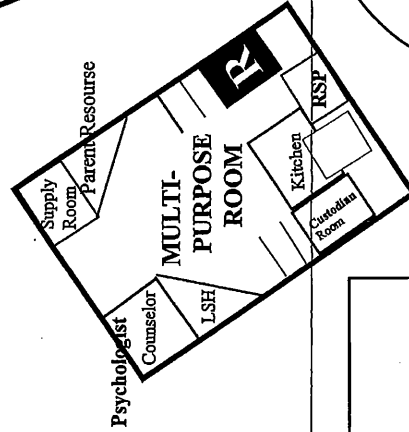
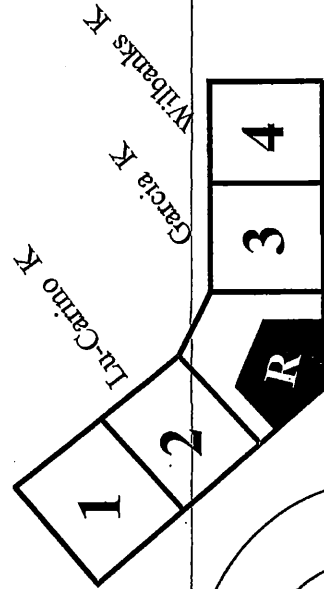
NOBLE ELEMENTARY SCHOOL  
 INSPECTED ON: **4-4-13**

**P-B** Music/Art  
**P-A** Science

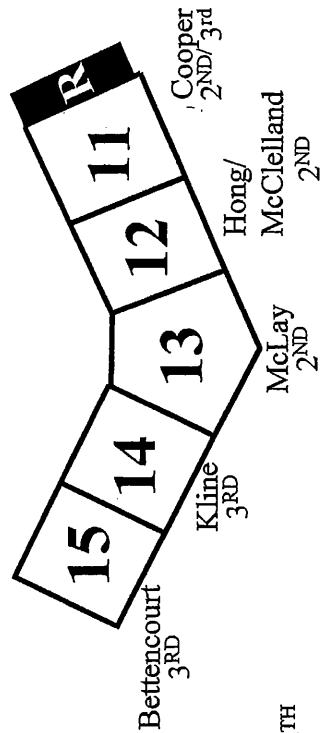
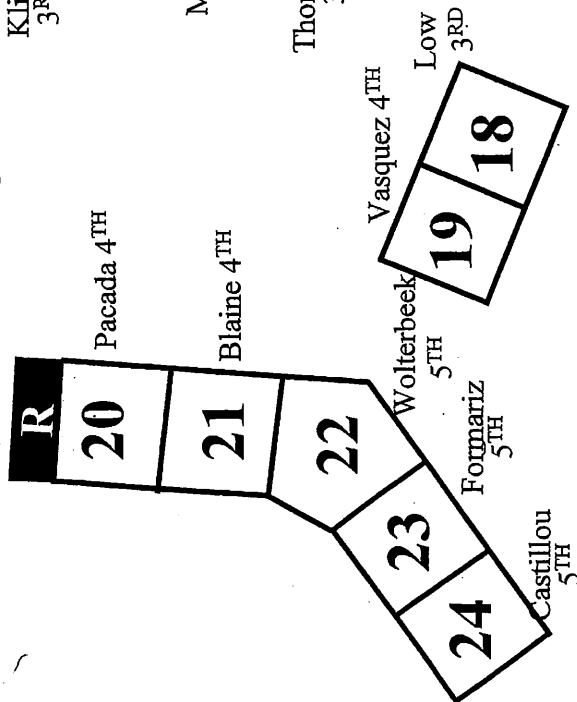
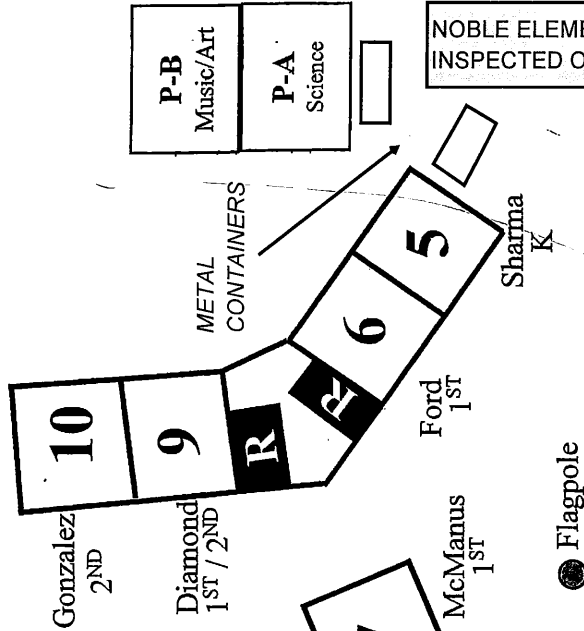
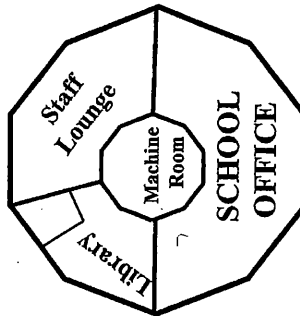
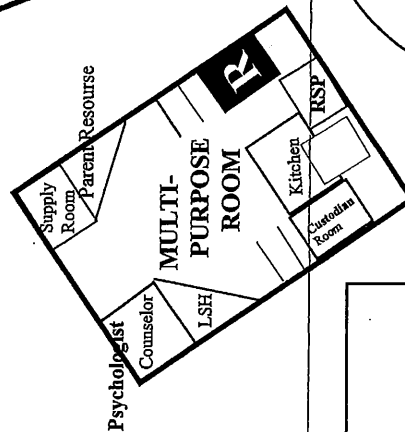
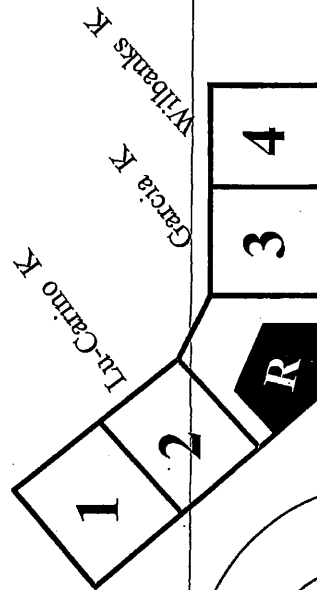
NOBLE ELEMENTARY SCHOOL  
 INSPECTED ON: 10-12-12

P-B  
 Music/Art

P-A  
 Science

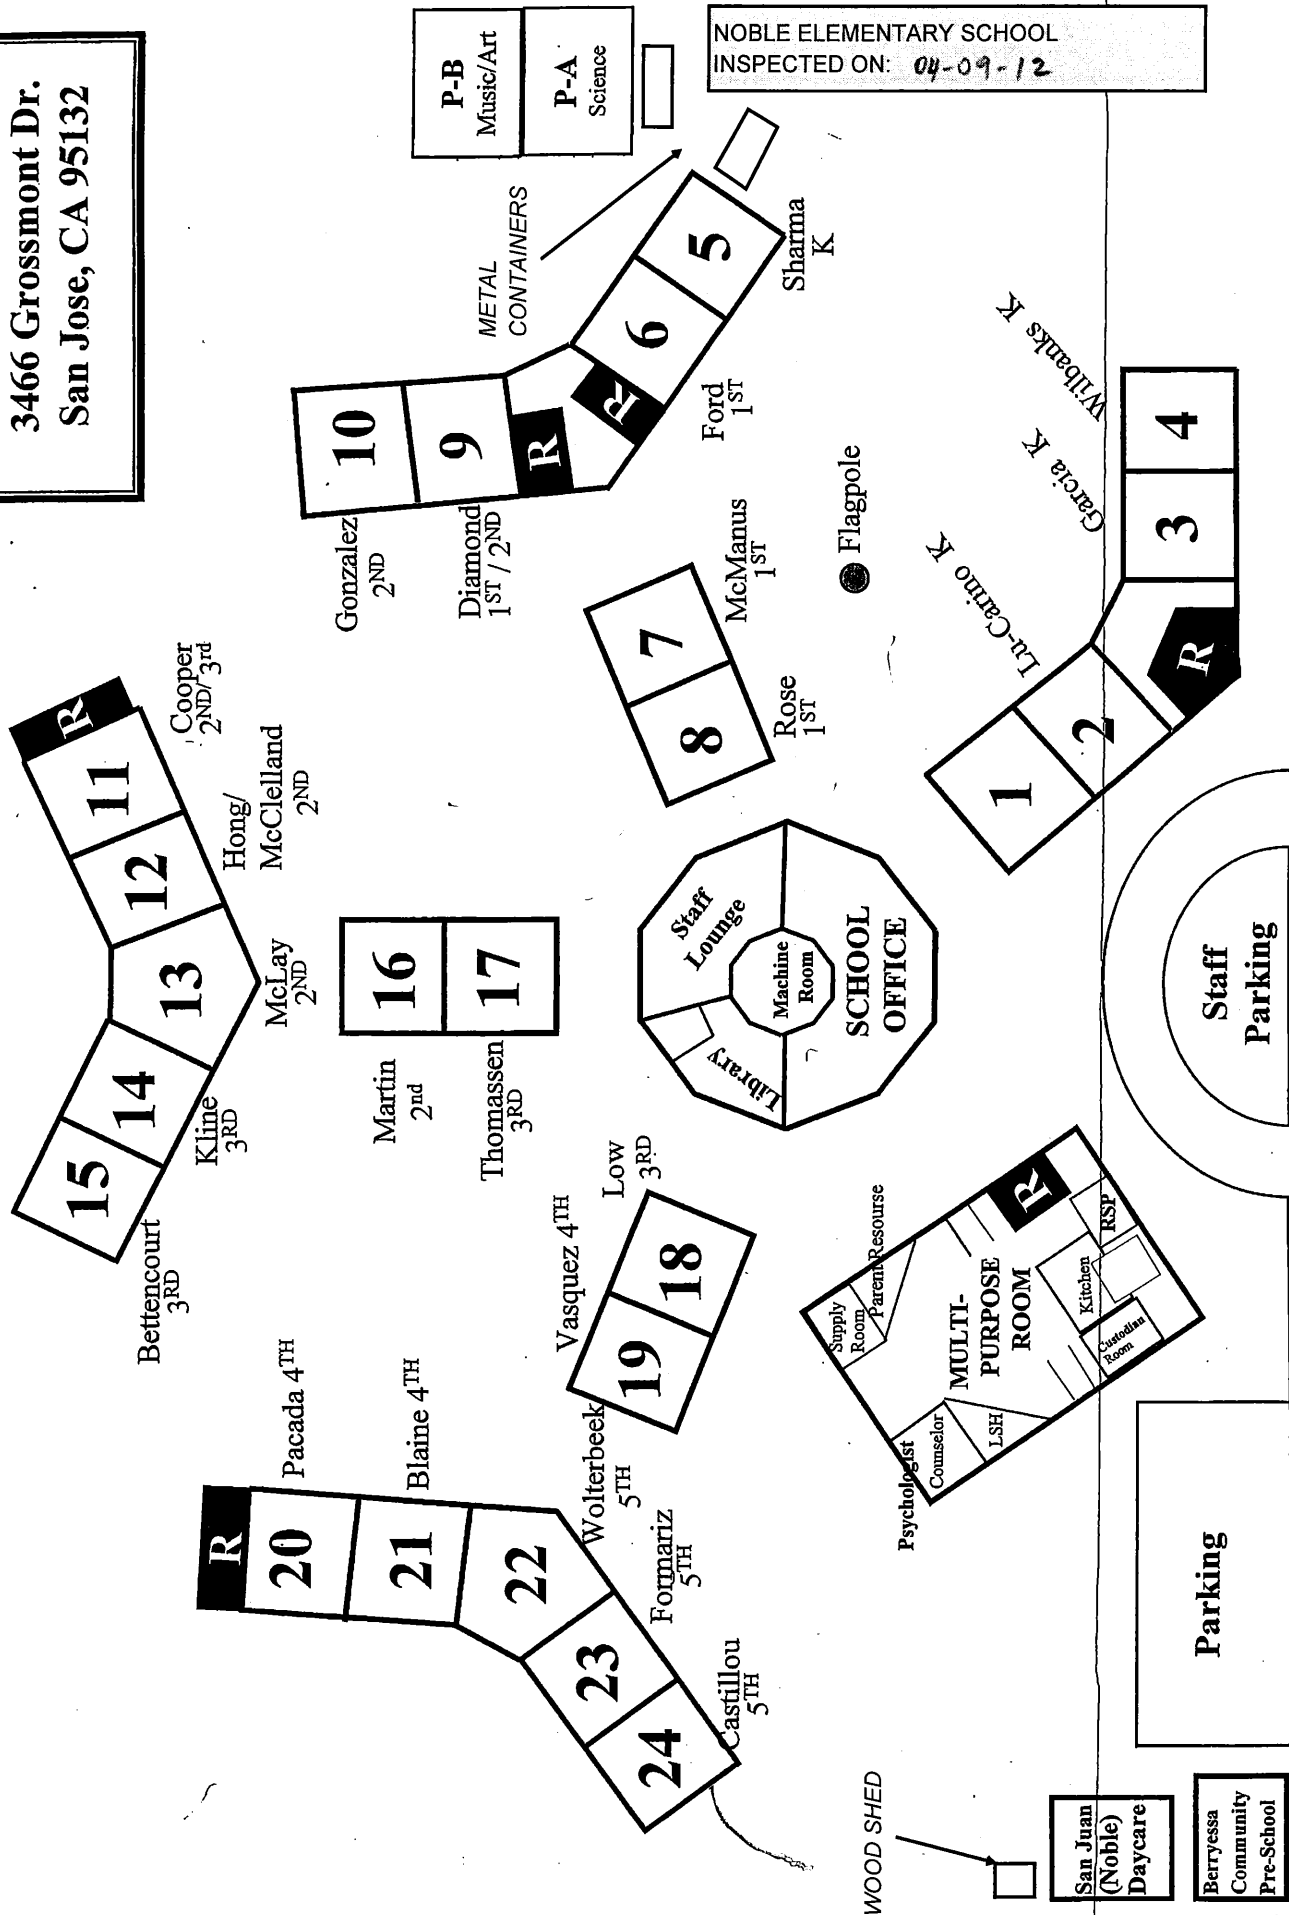
NOBLE ELEMENTARY SCHOOL  
 INSPECTED ON: 04-09-12

**R** = restroom

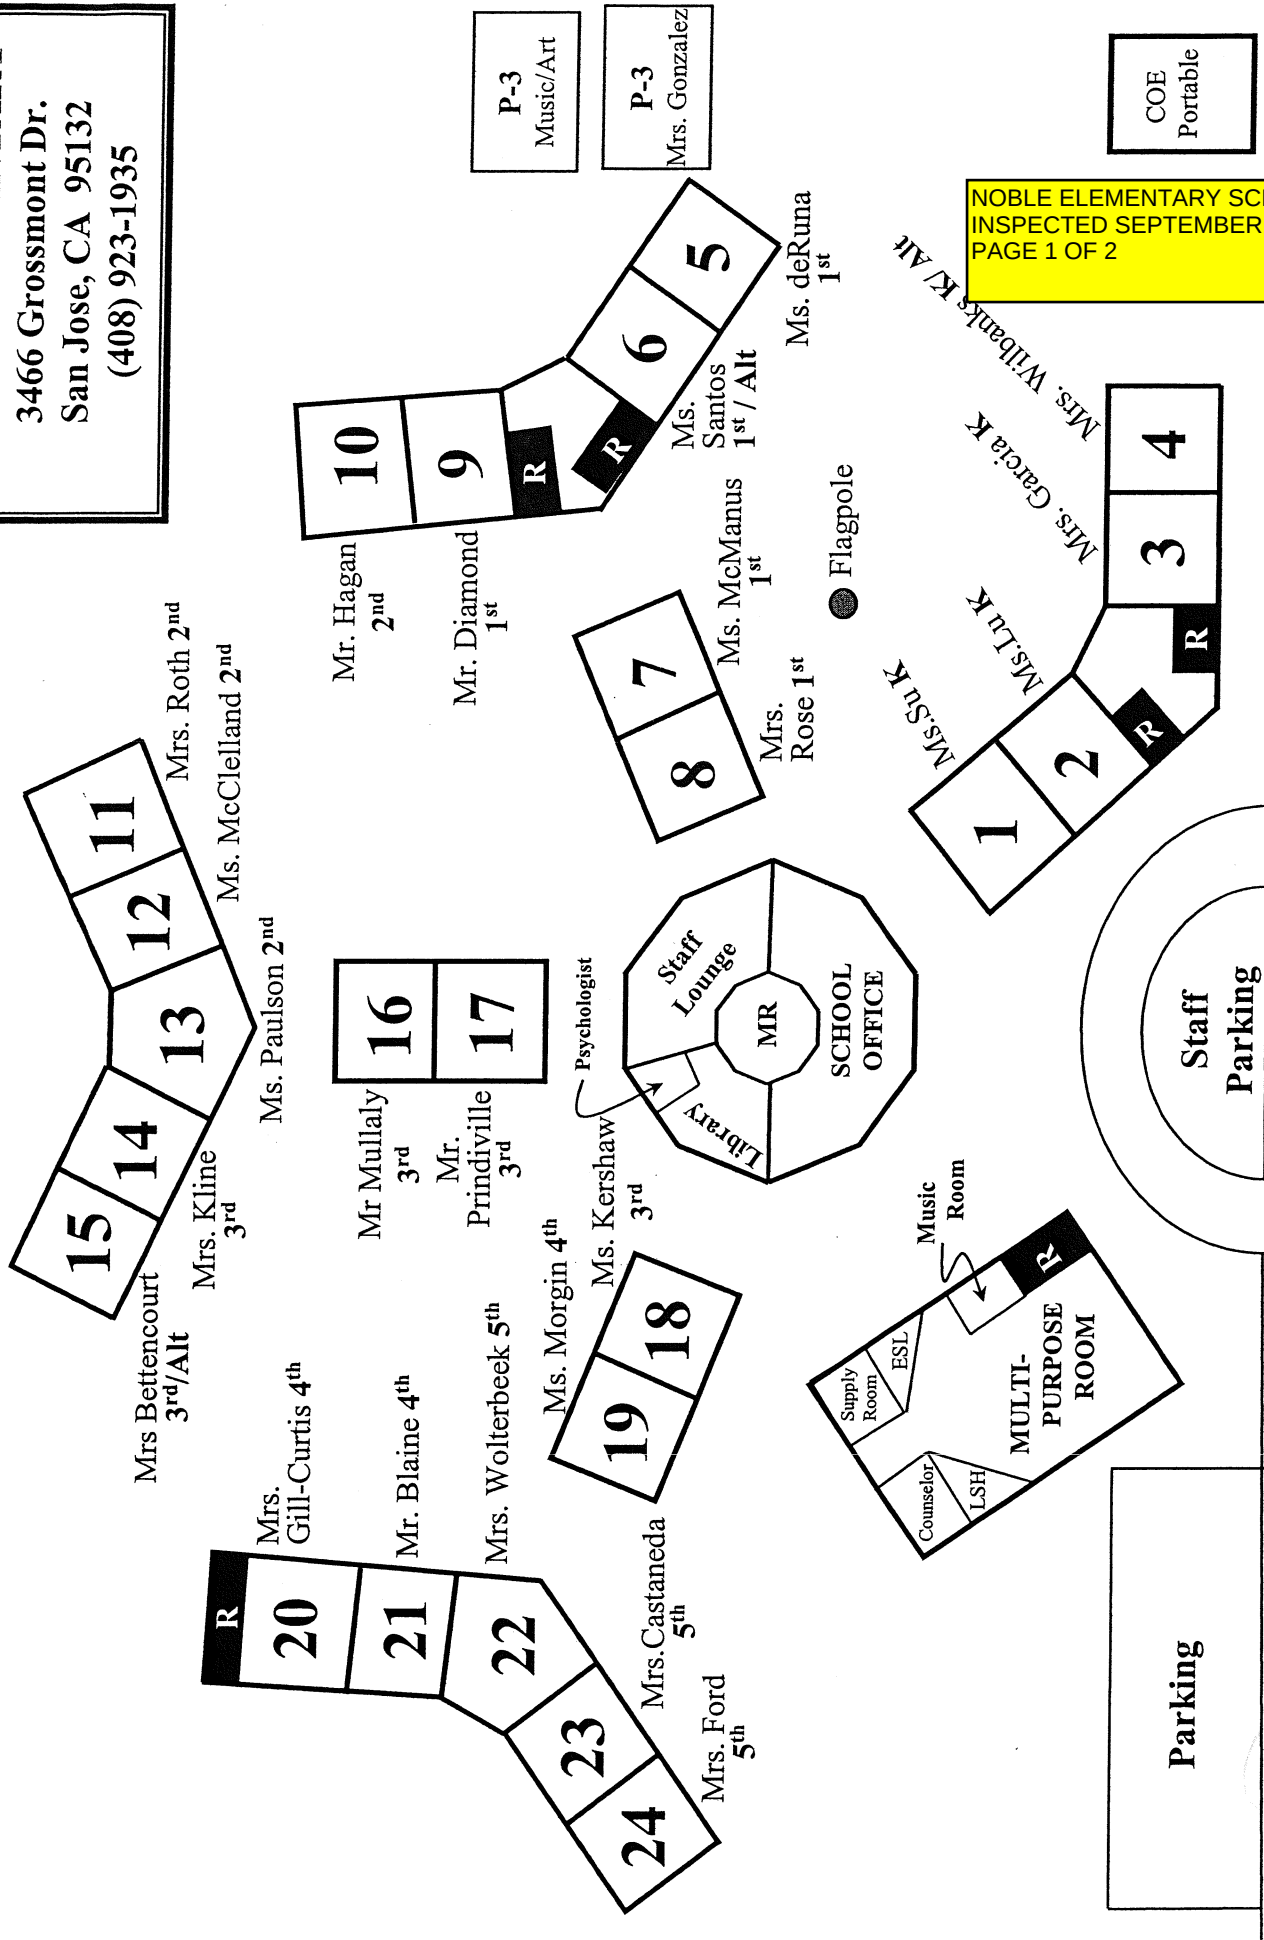
**NOBLE ELEMENTARY SCHOOL**  
**INSPECTED SEPTEMBER 2005**  
**PAGE 1 OF 2**

**NOBLE ELEMENTARY**  
**3466 Grossmont Dr.**  
**San Jose, CA 95132**  
**(408) 923-1935**

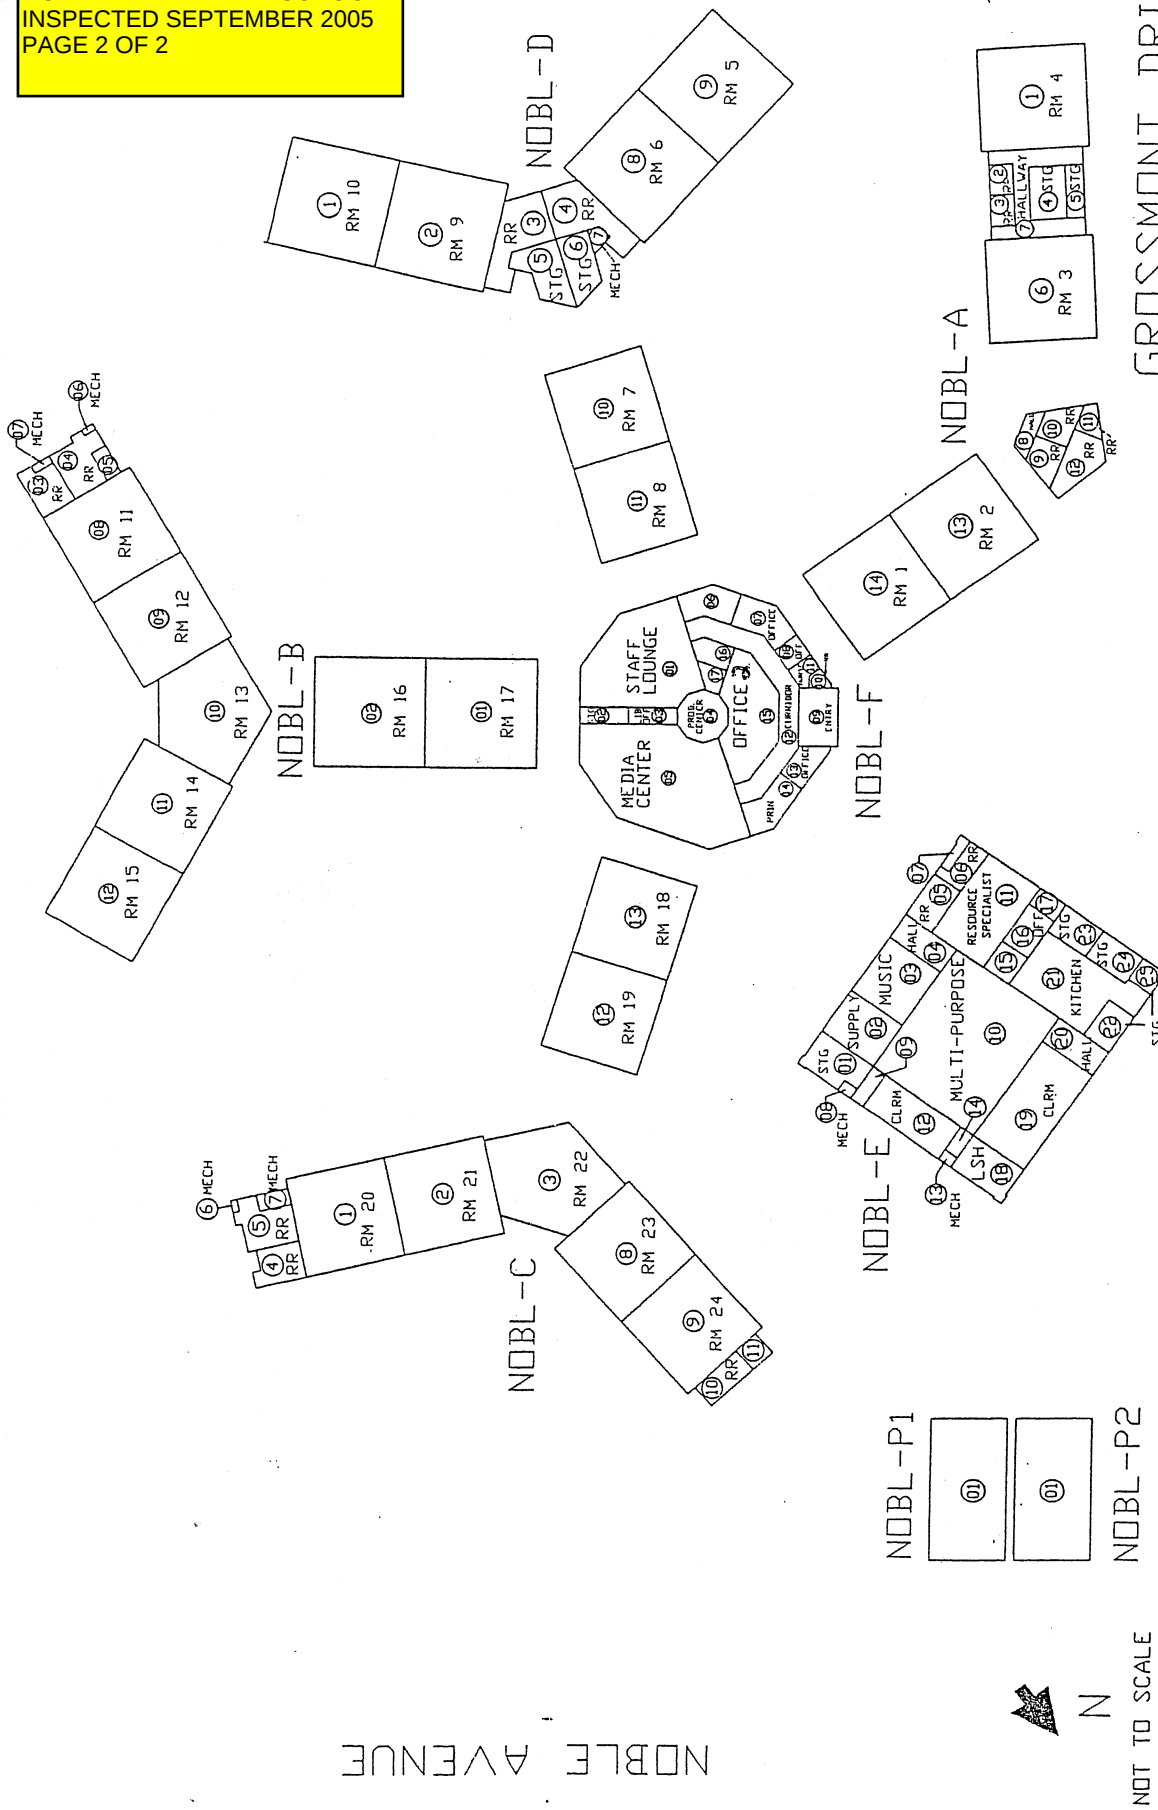
NOBLE ELEMENTARY SCHOOL  
INSPECTED SEPTEMBER 2005  
PAGE 2 OF 2

# NAMING CONVENTION SITEPLAN
