## **Civil/Site Assessment & Recommendations**

### **Mountain View Los Altos High School District**

**Brelje & Race Consulting Engineers**

### **Campus Assessments**

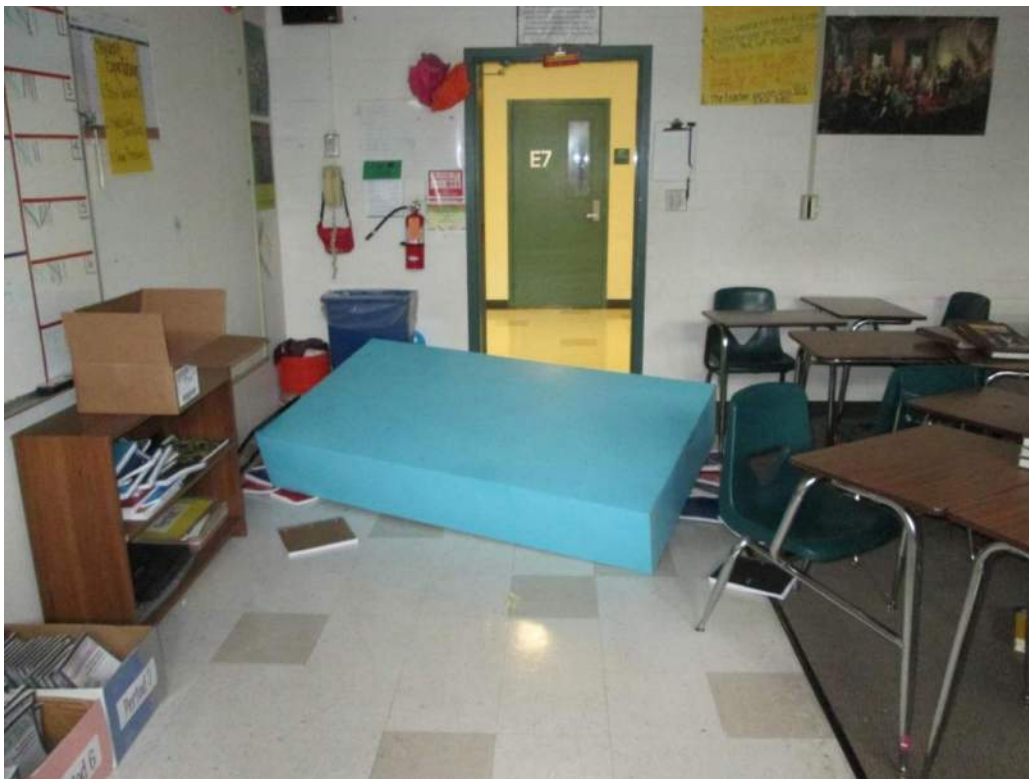
Free standing  
cabinets placed  
next to classroom  
doors can block  
exits

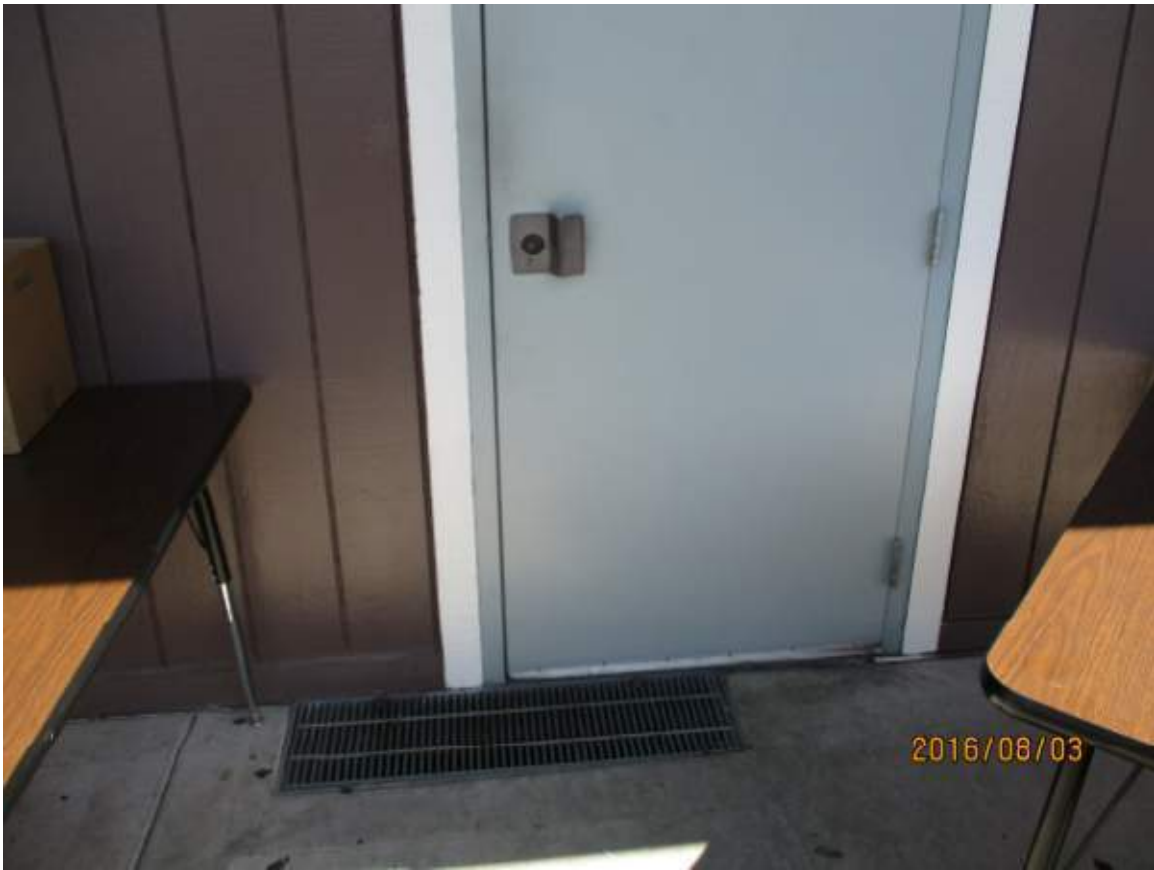
⑤

**MOUNTAIN VIEW HIGH SCHOOL**  
NON ADA GRATE AT DOORWAY

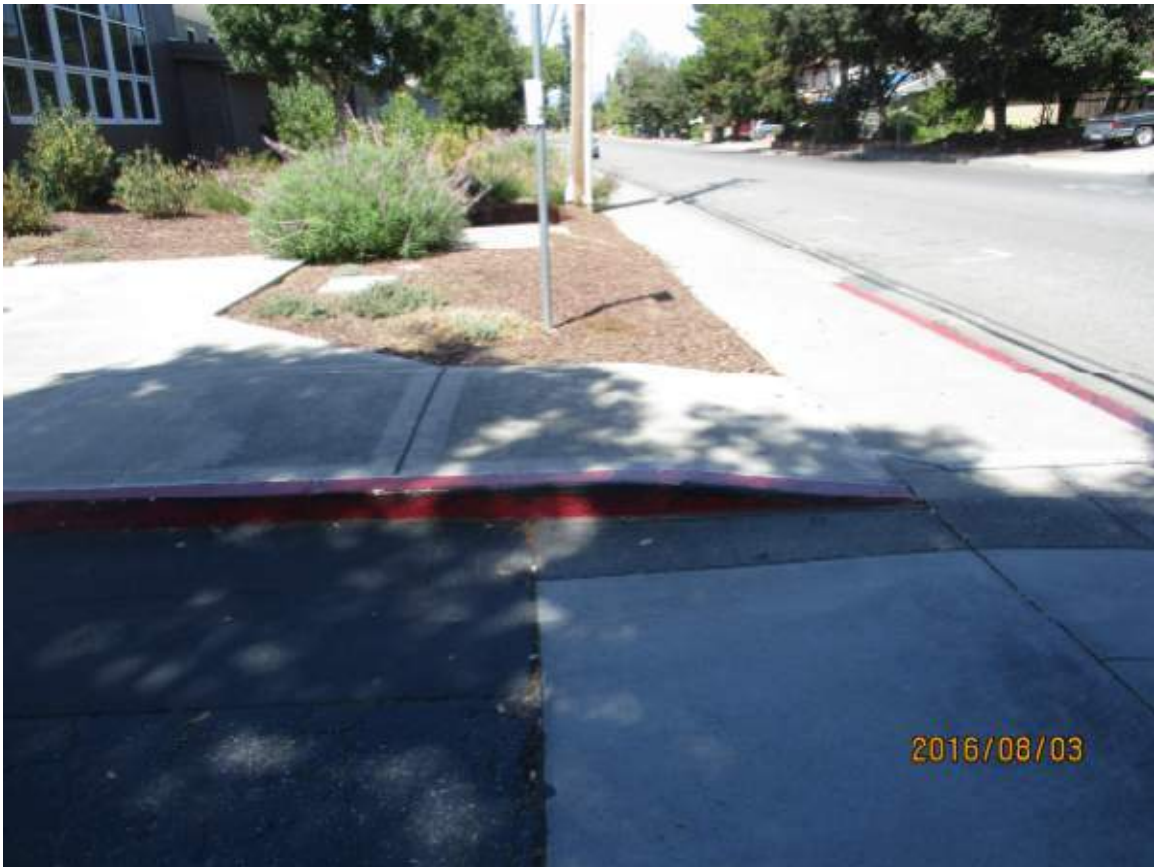
⑥

**MOUNTAIN VIEW HIGH SCHOOL**  
NON-COMPLIANT ACCESS TO PUBLIC RIGHT OF WAY

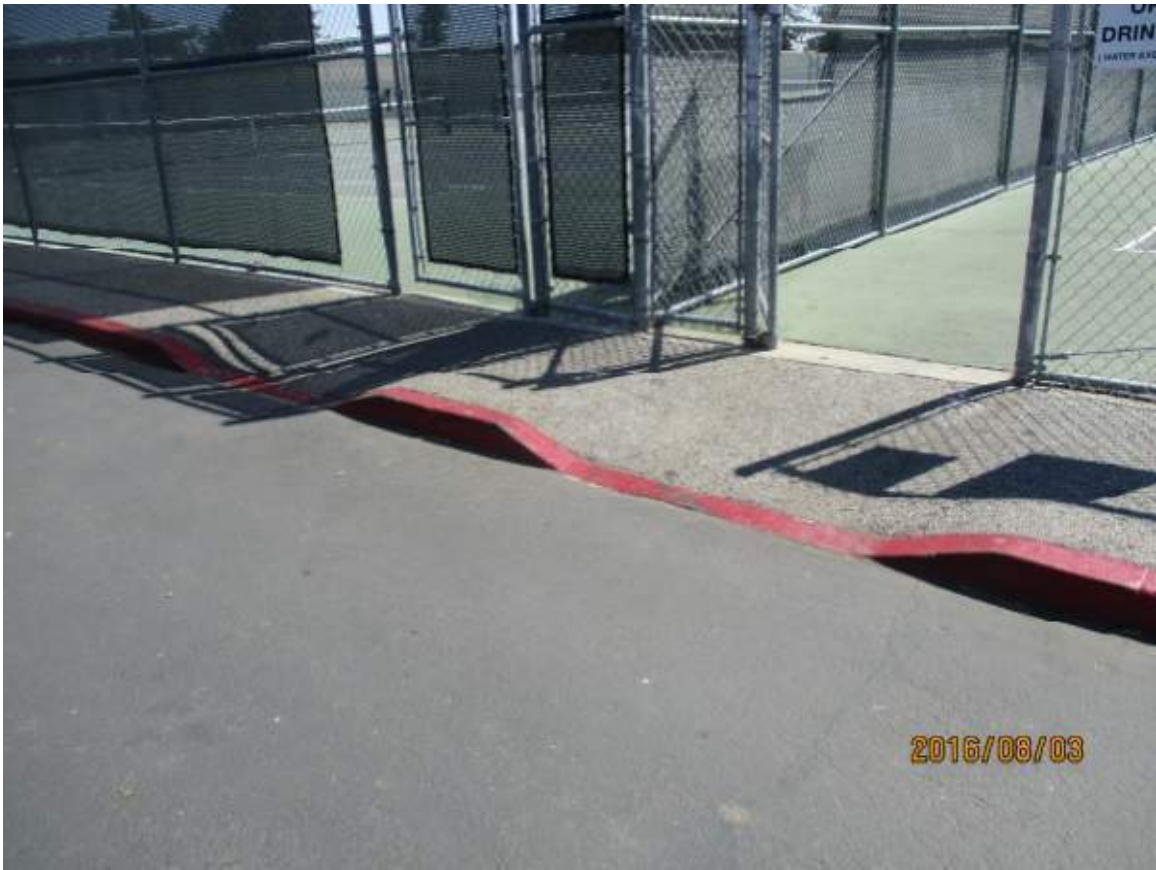
⑦

**MOUNTAIN VIEW HIGH SCHOOL**  
NON-COMPLIANT ADA RAMP

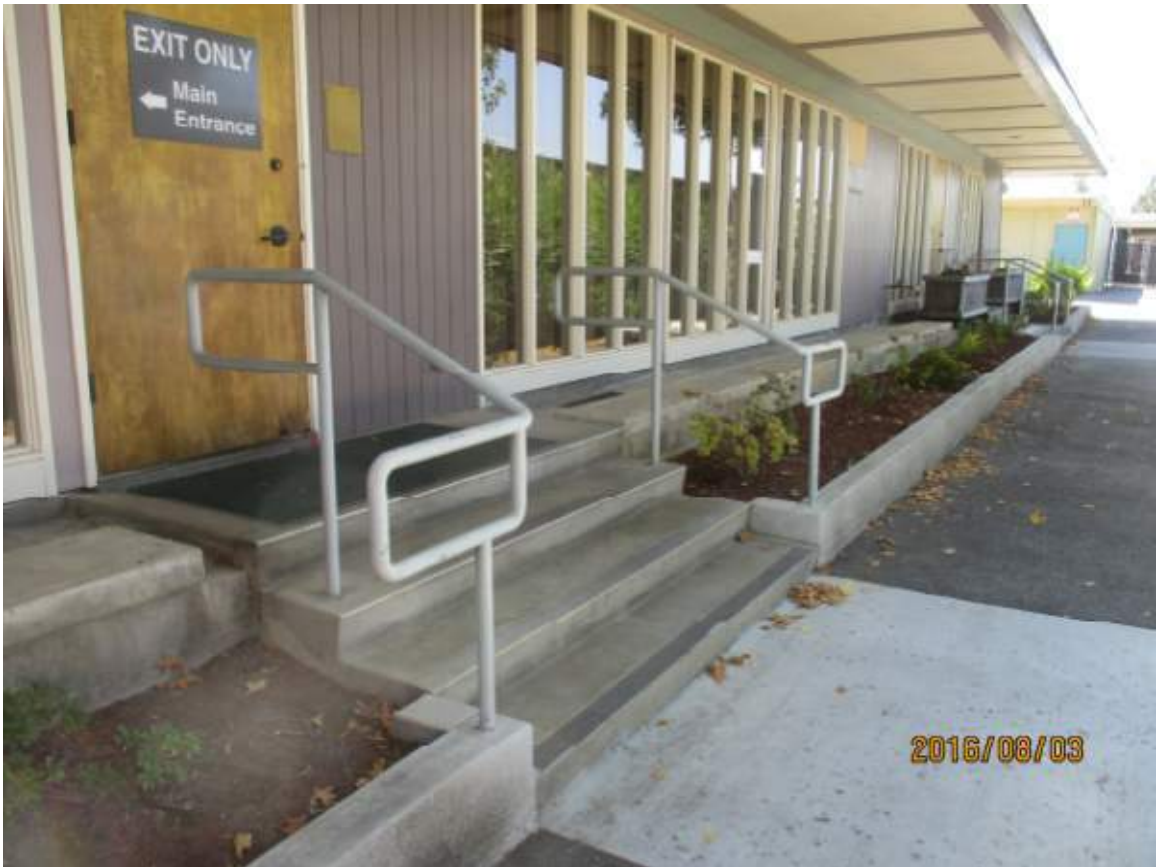
⑧

**MOUNTAIN VIEW HIGH SCHOOL**  
NON-COMPLIANT EXIT

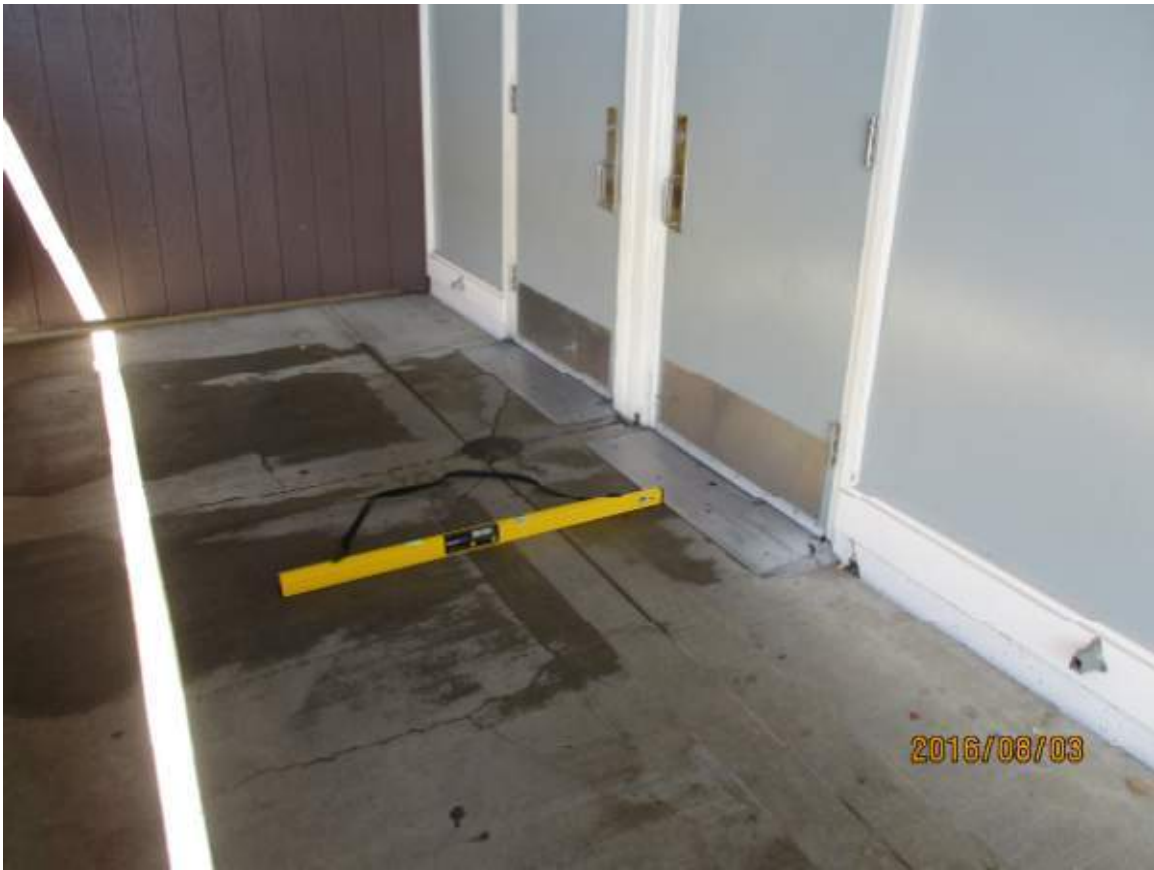
⑨

**MOUNTAIN VIEW HIGH SCHOOL**  
NON-COMPLIANT THRESHOLD AND LANDING

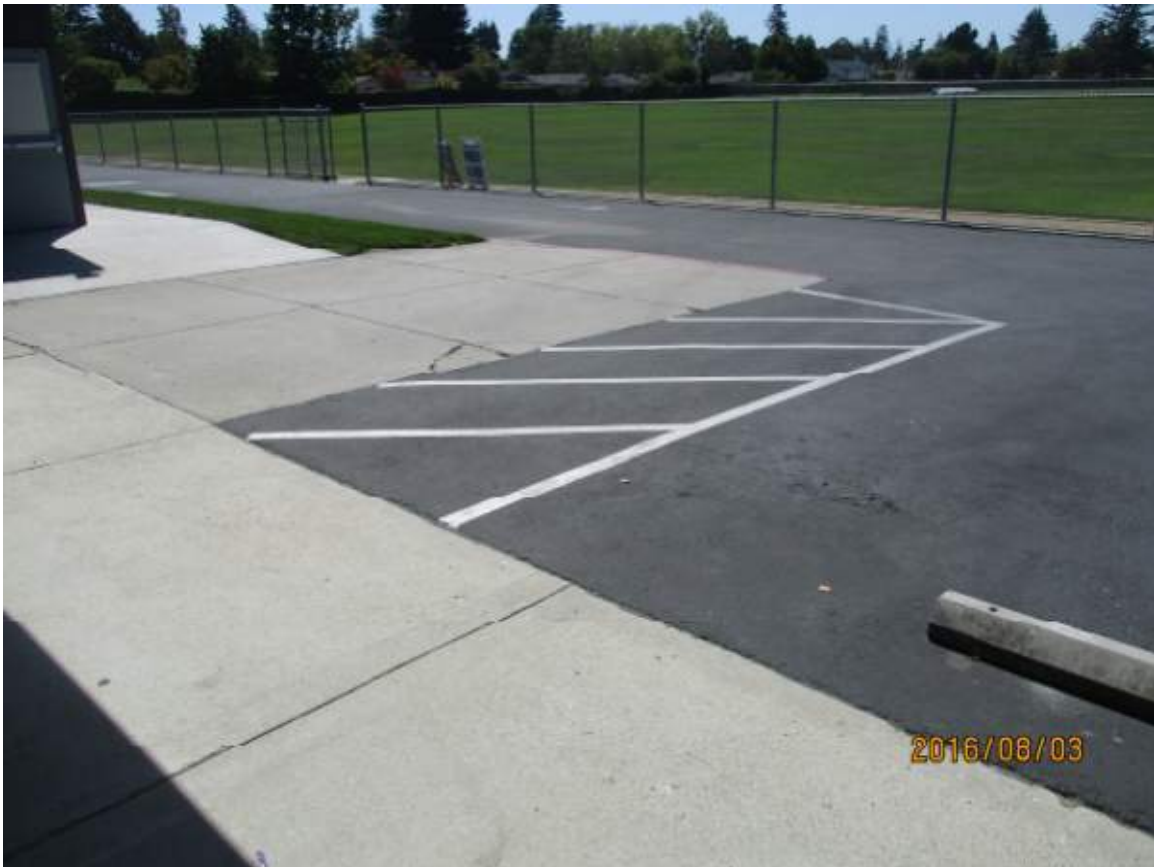
⑩

**MOUNTAIN VIEW HIGH SCHOOL**  
TRUNCATED DOMES REQUIRED AT WALKOUTS

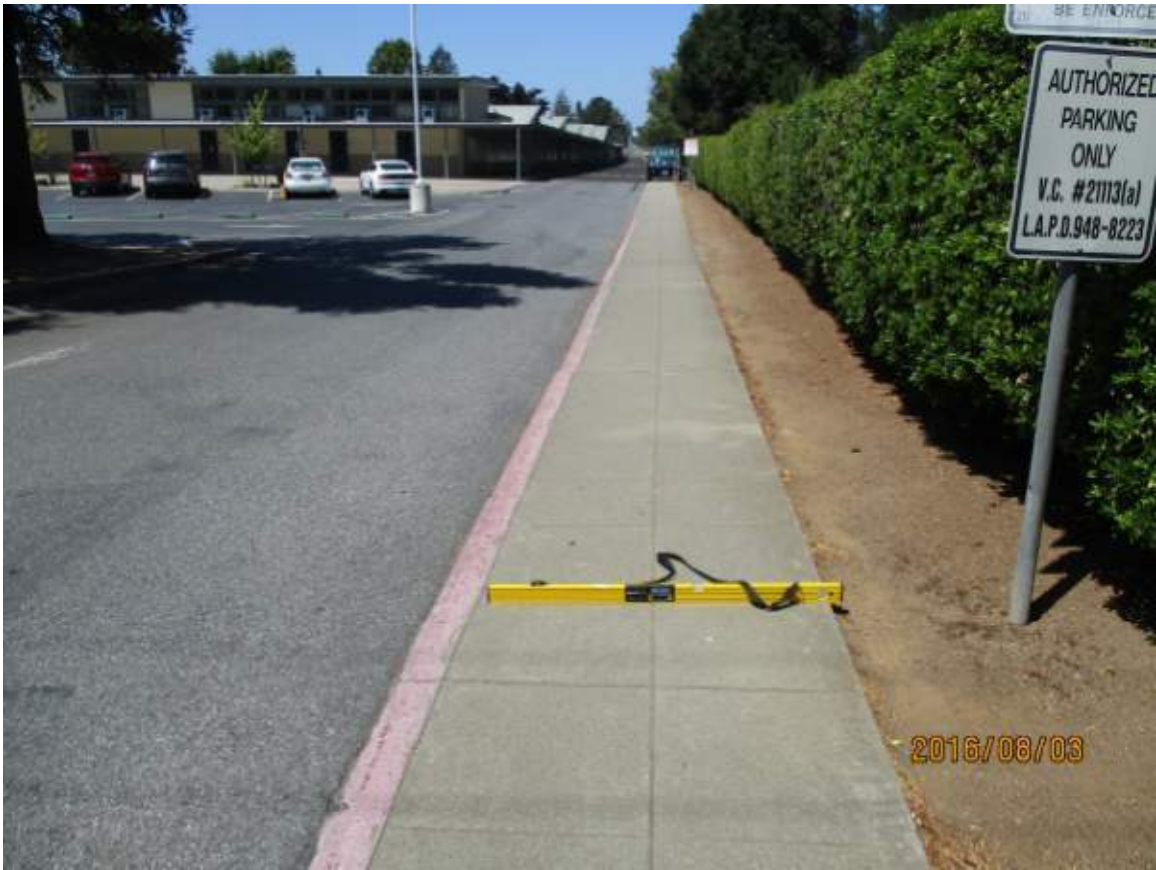
①

**LOS ALTOS HIGH SCHOOL**  
CROSS SLOPE GREATER THAN 2%

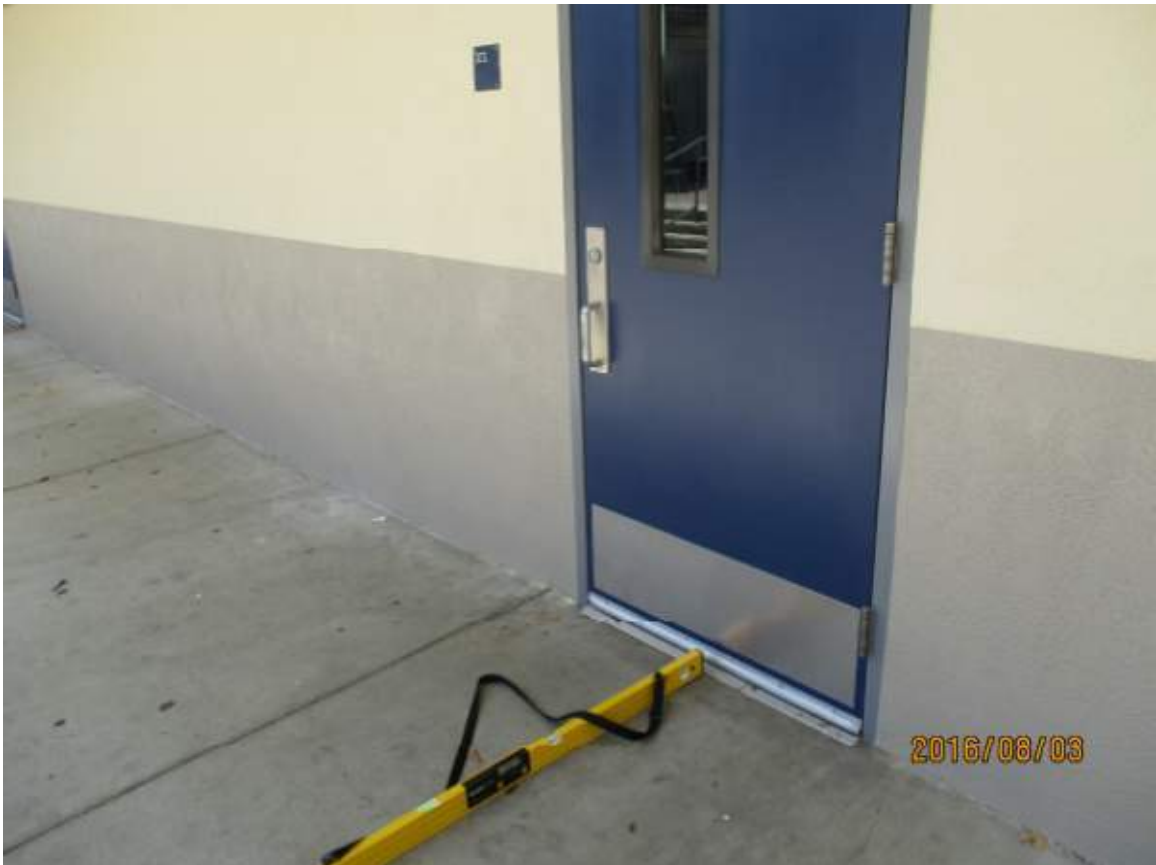
②

**LOS ALTOS HIGH SCHOOL**  
LANDINGS WITH SLOPES GREATER THAN 2%

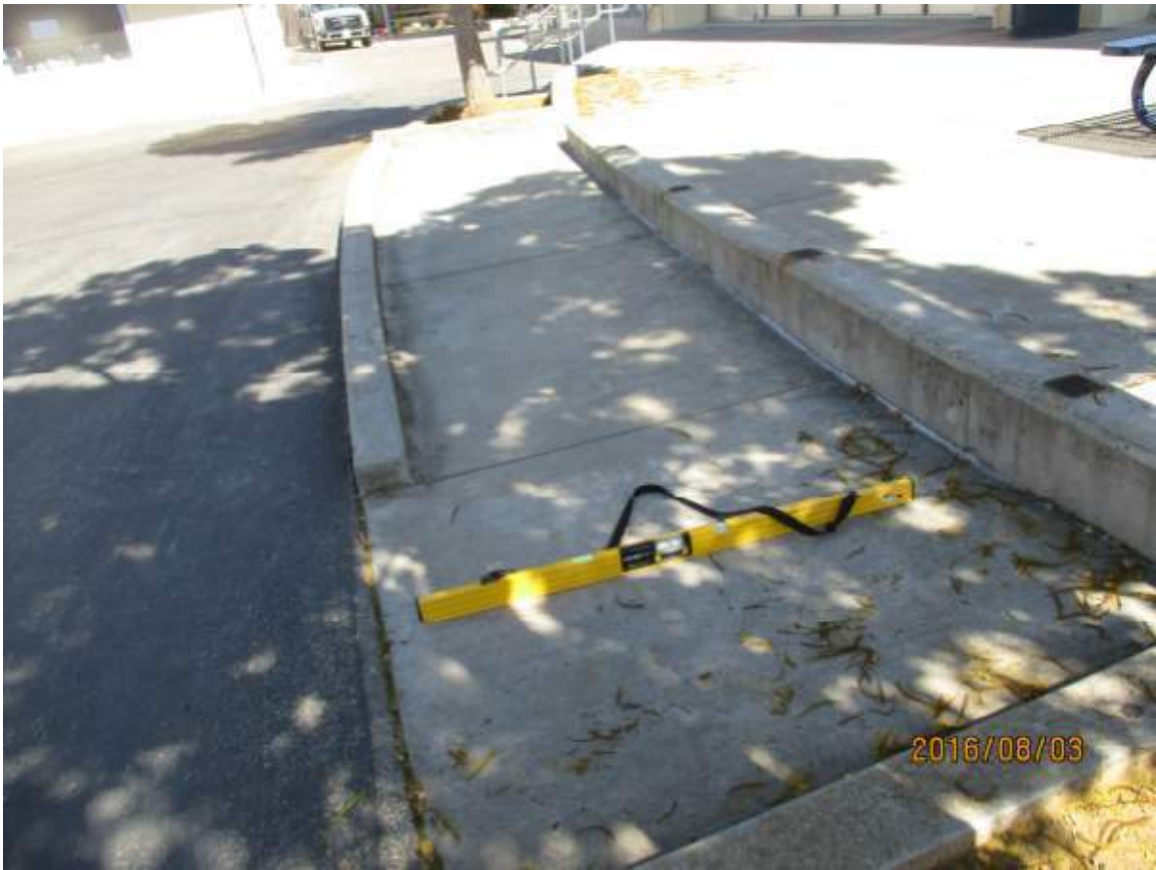
③

LOS ALTOS HIGH SCHOOL  
NON COMPLIANT LANDING

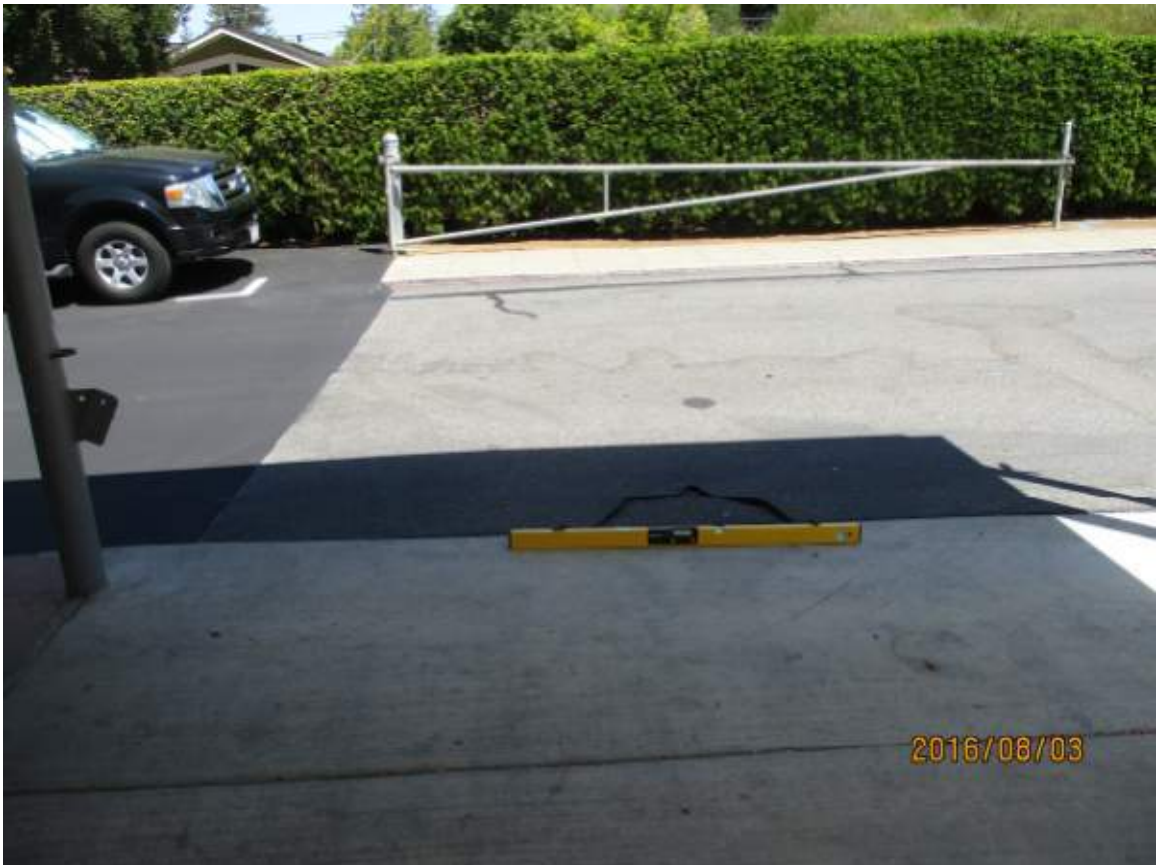
④

LOS ALTOS HIGH SCHOOL  
NON COMPLIANT WALKOUT AT PATH OF TRAVEL

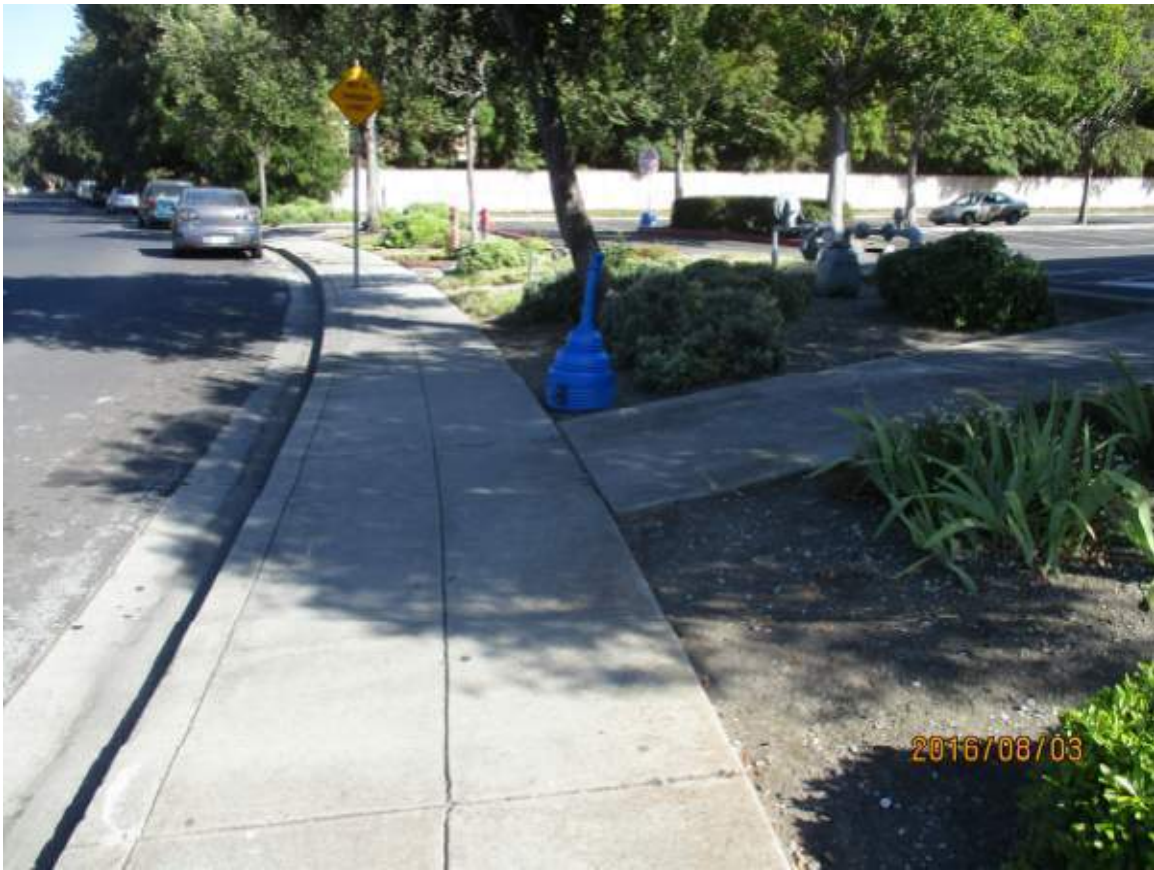
①

**MOUNTAIN VIEW ADULT EDUCATION CENTER**  
NON-COMPLIANT RAMP TO PUBLIC RIGHT OF WAY

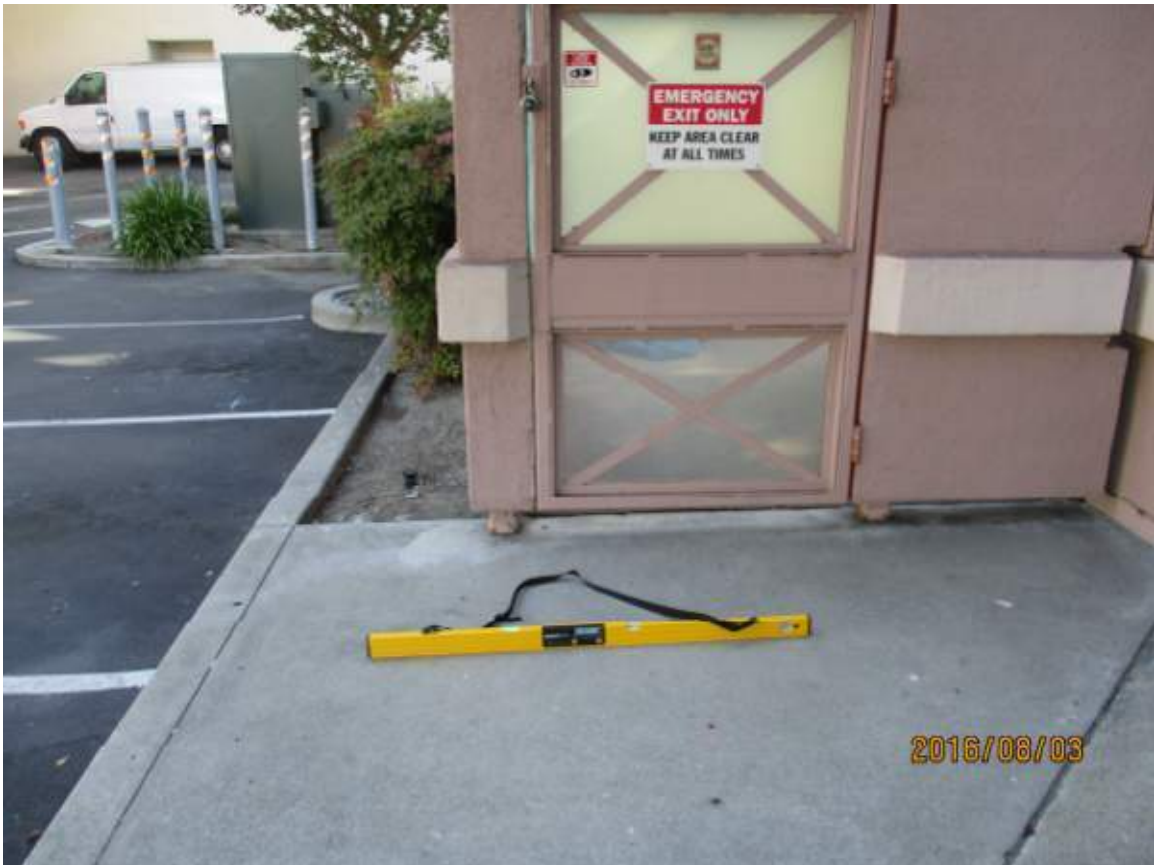
②

**MOUNTAIN VIEW ADULT EDUCATION CENTER**  
WALKWAY WITH EXCESSIVE CROSS SLOPE

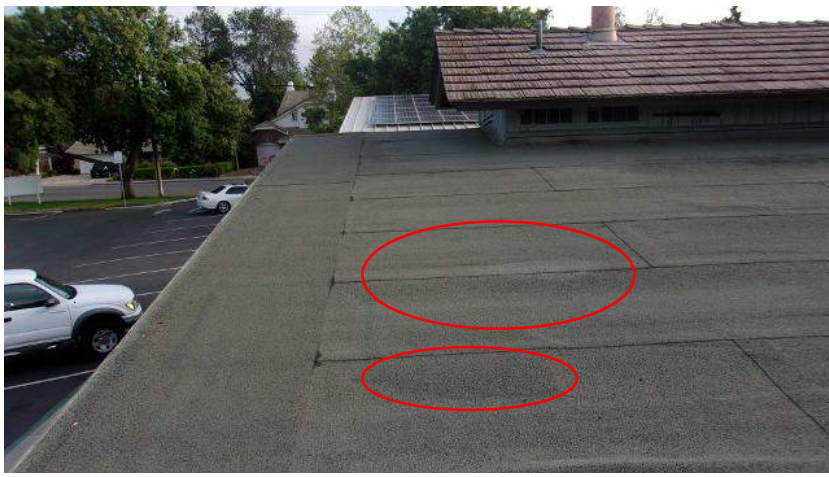
**Photo 3**

100 Wing  
Roof has a fair number of blisters.  
Low slope roof does not comply  
with current Title 24.

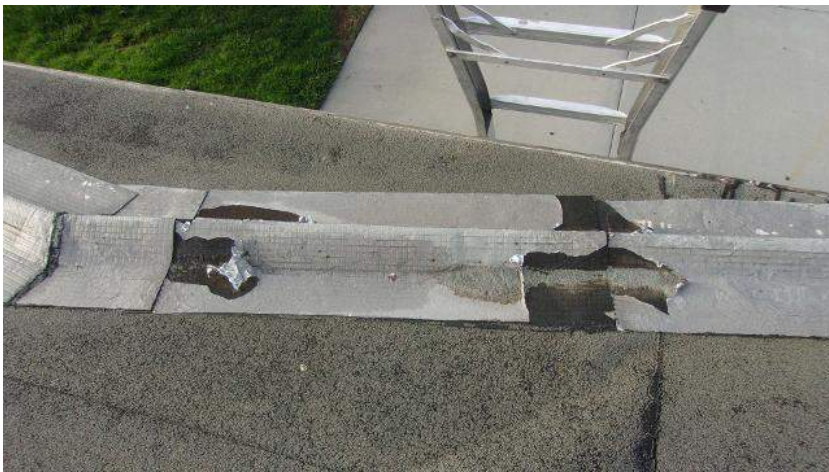
**Photo 5**

Worn flashing materials are present.  
Corrections are recommended.

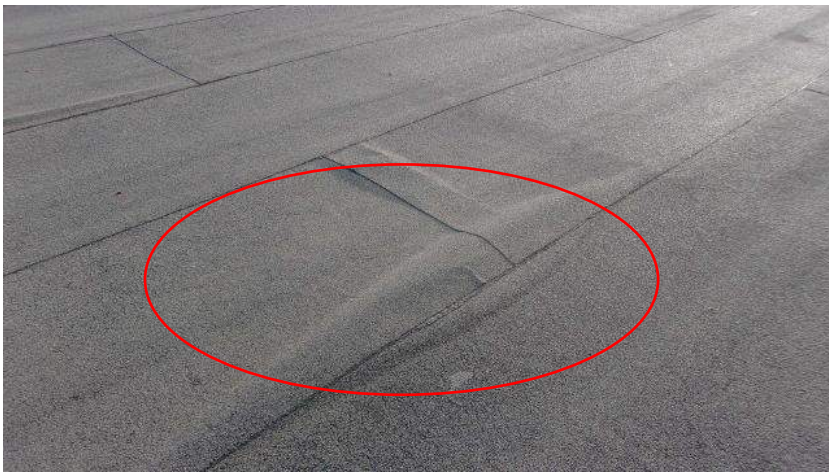
**Photo 8**

Large field blisters

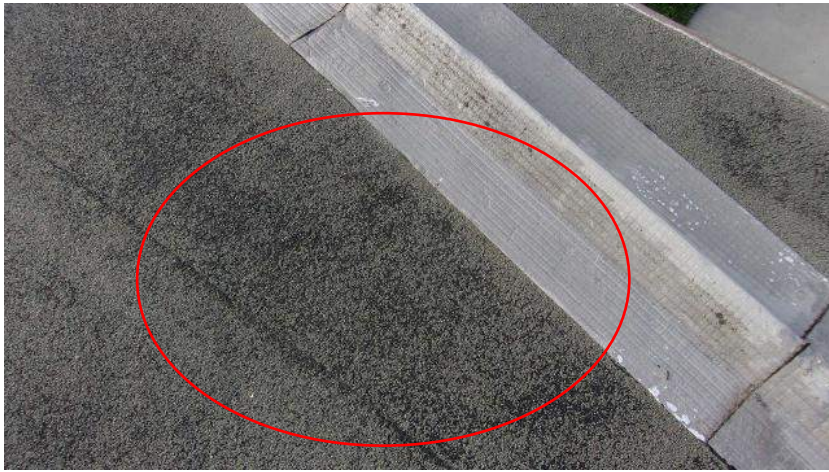
**Photo 10**

Granular erosion noted at the cap sheet (Multiple locations). Roof restoration/replacement is recommended.

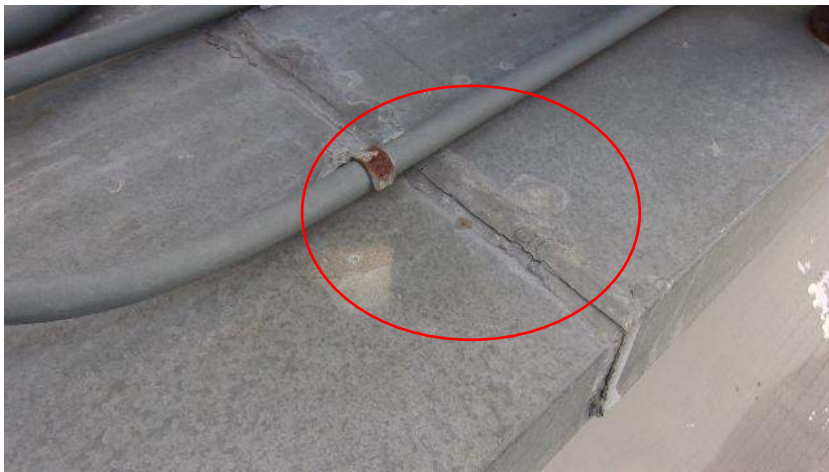
**Photo 11**

Cracked solder joints noted at the sheet metal curb caps. Corrections are recommended.

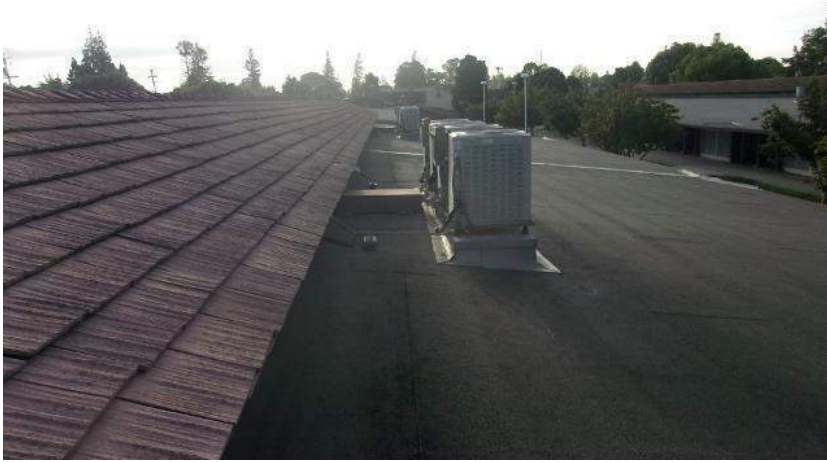
**Photo 12**

Recommend sealing the storm collar/vent pipe connections at the shingle roof area.

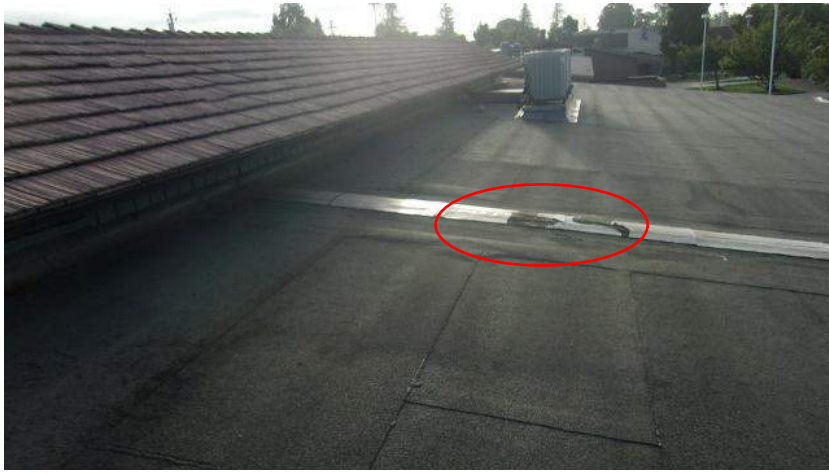
**Photo 14**

If additional insulation is added to the roof assembly the siding will need to be replaced to accomodate the new flashing height.

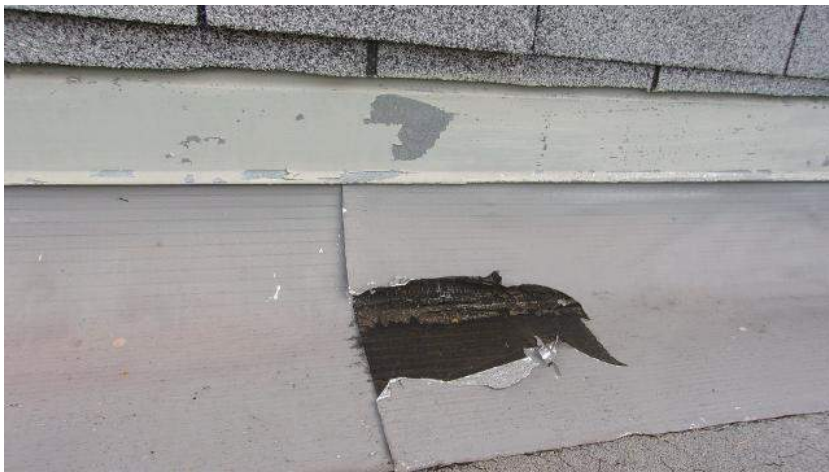
**Photo 34**

Torn/worn flashing's are present.  
Corrections are recommended.

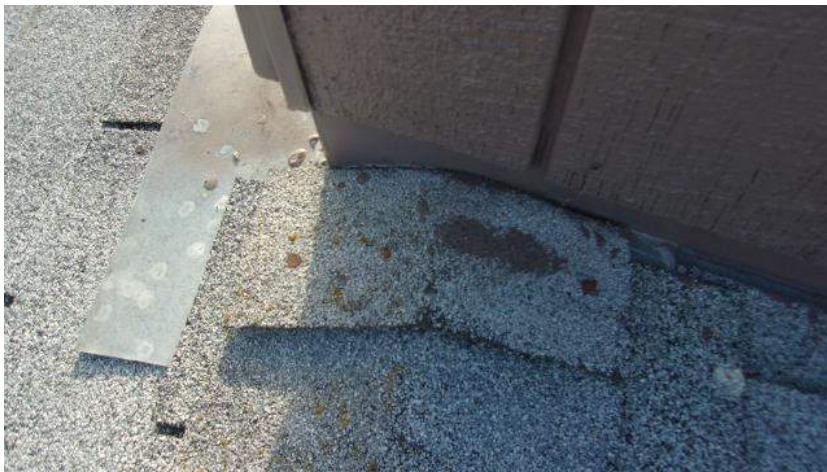
**Photo 40**

Shingle cupping/roof deck deflection noted at the composition shingle roof area.

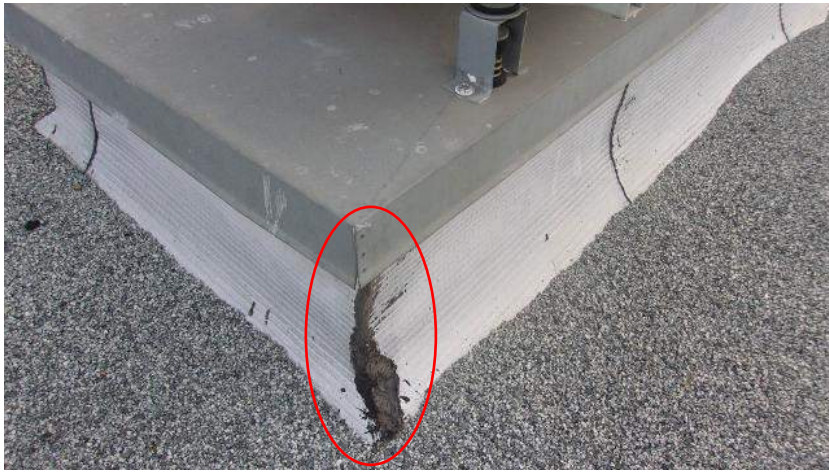
**Photo 81**

Wear/weathering noted at the gravel roof edges.

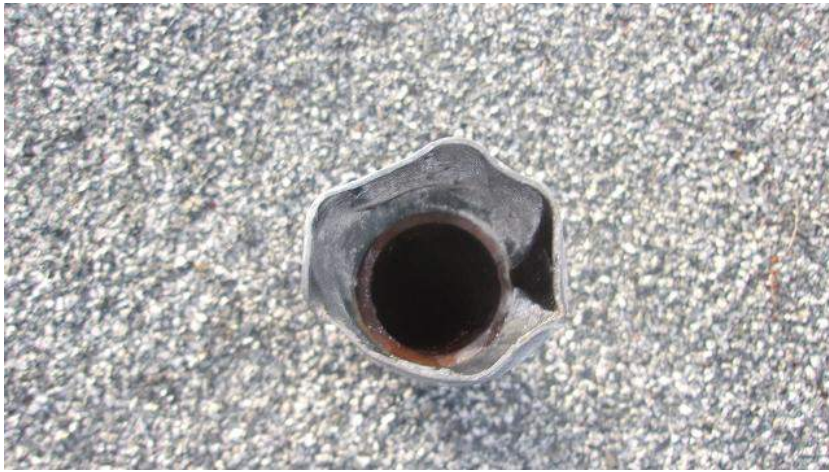
**Photo 87**

Unsealed roof jacks are present. Corrections are recommended.

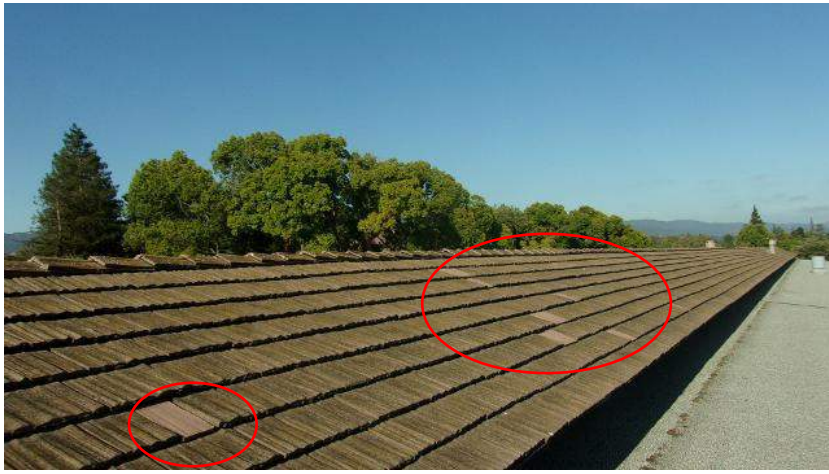
**Photo 122**

Overall building the building 300 roof was found to be in fair condition.

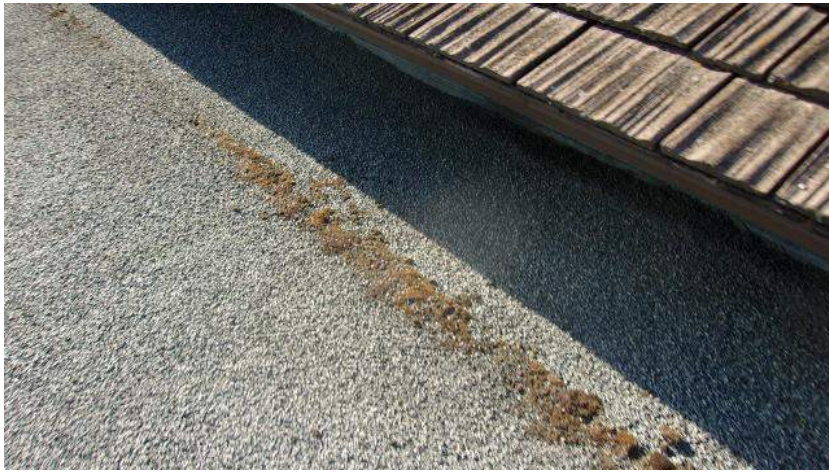
**Photo 132**

Damaged shingles noted. Corrections are recommended.

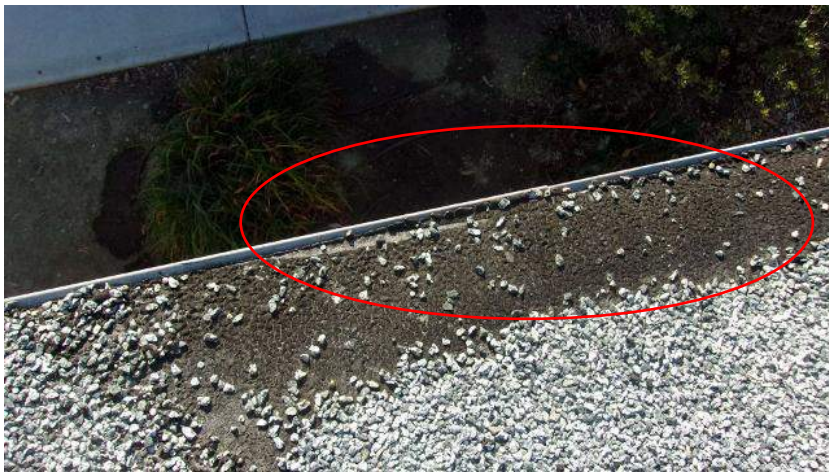
**Photo 163**

Wear/weathering/exposed roofing plies noted at the roof edges. Repair/replace is recommended.

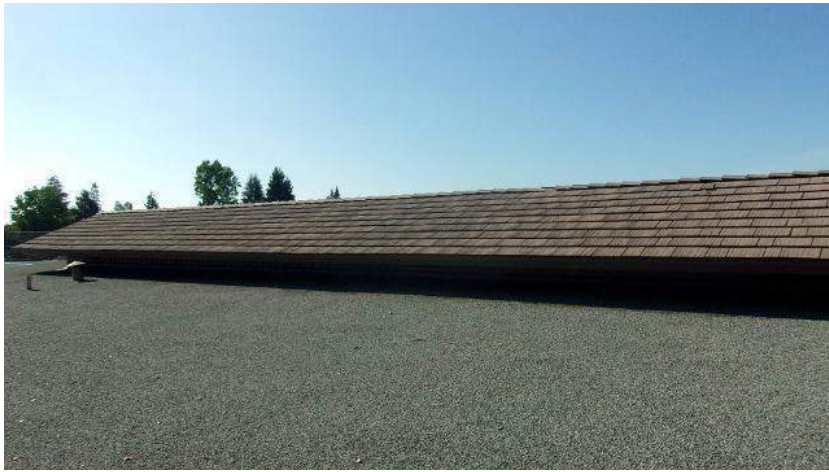
**Photo 213**

500 Wing

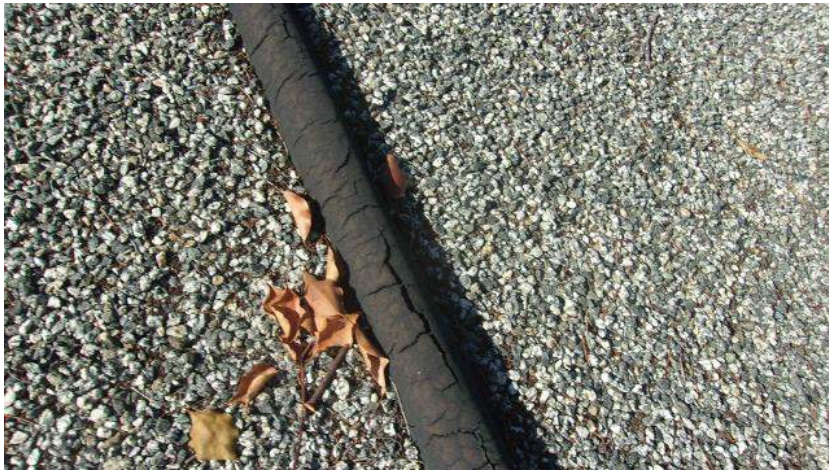
**Photo 214**

Overall the building 500 roof was found to be in fair condition.

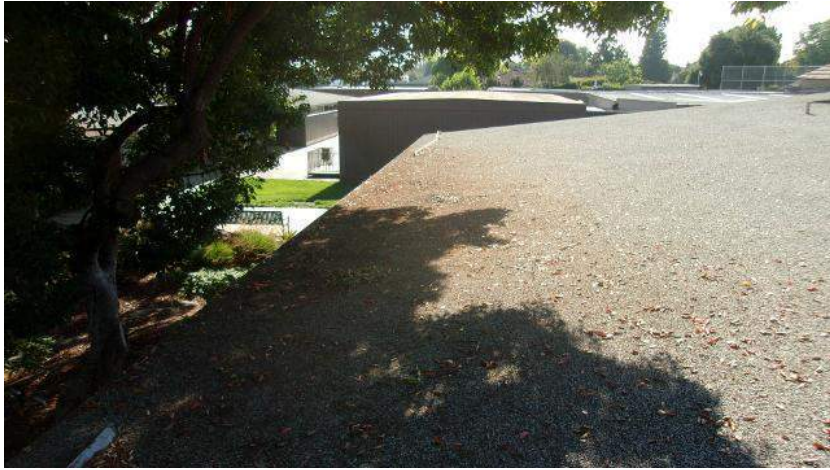
**Photo 223**

Building 500 general roof photos

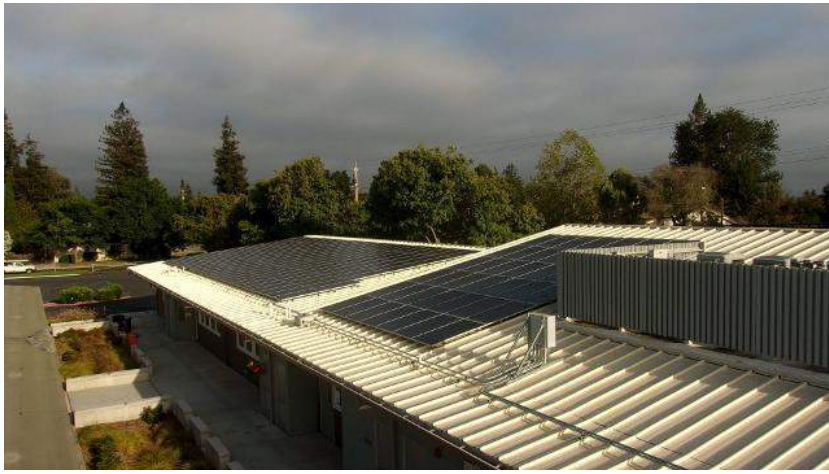
**Photo 261**

600 Wing  
Garland R-mer Span metal roof

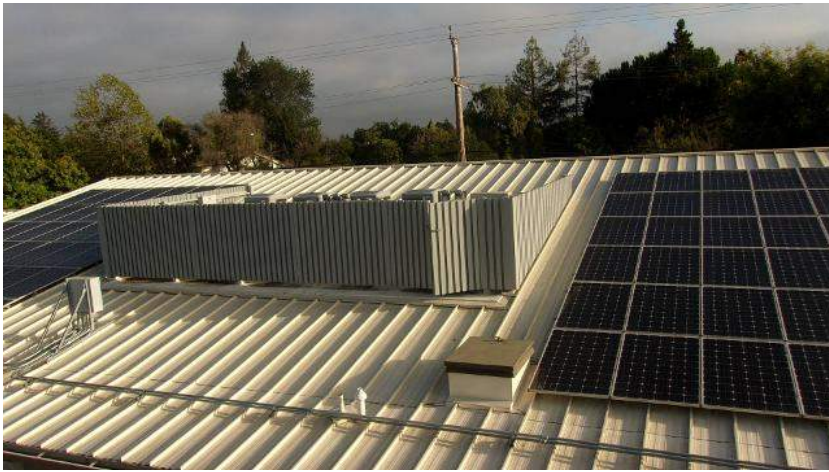
**Photo 262**

Building 600 was found to be in good condition.

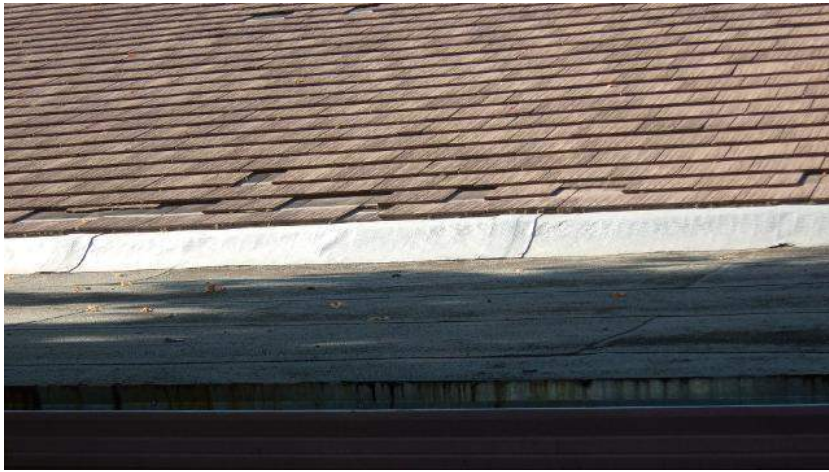
**Photo 325**

Several damaged/missing roof shingles are present. Corrections are recommended.

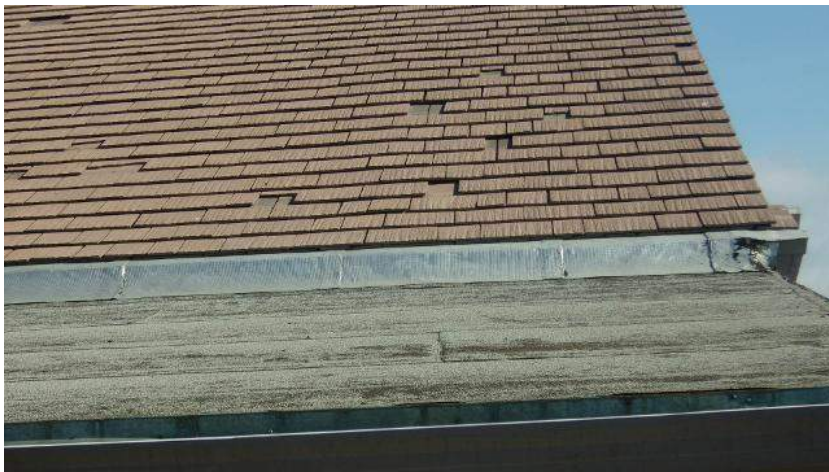
**Photo 329**

Granular erosion noted at the mineral cap sheet (Gym/Covered Walkway). Roof restoration/replacement is recommended.

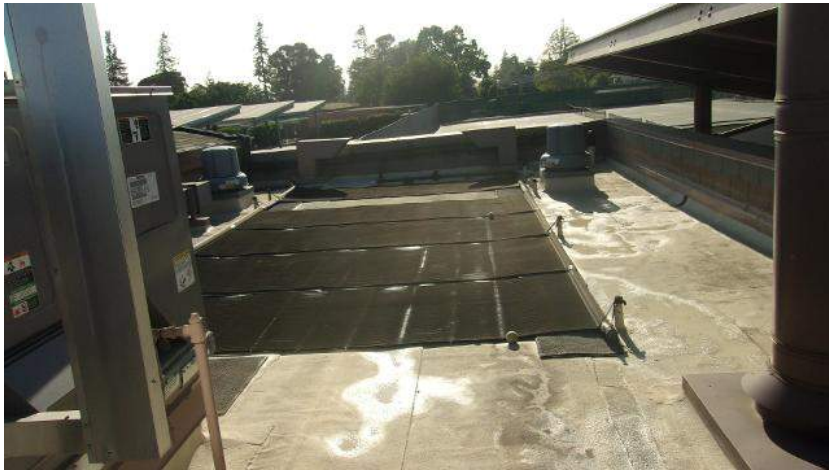
**Photo 333**

Weight Room/Pool Equipment Roof

Roofs were replaced with Garland roofing materials in 2013.

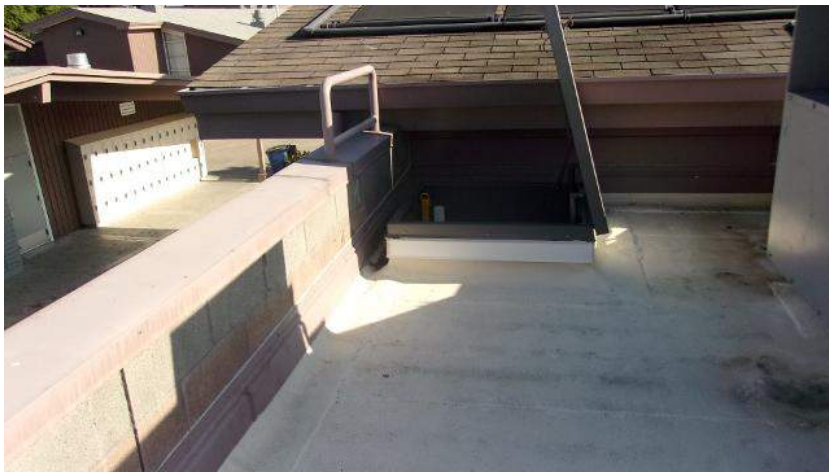
**Photo 338**

Roof shingles (where visible) appear to be in good condition.

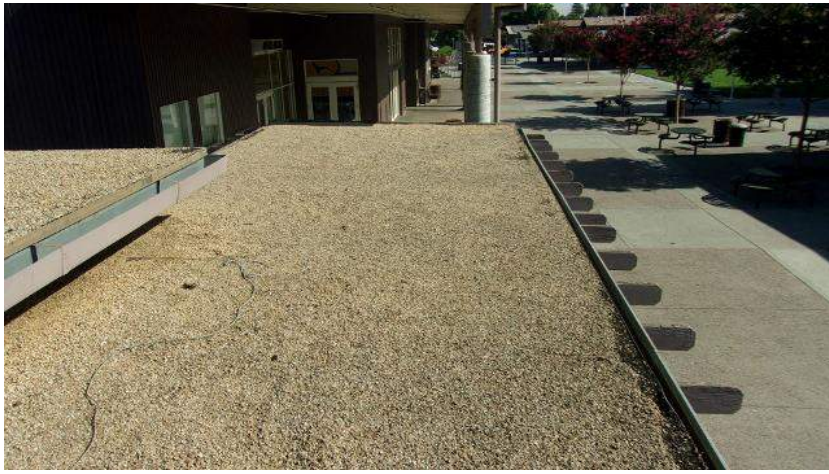
**Photo 351**

Rof is failing and needs to be replaced
