## **Civil/Site Assessment & Recommendations**

### **Mountain View Los Altos High School District**

**Brelje & Race Consulting Engineers**

### **Campus Assessments**

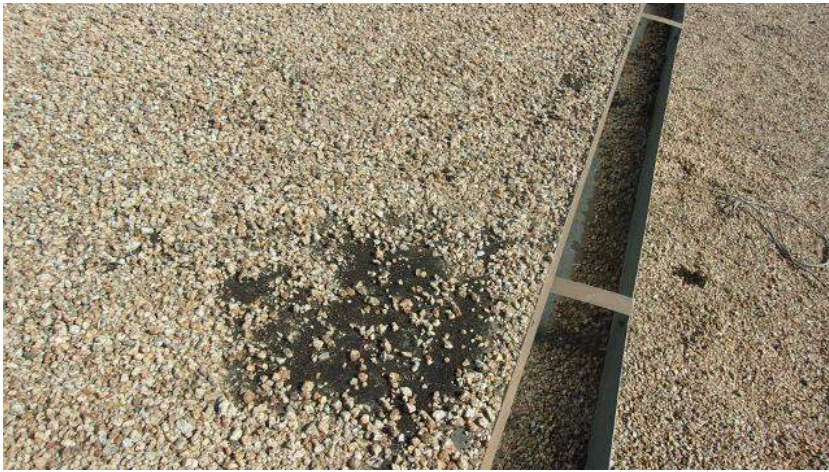
**Photo 352**

Multiple bare spots are present at the gravel roof area. Exposed plies show signs of heavy wear. Roof replacement is recommended.

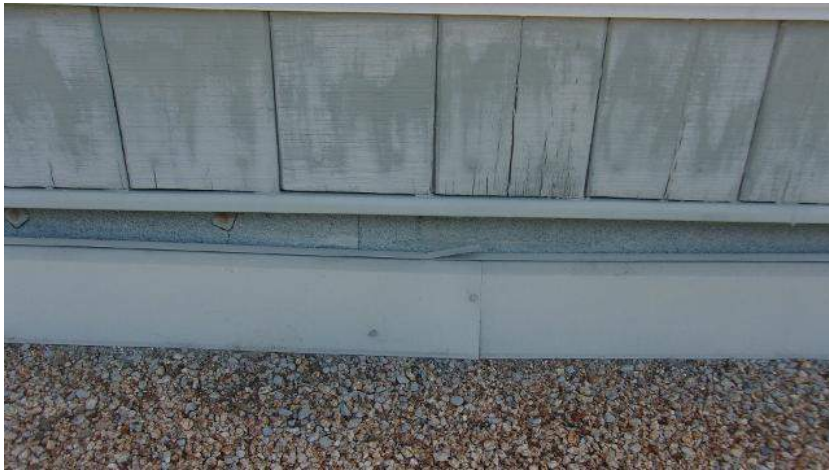
**Photo 357**

Loose counter flashing is present.  
Corrections are recommended.

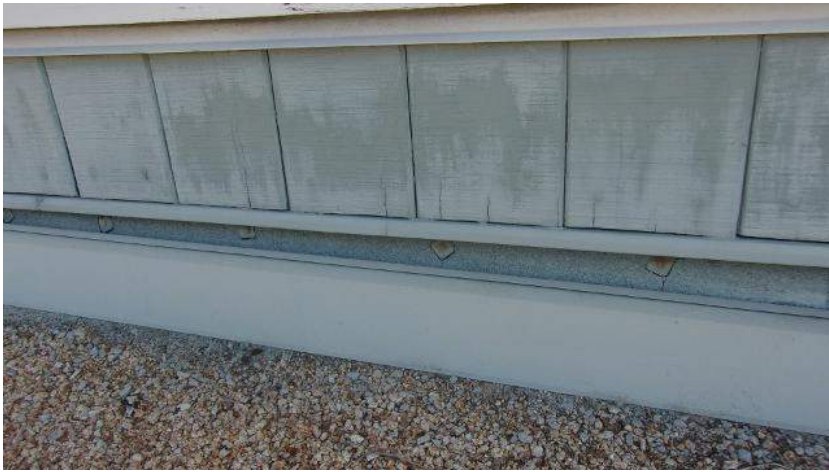
**Photo 358**

Exposed fasteners behind counter flashing  
should be sealed with mastic.

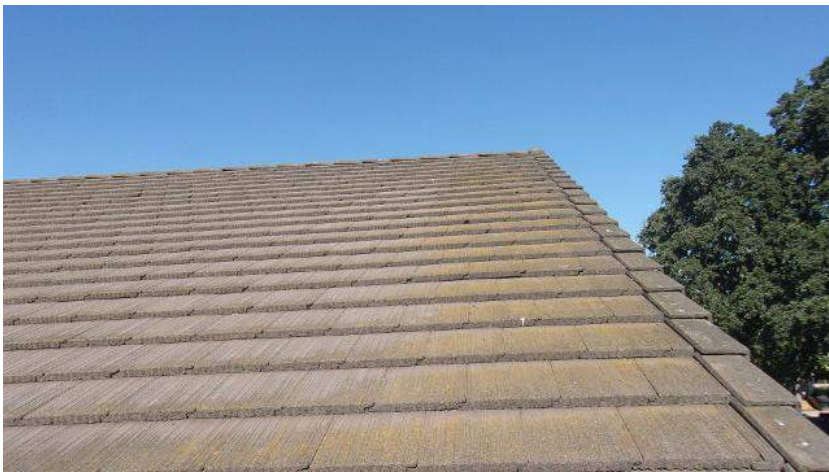
**Photo 359**

Concrete tile roof appears to be  
in fair condition.

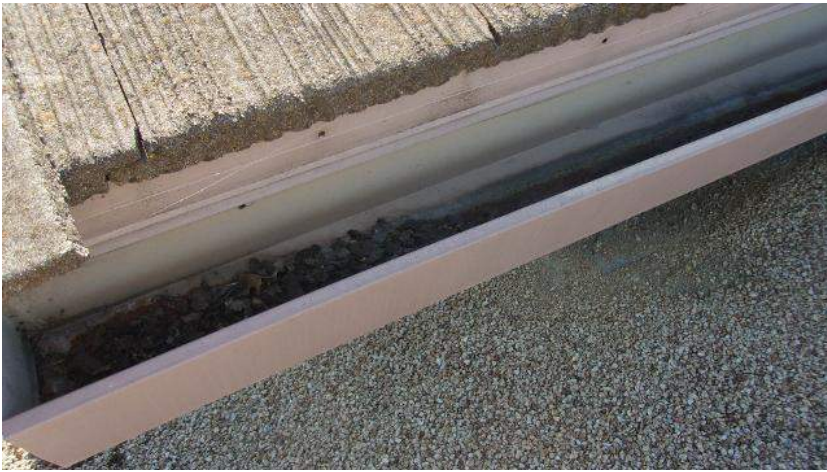
**Photo 361**

Debris should be removed from face mounted gutters.

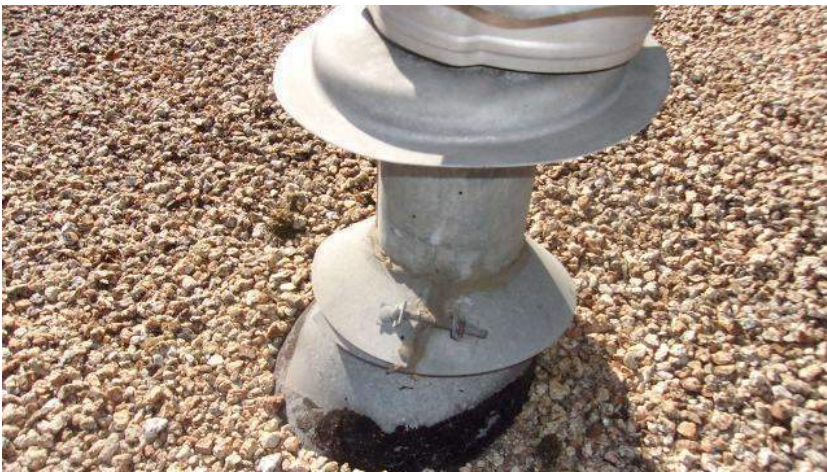
**Photo 362**

Storm collar/vent pipe connections should be re-sealed.

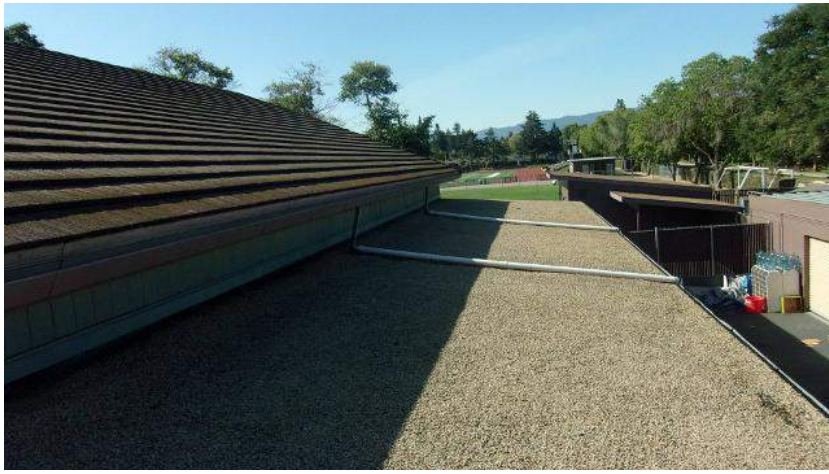
**Photo 372**

Downspouts need to be extended to gutters when roof is replaced.

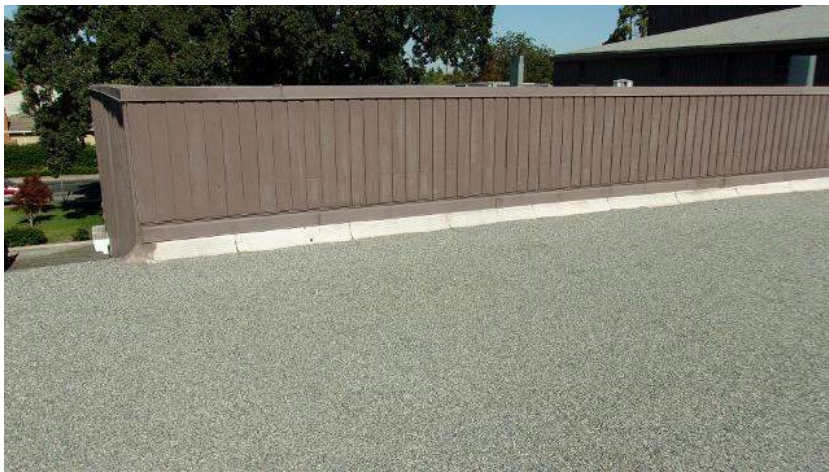
**Photo 386**

Overall, the roof system was found to be in good condition.

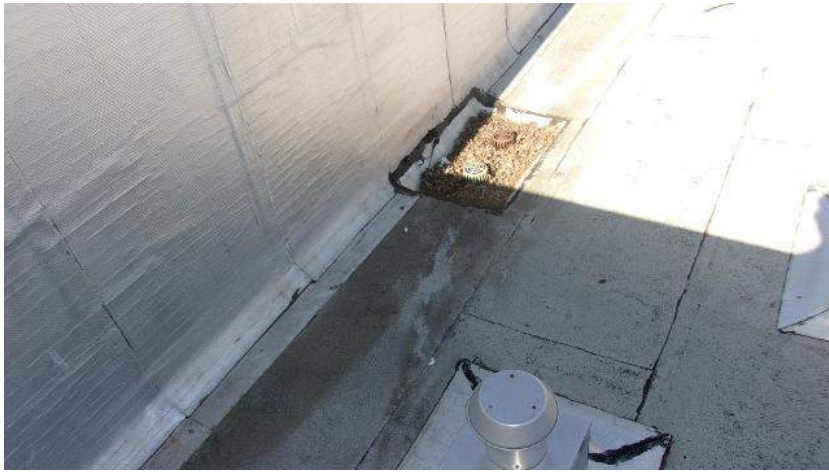
**Photo 388**

Recommend clearing debris from roof drains.

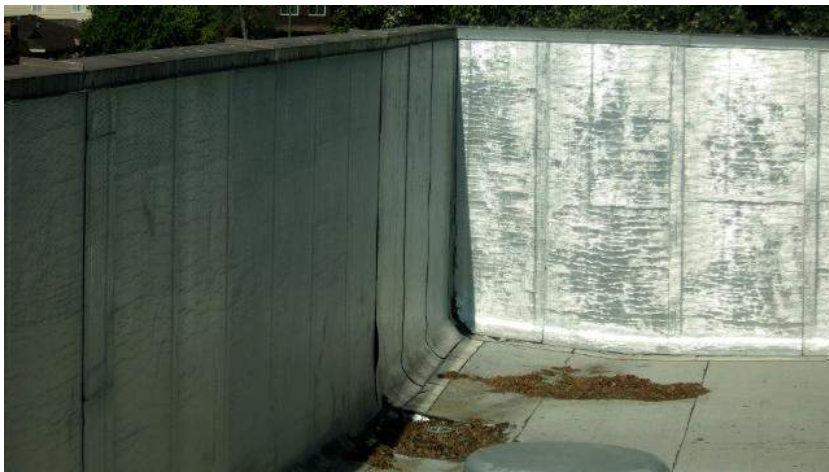
**Photo 389**

Recommend clearing tree debris from flat roof areas.

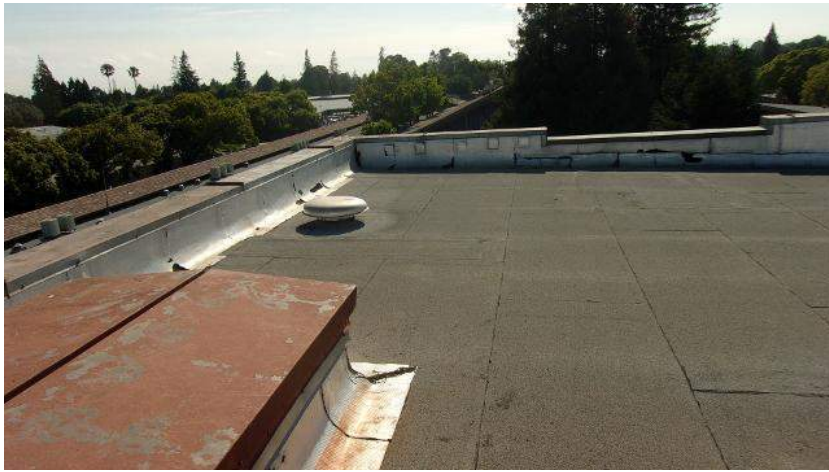
**Photo 394**

Upper cap sheet roof  
Typical wear noted. Roof coating is recommended.

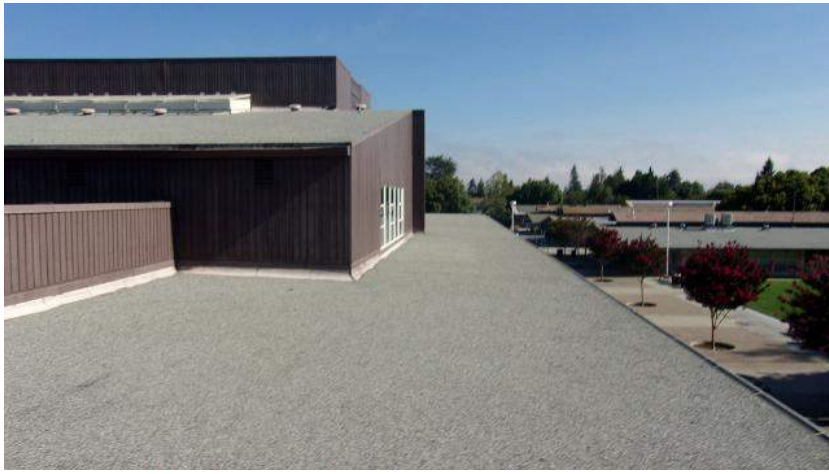
**Photo 399**

General roof photos

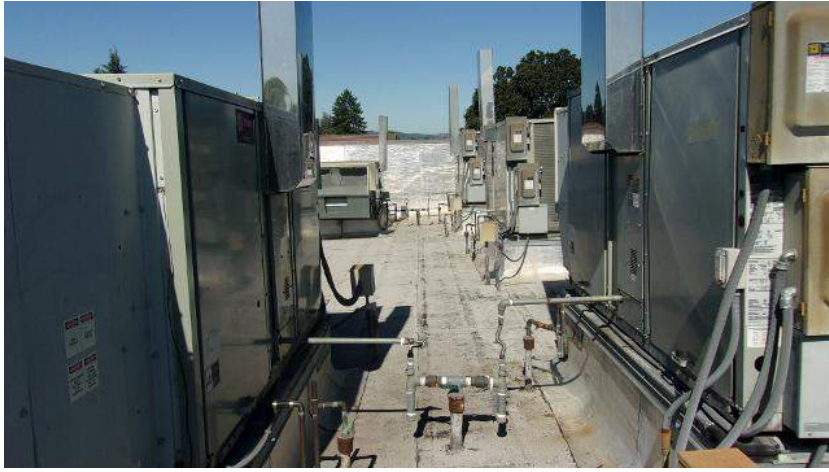
**Photo 443**

Library

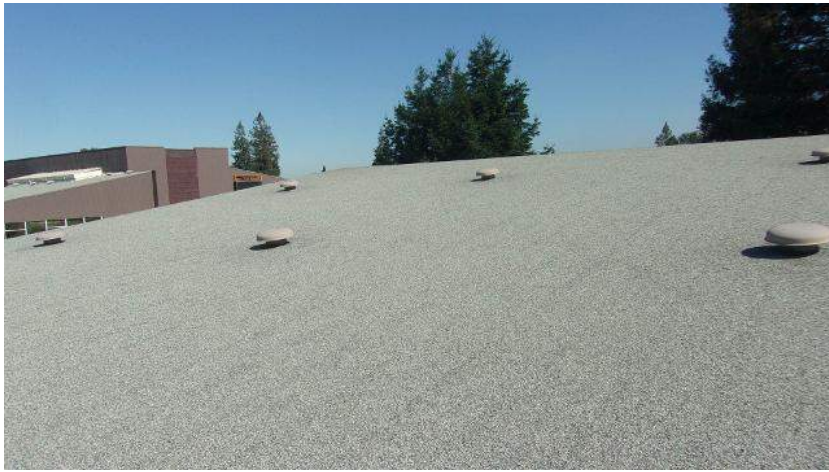
**Photo 444**

Overall, the library roof system was found to be in good condition.

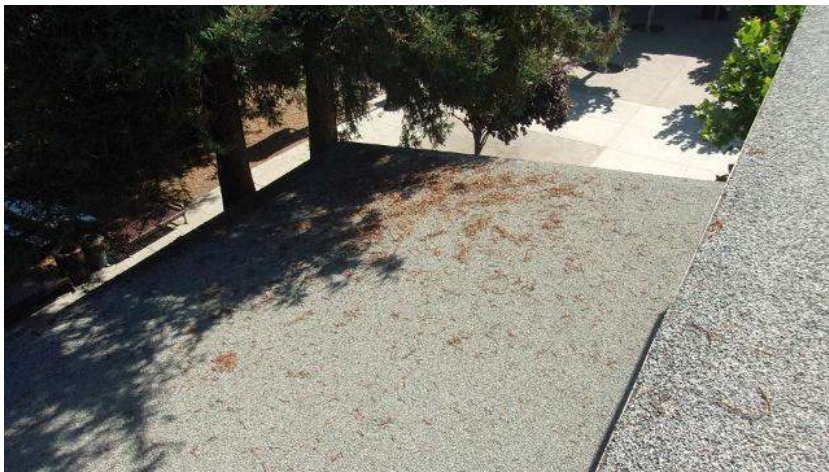
**Photo 448**

Granular erosion noted at the mineral cap sheet roof. Roof coating/restoration is recommended.

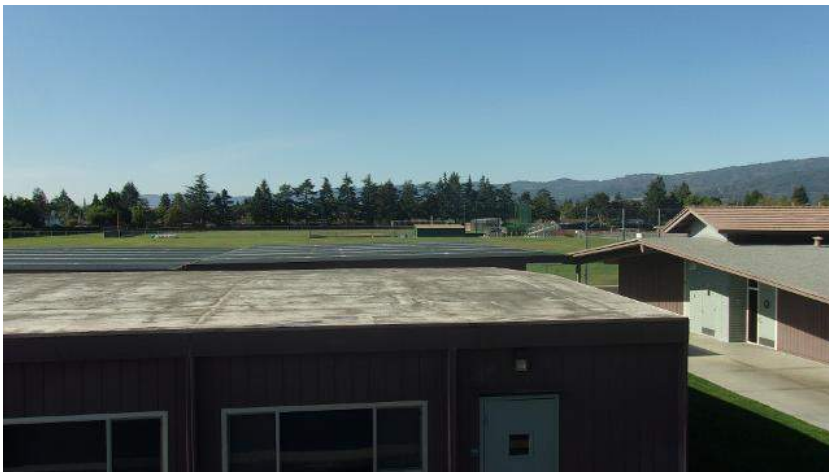
**Photo 497**

Portables

These need to be replaced but I assumed the portable building was being replaced in it's entirety.

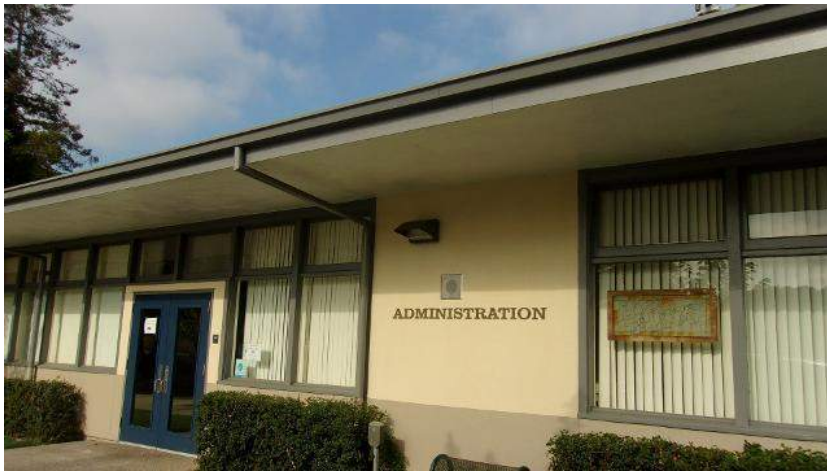
**Photo 1**

Administration Office

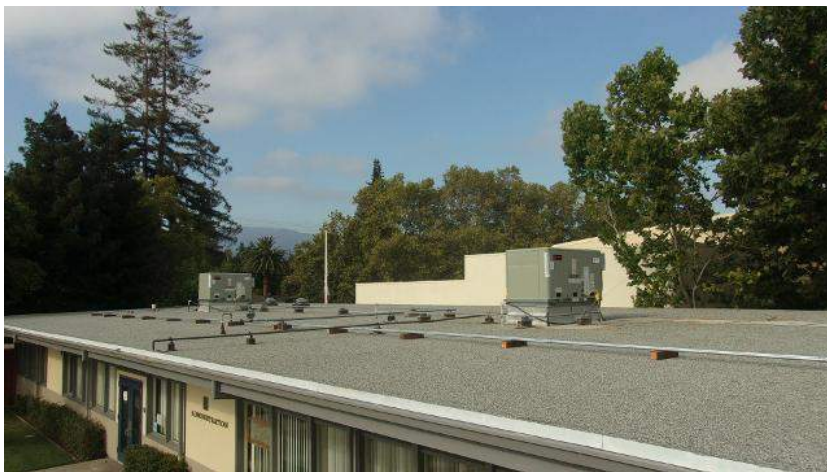
**Photo 2**

Overall the administration office roof is in fair condition.

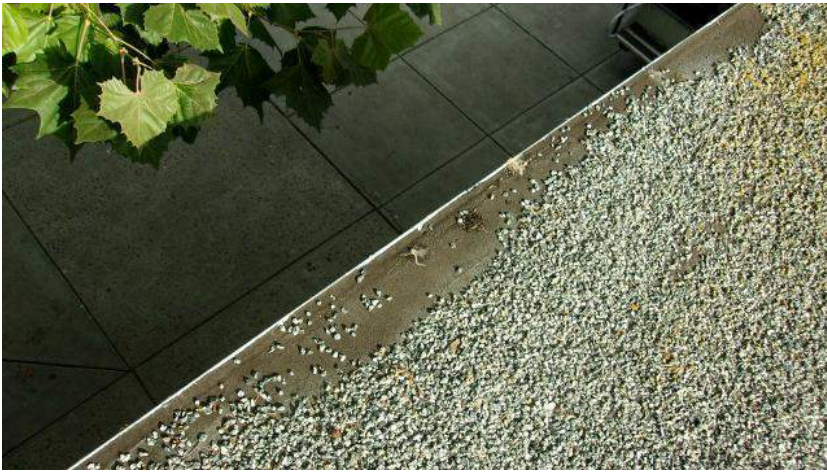
**Photo 4**

Wear/bare spots noted at the roof edges. Maintenance repairs are recommended.

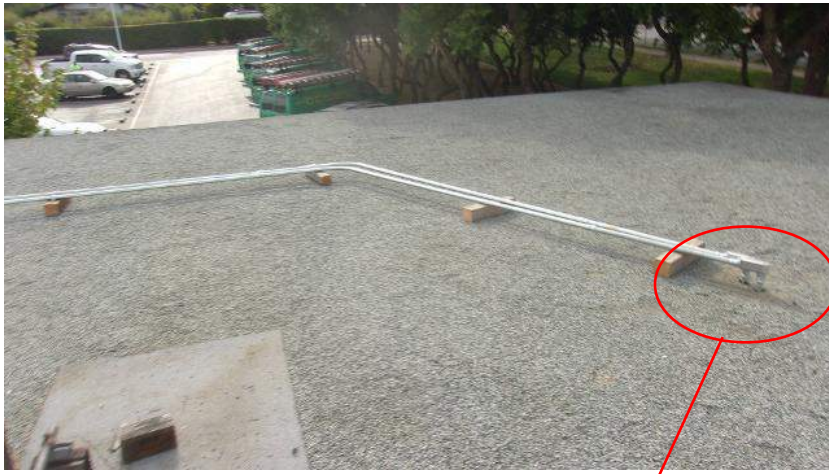
**Photo 6**

Support pads should be installed under the conduit support blocks.

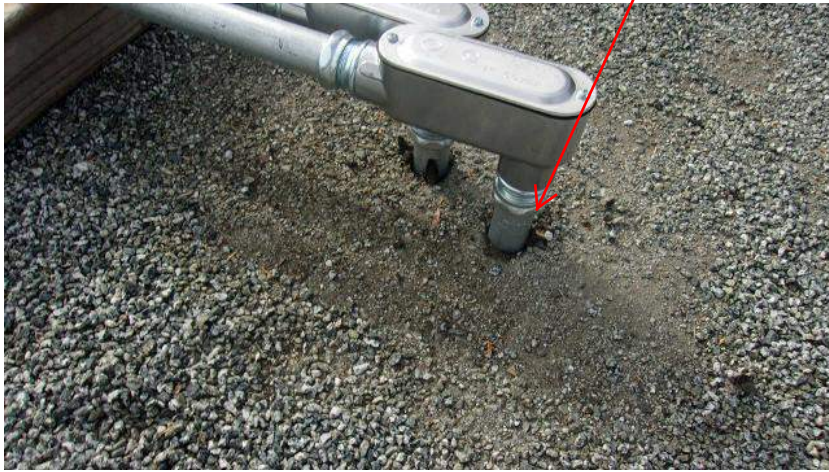
**Photo 7**

A proper flashing is not installed under the conduit penetration. Corrections are needed.

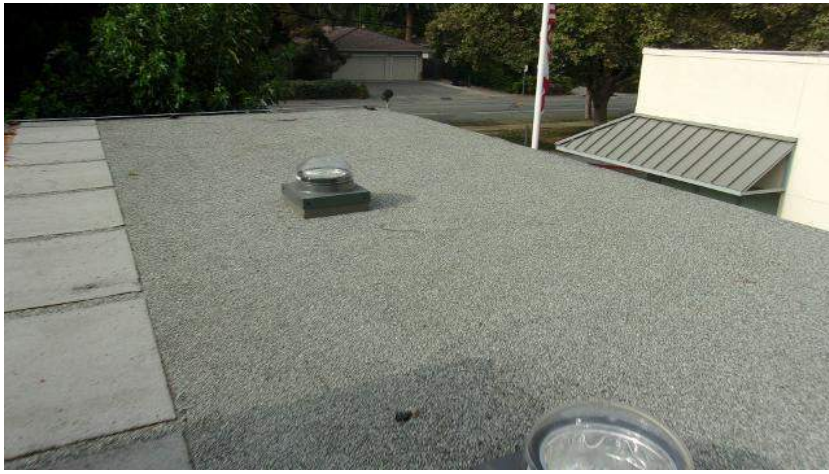
**Photo 9**

Curb mounted Solar Tubes have been installed. Solar Tubes will be reusable when roof is replaced.

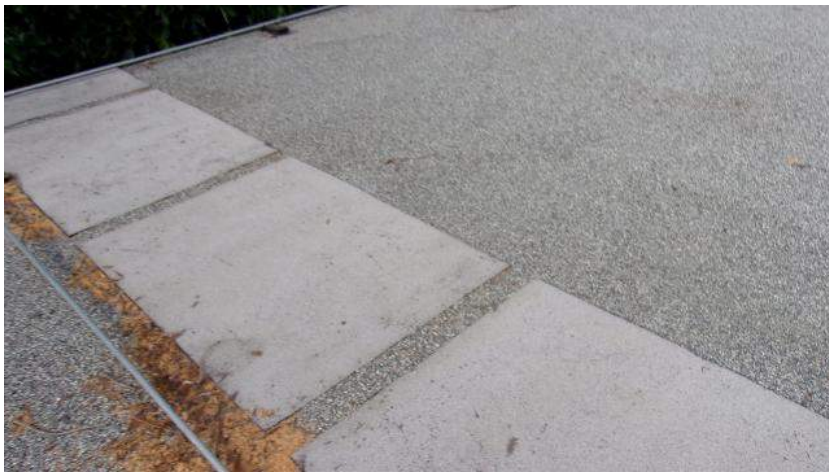
**Photo 11**

Walkway pads installed on most roof sections.

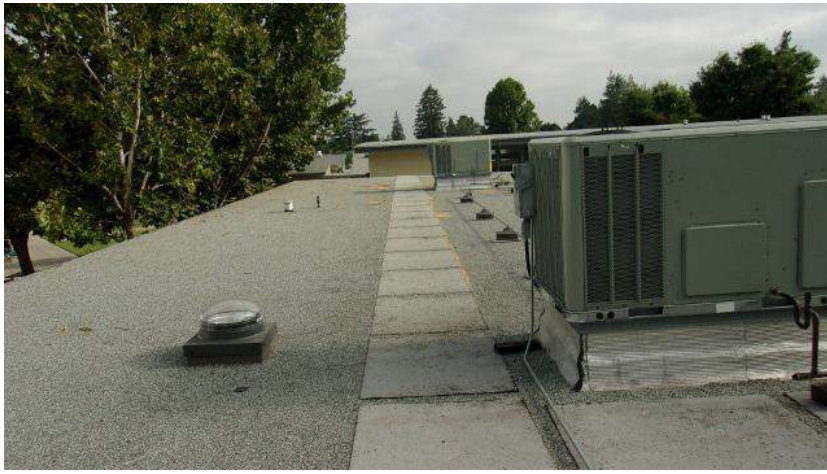
**Photo 12**

HVAC curbs installed at proper height but not leveled.

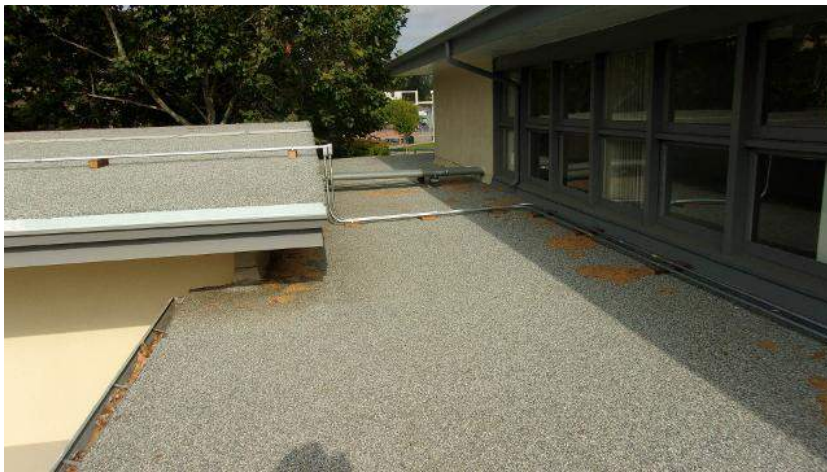
**Photo 14**

The front covered walkway at the attendance office is in fair condition.

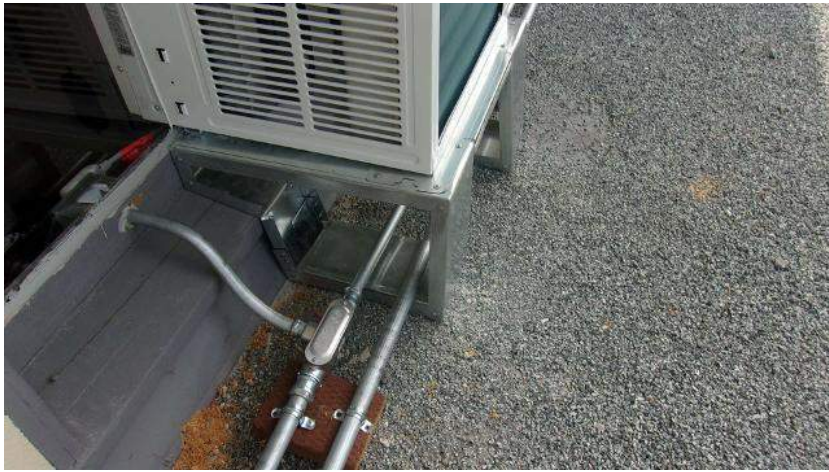
**Photo 16**

Verify supports for window mounted AC are DSA approved or need to be replaced. These are new.

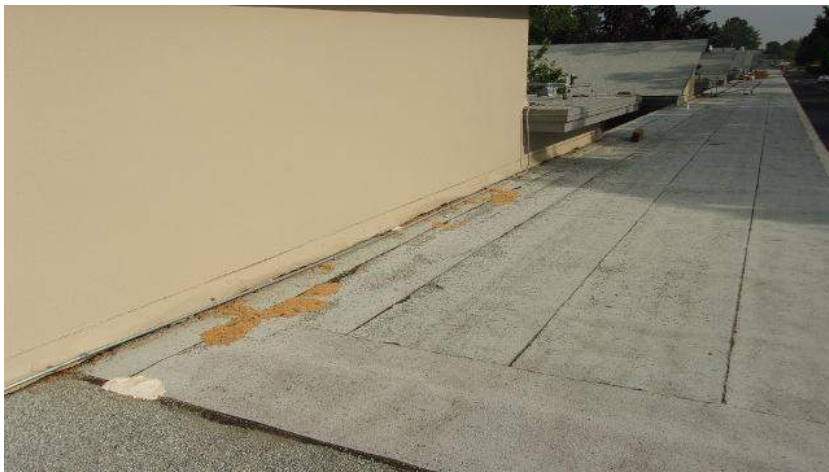
**Photo 20**

Granular erosion noted at the east side covered walkway. Roof coating or restoration is recommended. Roof should be coated.

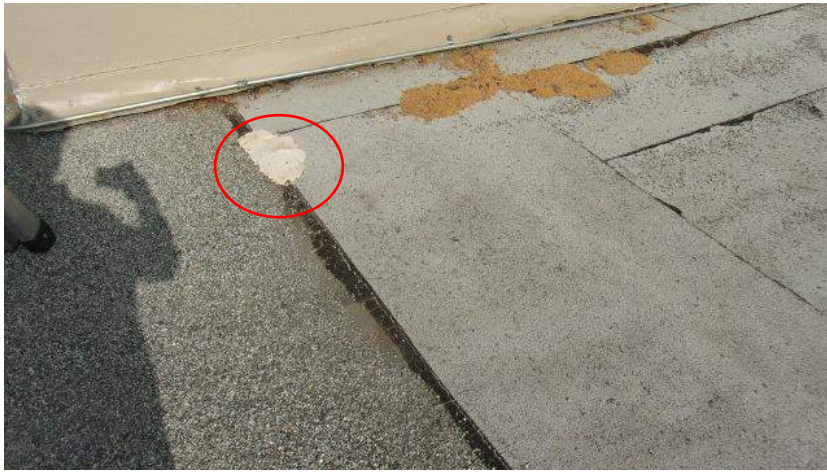
**Photo 21**

Tie in between older gravel roof and new cap sheet roof has leaked. Gravel roof to be replaced.

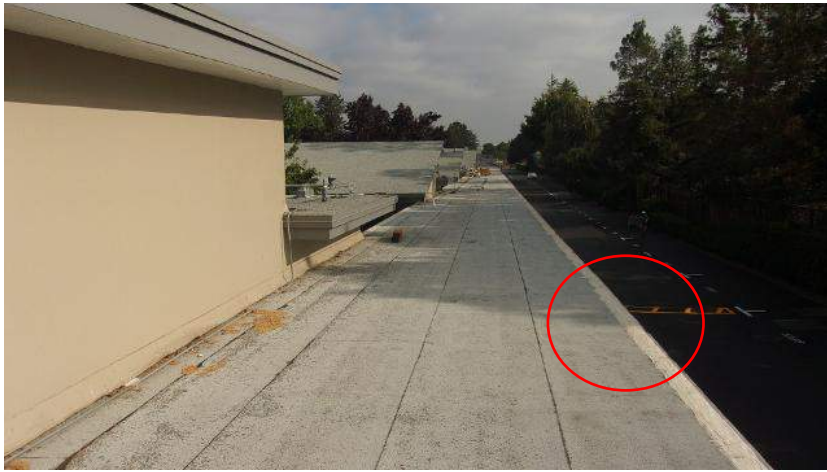
**Photo 22**

Gravel stop edge of cap sheet roof has been resealed.

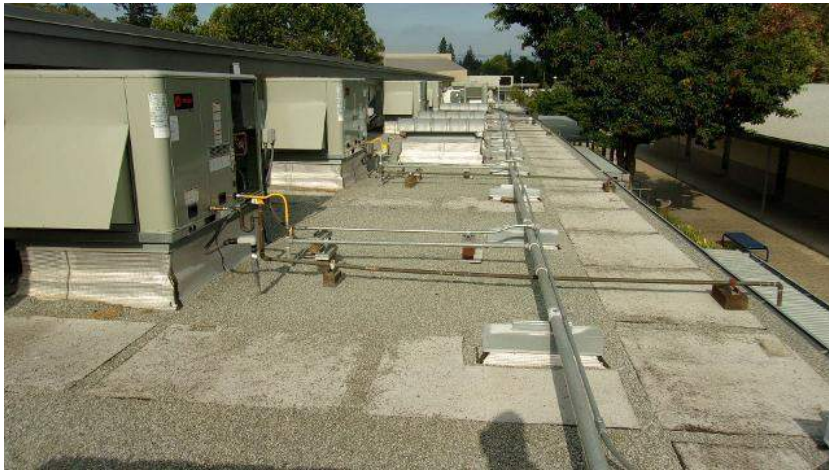
**Photo 24**

Most of the HVAC units look to be fairly new.

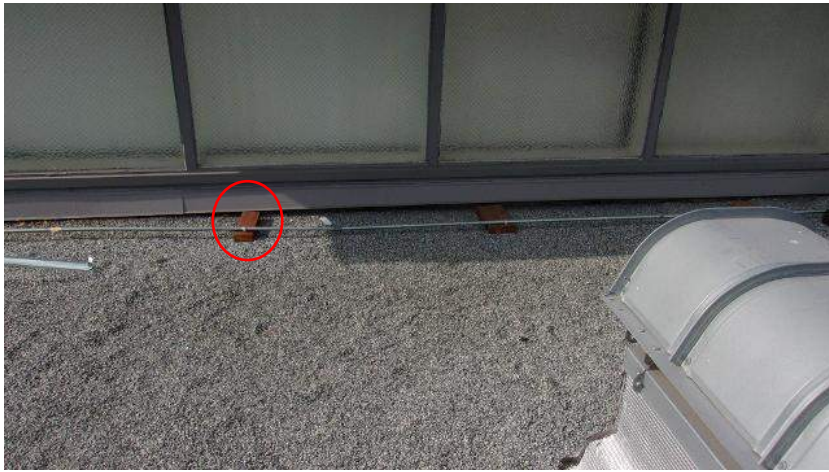
**Photo 25**

Support pads should be installed under the conduit support blocks.

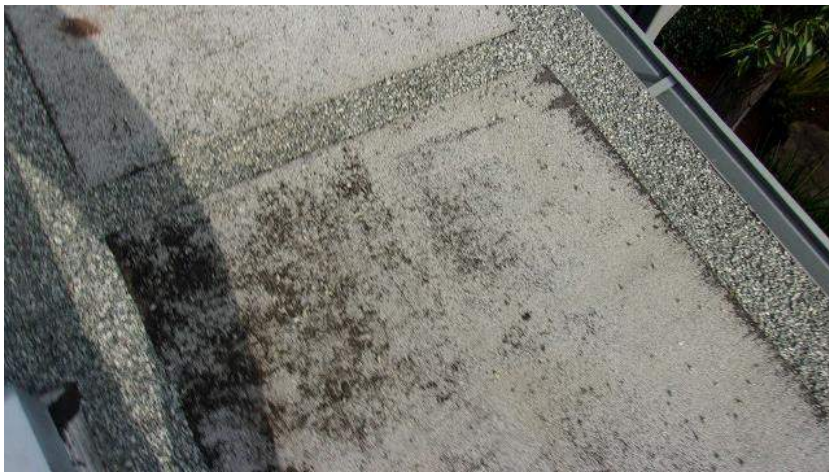
**Photo 26**

Granular erosion noted at the roof area walk pads. Check all and replace as needed.

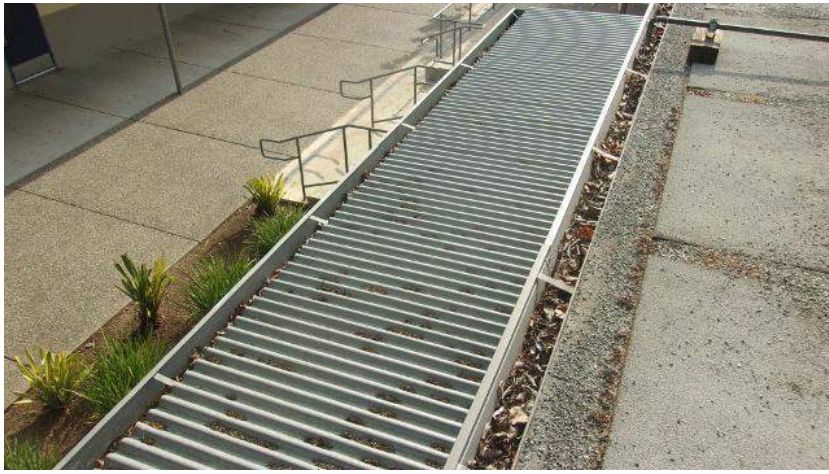
**Photo 27**

Debris should be cleared from the face mounted gutters.

Gutter screens to be installed when roof is replaced.

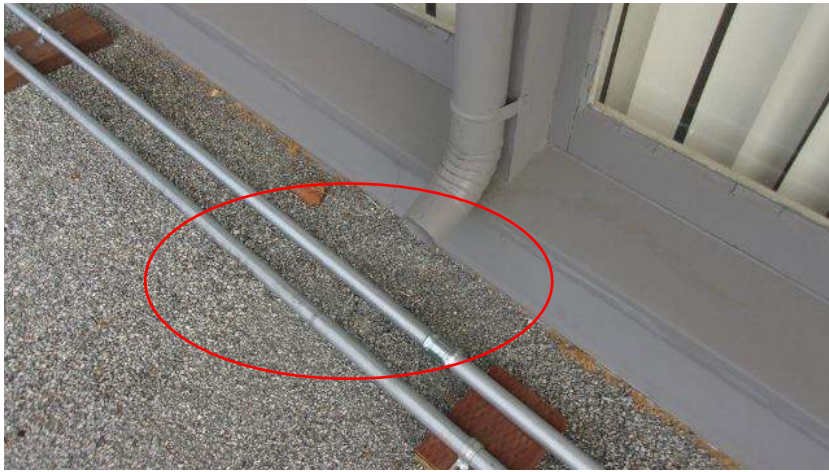
**Photo 28**

Splashblocks/extensions should be installed at the downspouts.

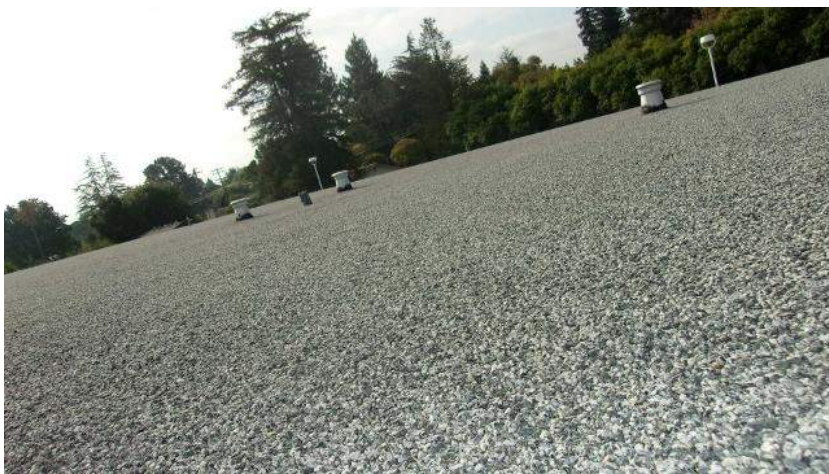
**Photo 29**

Upper roof area was found to be in fair condition.

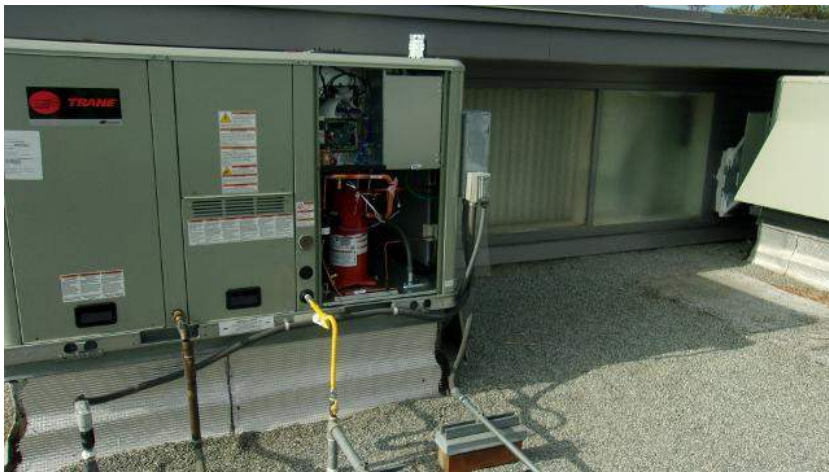
**Photo 31**

General attendance office/building 100 roof photos.

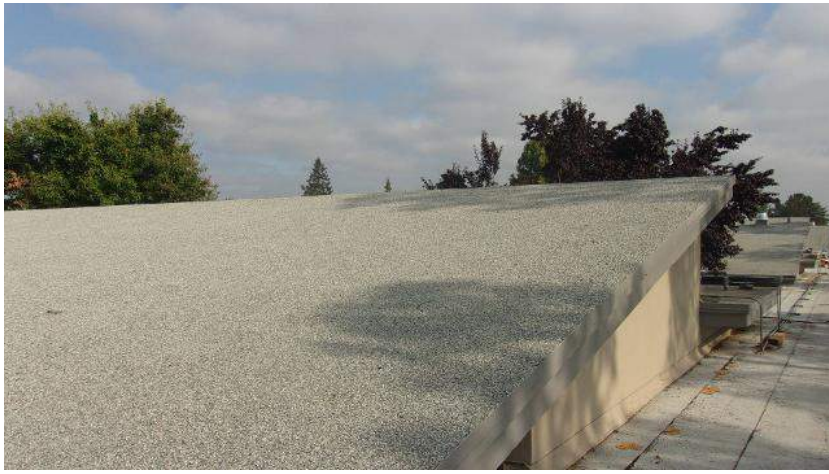
**Photo 47**

Building 200

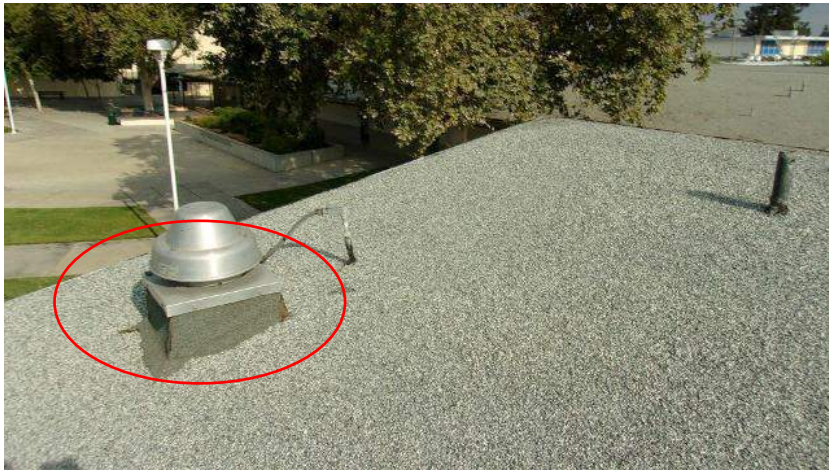
**Photo 48**

Overall, building 200's roof system is in fair condition.

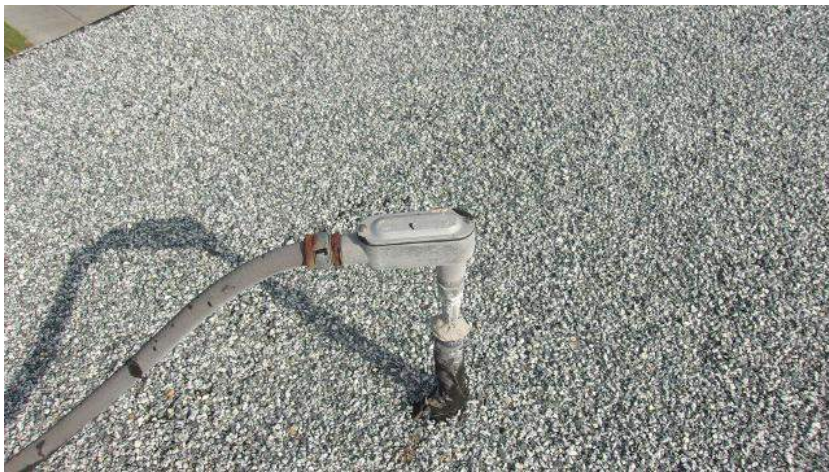
**Photo 49**

The flashing on this roof is older.

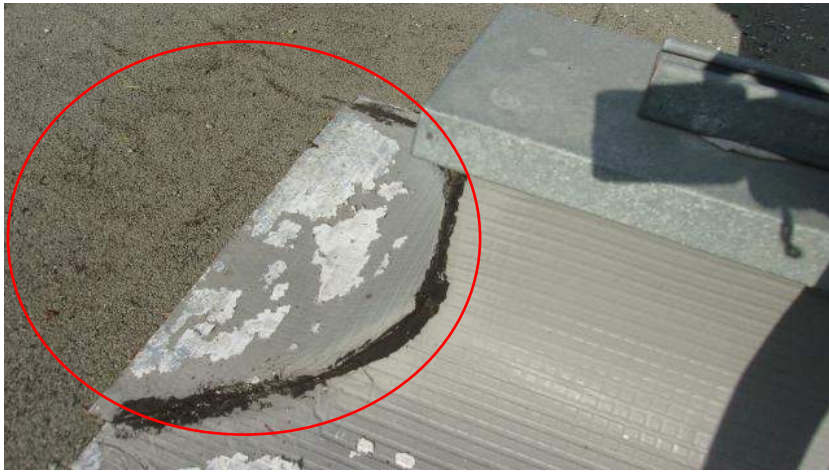
**Photo 51**

Small voids noted at the roof edges. General maintenance repairs are recommended. Metal edge is sawing it's way out of roof which indicated roof is 15 plus years old.

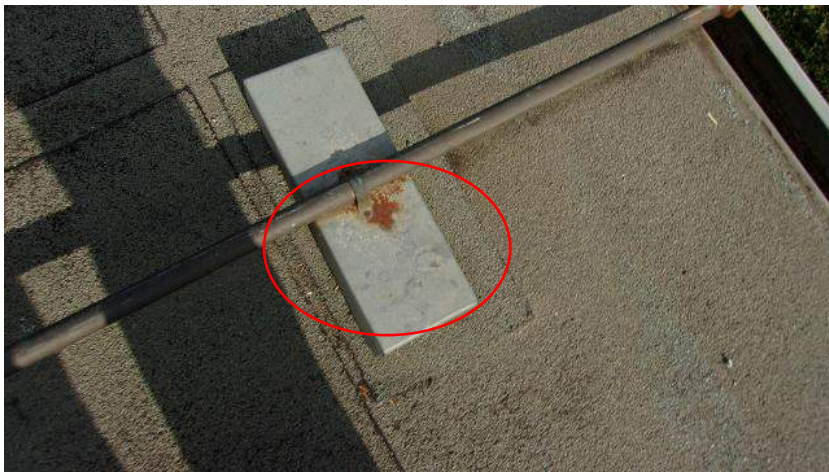
**Photo 52**

Recommend three coursing curb corners with mastic and mesh. Check all

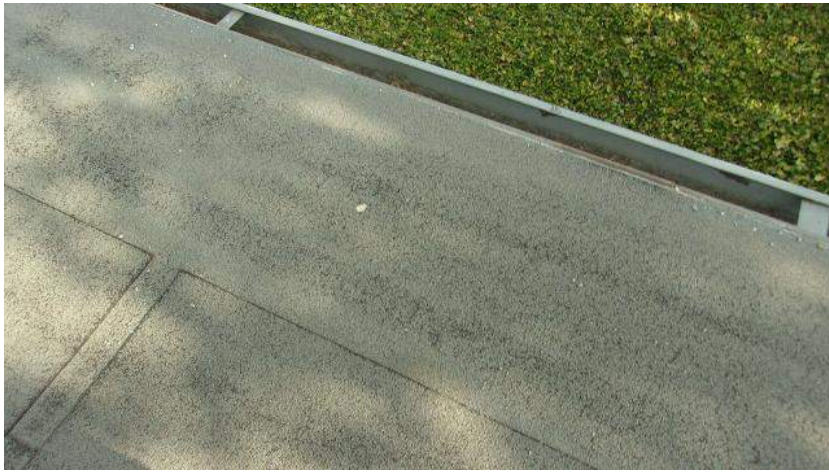
**Photo 54**

Recommend clearing debris from face mounted gutters.

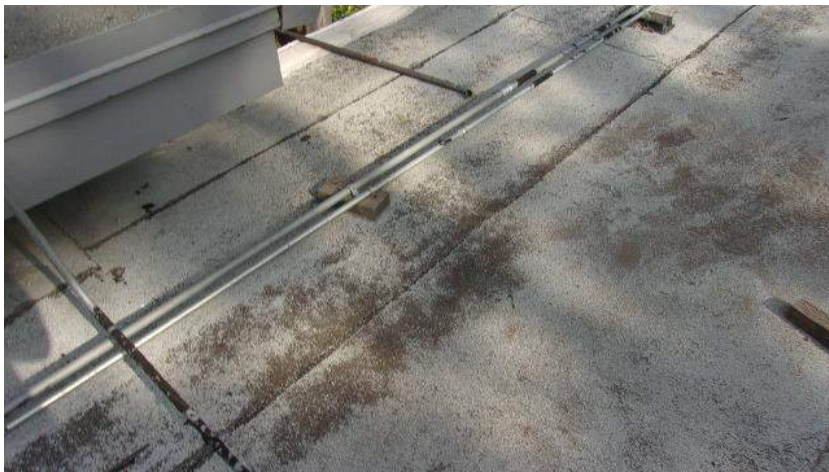
**Photo 55**

Granular erosion noted at the mineral cap sheet roof. Roof coating/restoration is recommended.

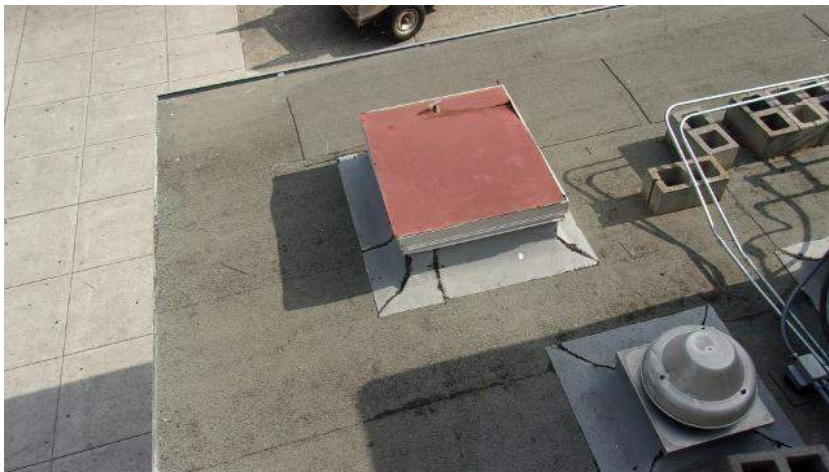
**Photo 58**

Support pads should be installed under roof  
area cinder blocks.

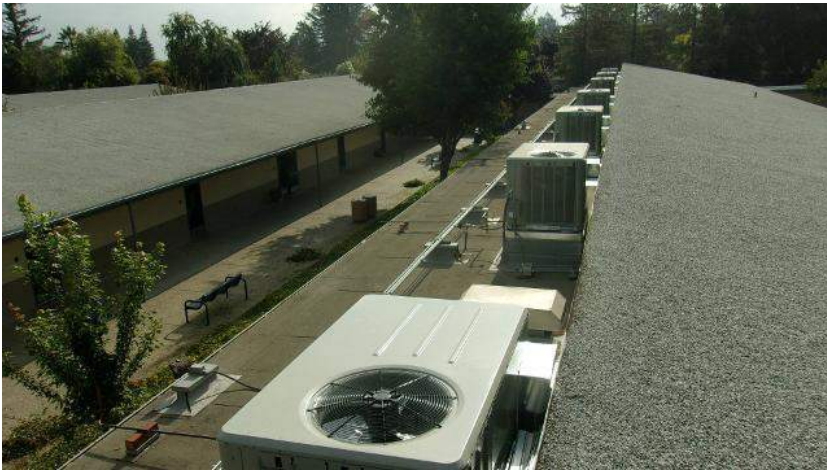
**Photo 59**

General building 200 roof photos.

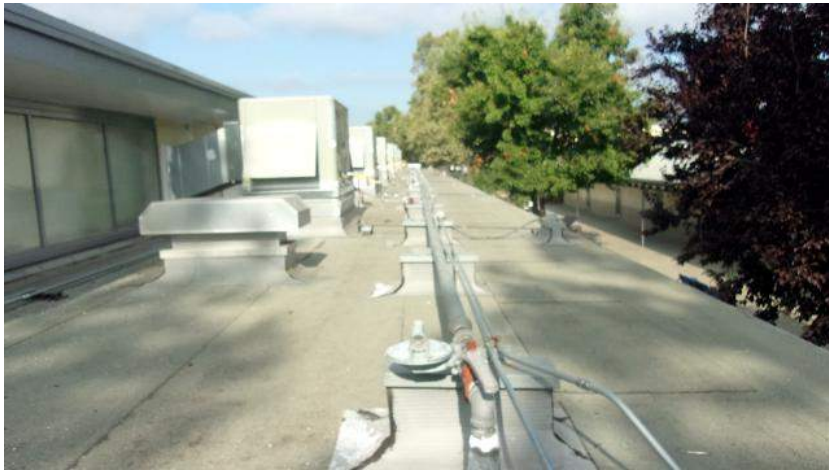
**Photo 62**

Roof is more than 10 years old but less than 15 in this roof section.

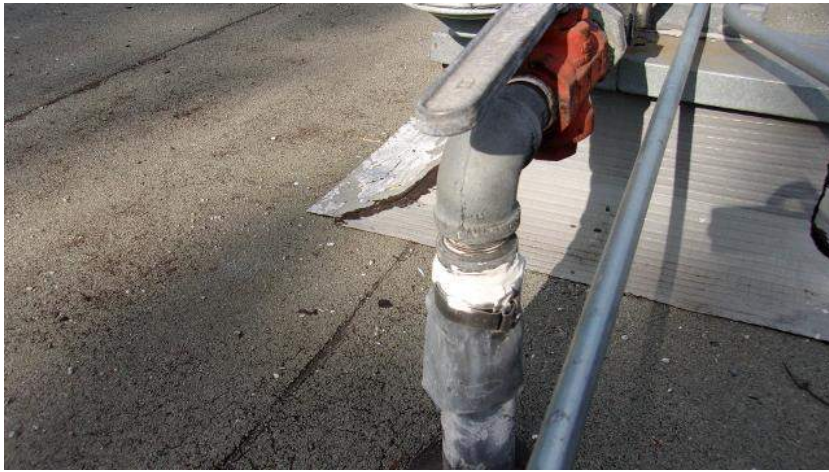
**Photo 63**

Support curbs are high enough and are well flashed.

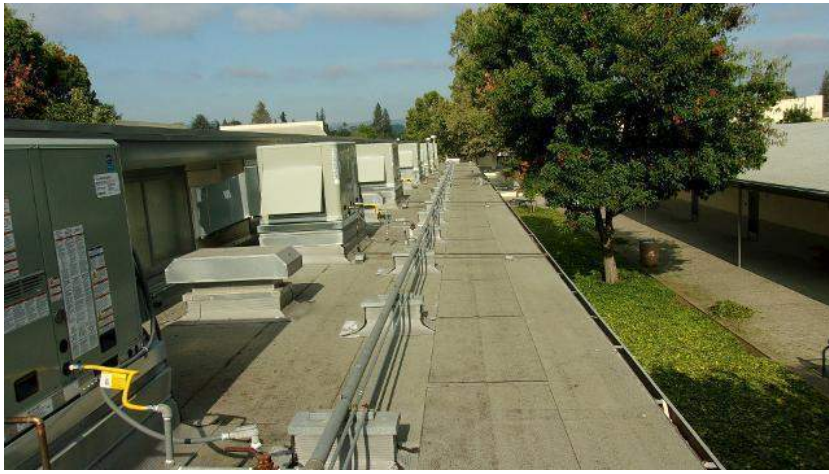
**Photo 65**

Rof should be coated if it is not scheduled to be replaced.

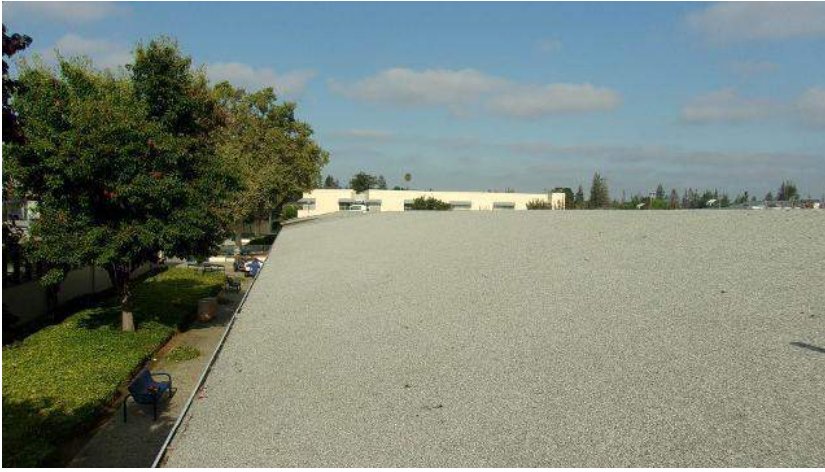
**Photo 74**

Building 300

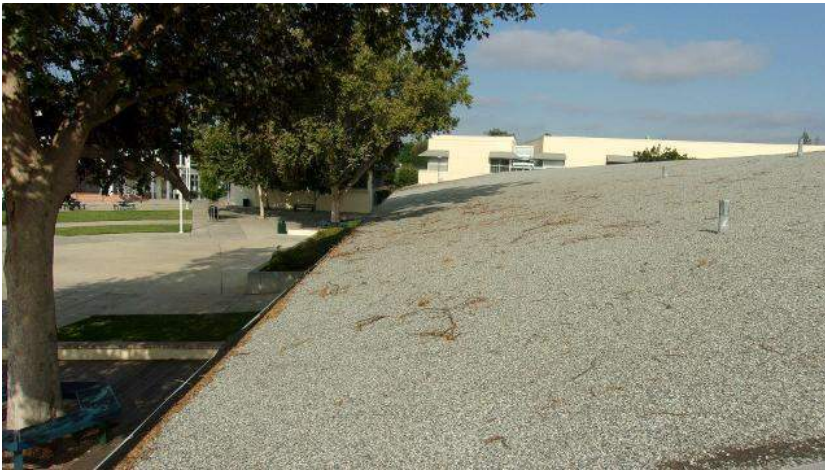
**Photo 75**

Overall building 300's roof was found to be in fair condition.

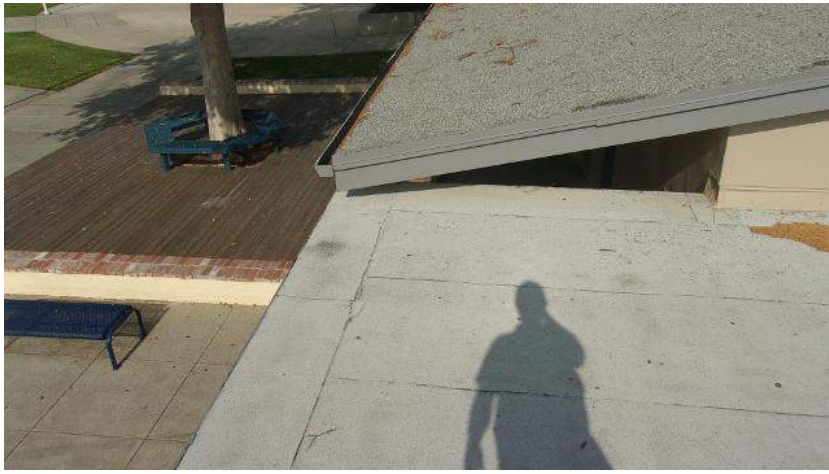
**Photo 77**

Central corridor is the newest roof section and does not need to be replaced.

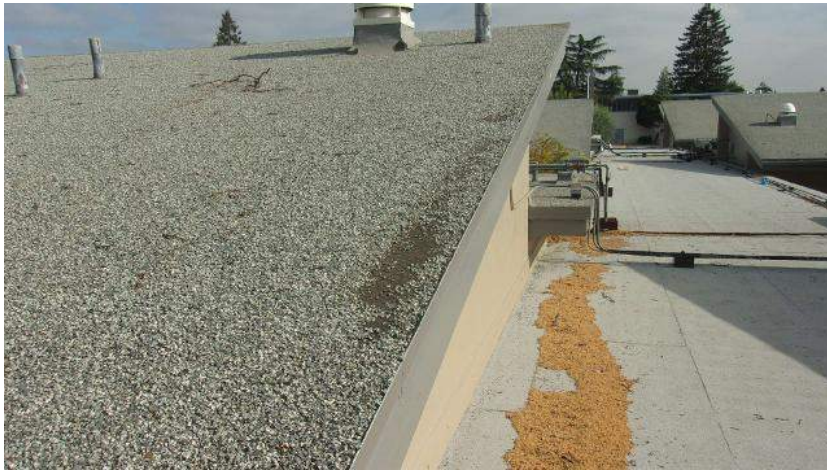
**Photo 83**

Bare spots noted at the roof edges. General maintenance repairs are recommended.

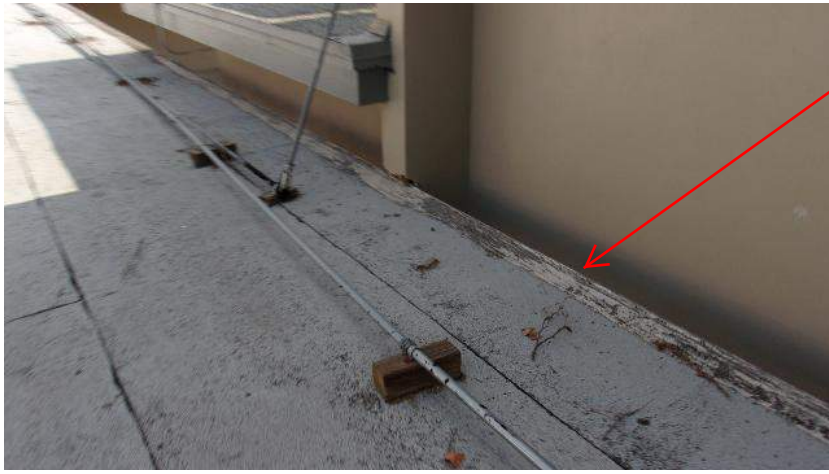
**Photo 95**

Entire edge of roof has been patched.

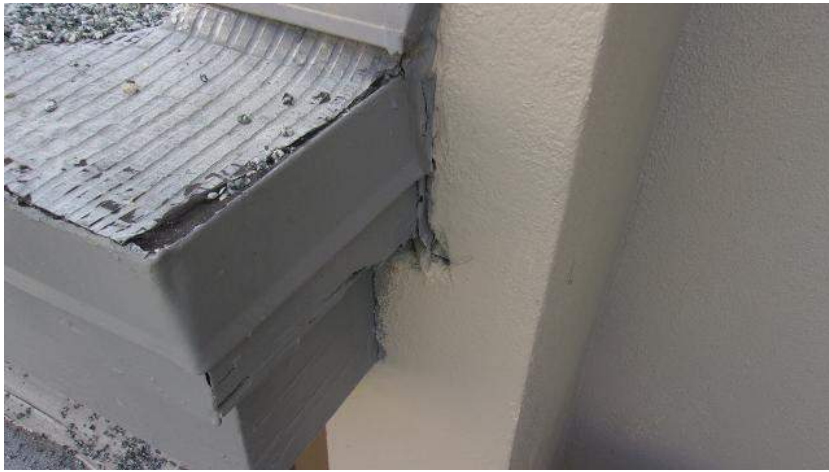
**Photo 96**

Entire perimeter has been patched.

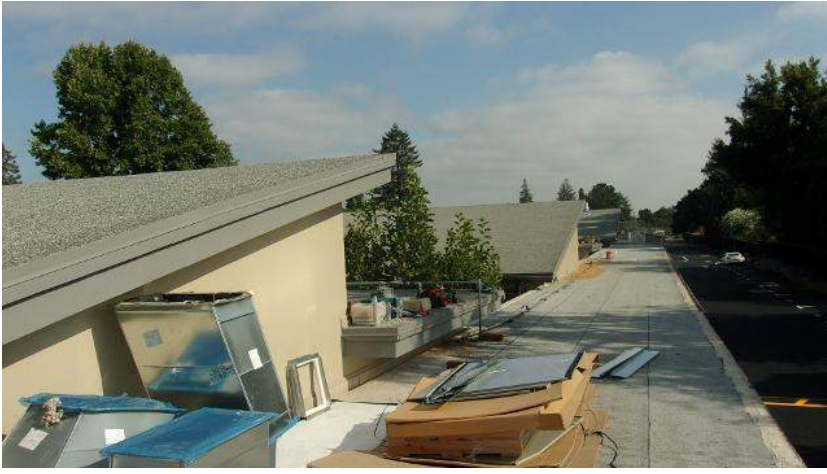
**Photo 116**

Overall, building 400's roof system was found to be in fair condition.

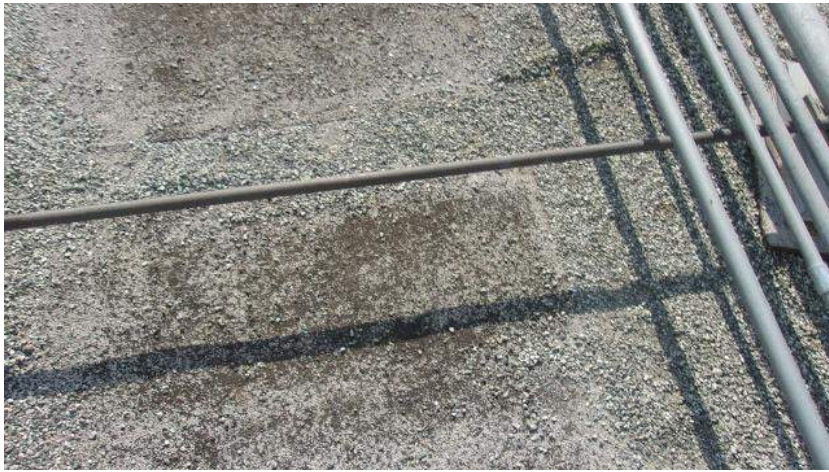
**Photo 120**

An un-flashed conduit penetration is present. proper flashing installation is needed.
