## **Civil/Site Assessment & Recommendations**

### **Mountain View Los Altos High School District**

**Brelje & Race Consulting Engineers**

### **Campus Assessments**

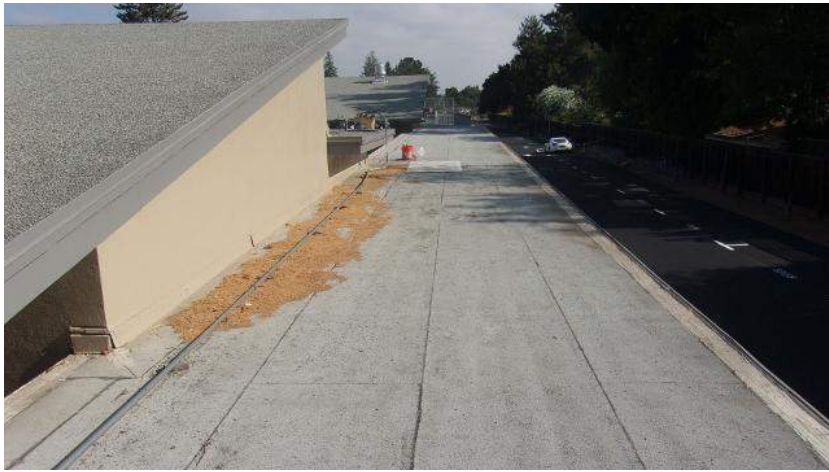
**Photo 150**

Overall, building 500's roof was found to be in fair condition.

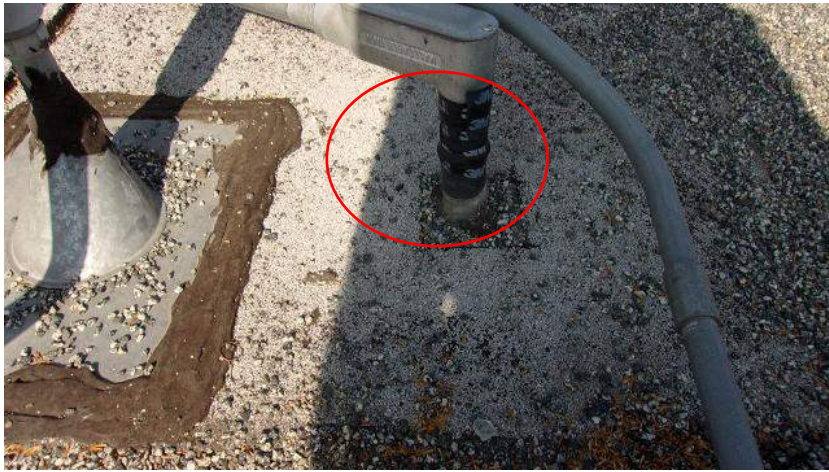
**Photo 156**

Improperly installed sheet metal flashing is present (lower roof area). Corrections are needed.

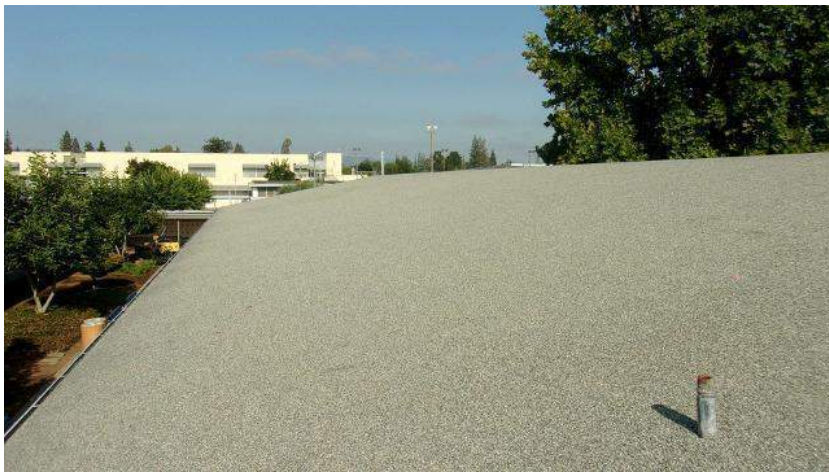
**Photo 157**

Un-flashed electrical conduit at the lower roof area. Corrections are recommended.

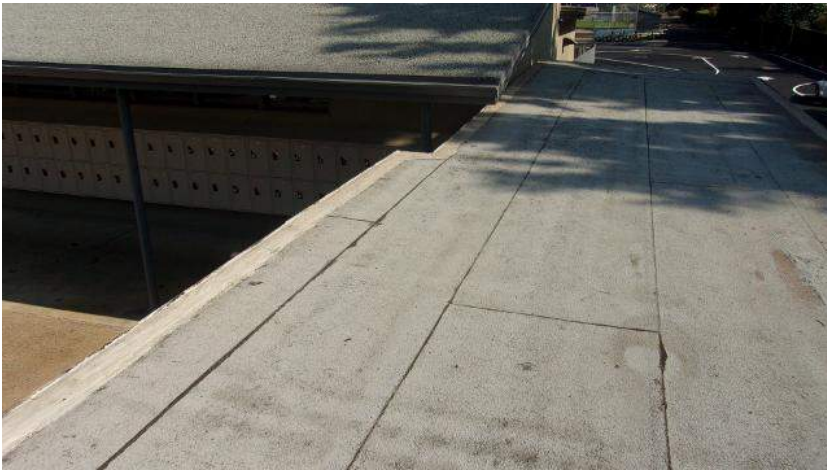
**Photo 172**

Building 600 roof was found to be in fair condition

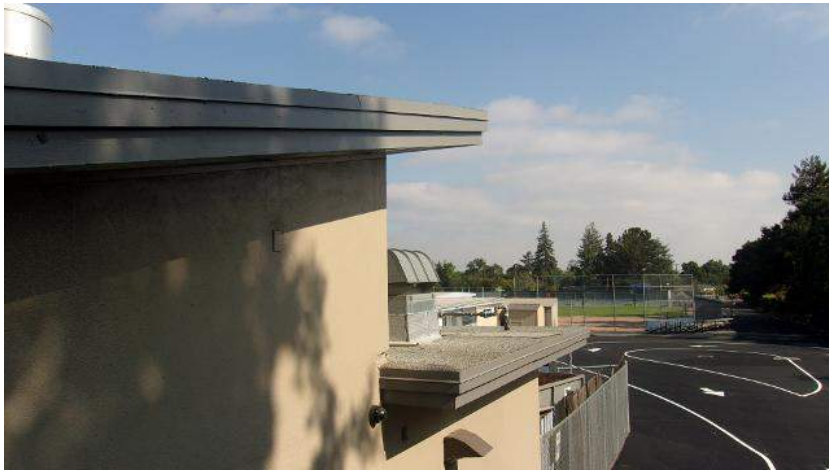
**Photo 174**

Building 600 roof was found to be in fair condition.

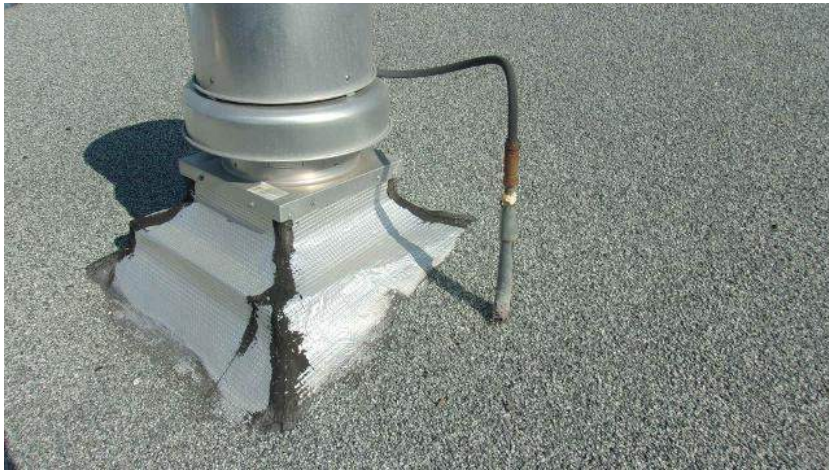
**Photo 179**

Roof jacks should be re-sealed.

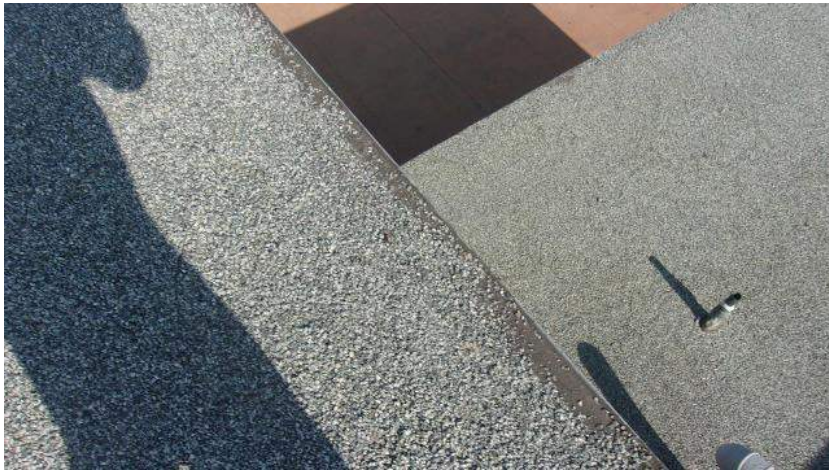
**Photo 183**

Storm collars should be re-sealed.

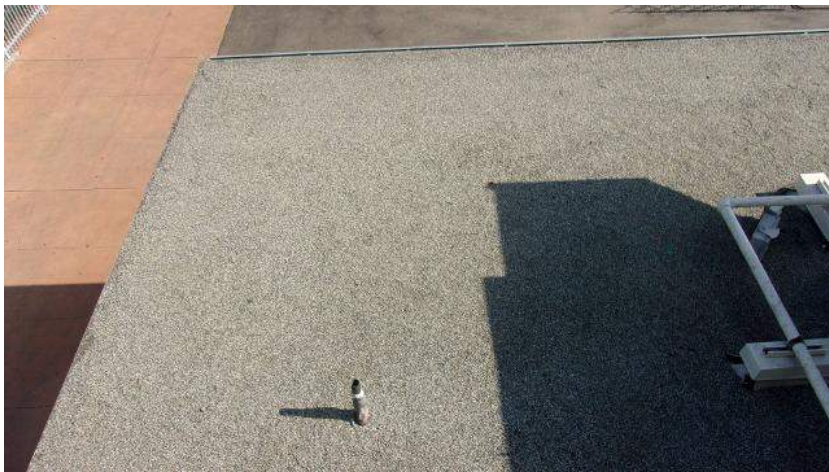
**Photo 184**

Bare spots at the roof edges should be repaired.

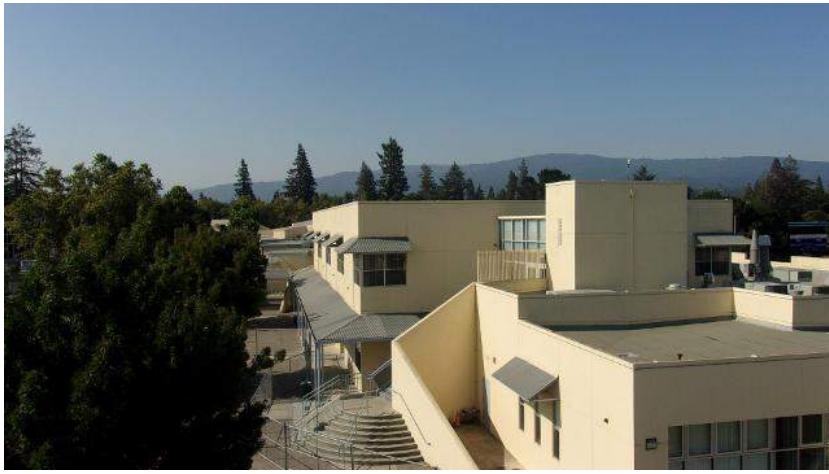
**Photo 198**

Building 700 was locked at the time of inspection. Roof system was not fully accessible. Areas (where visible) appear to be in good condition.

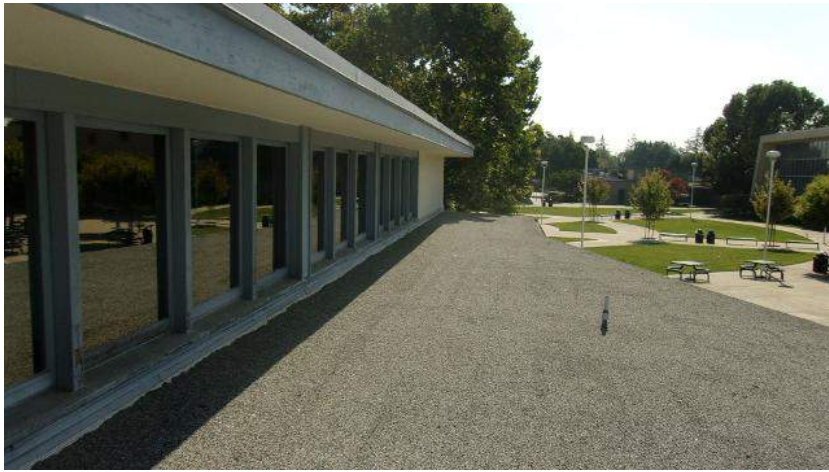
**Photo 214**

Building 800, Music Building roof was found to be in fair condition.

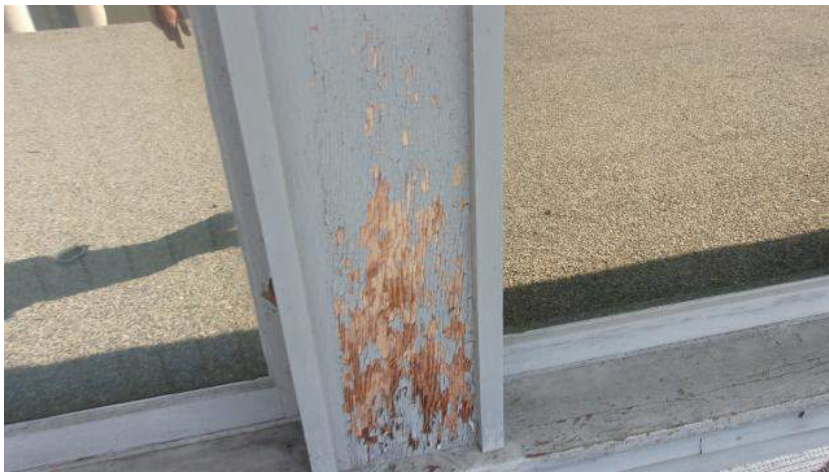
**Photo 215**

Peeling/weathered paint noted at the upper window areas. Paint/sealant work is recommended.

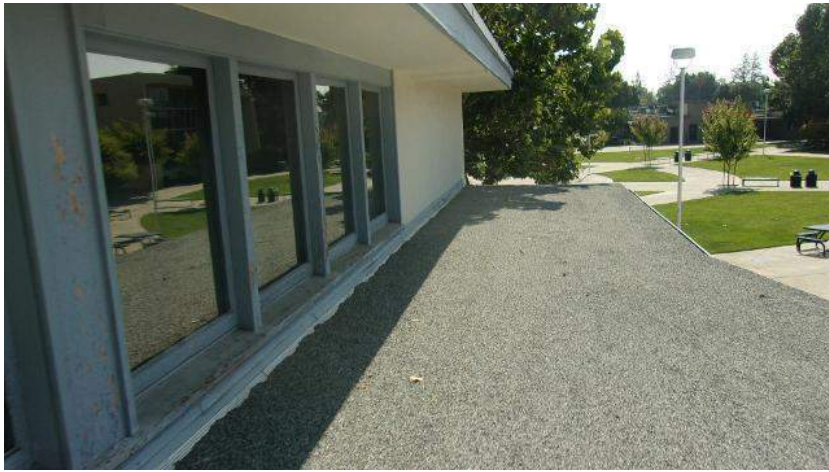
**Photo 217**

Covered walkway area at building 800 was found to be in fair condition.

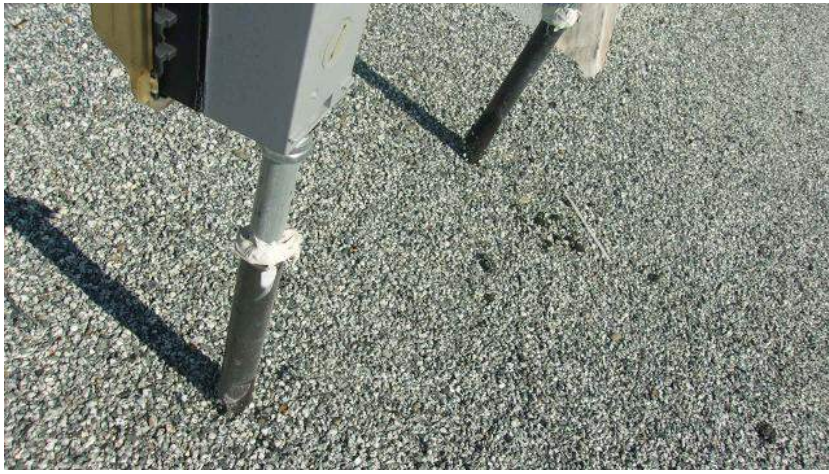
**Photo 222**

Lead jacks should be re-sealed. Current sealant shows signs of wear/weathering.

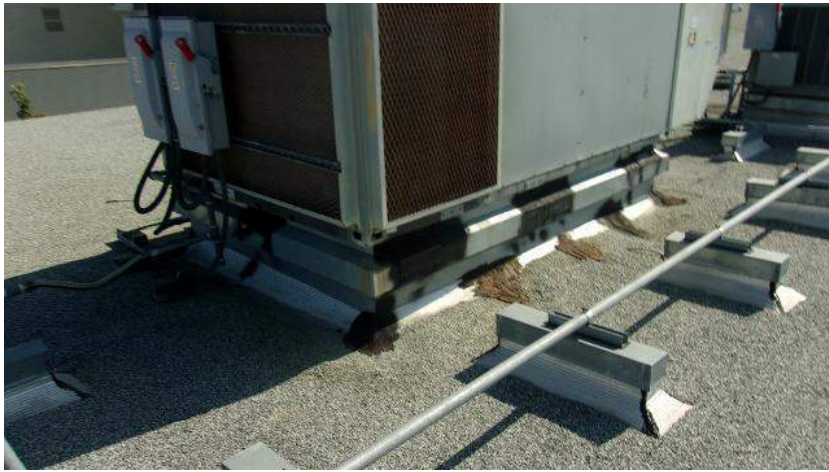
**Photo 229**

Mastic at equipment flashing shows signs of wear/weathering. Re-sealing is recommended.

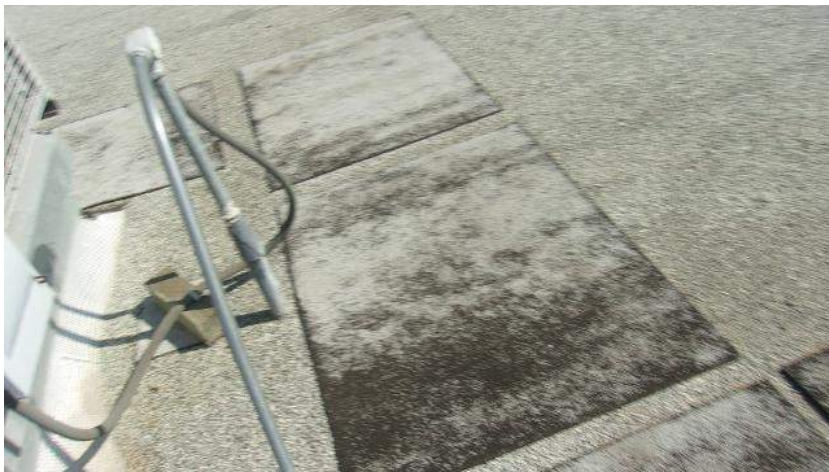
**Photo 230**

Worn walk pads are present. Walk pad replacement is recommended.

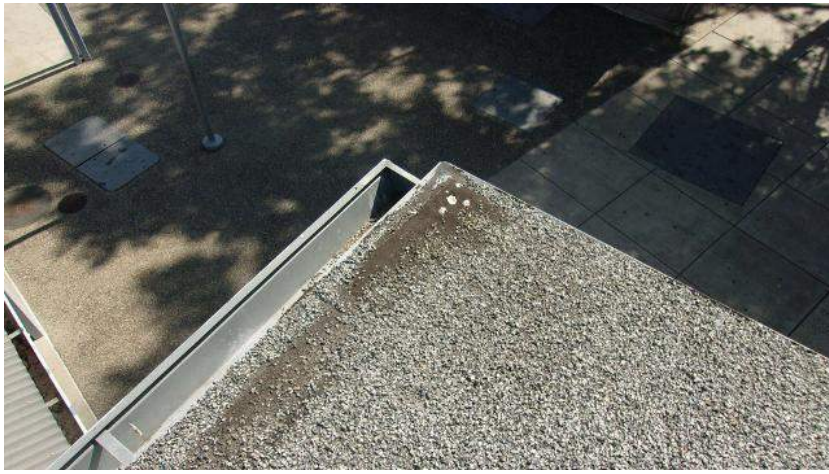
**Photo 231**

Bare spots noted at the roof edges. Roof edge repairs are needed.

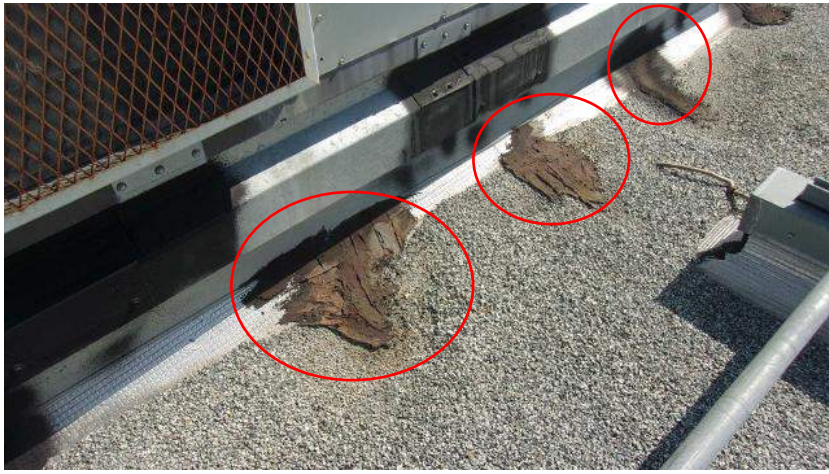
**Photo 234**

Previous leaks at units

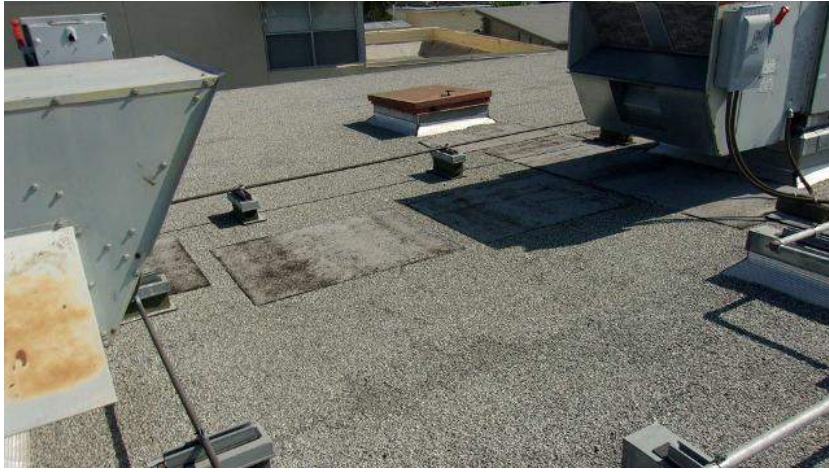
**Photo 236**

Roof is in poor condition

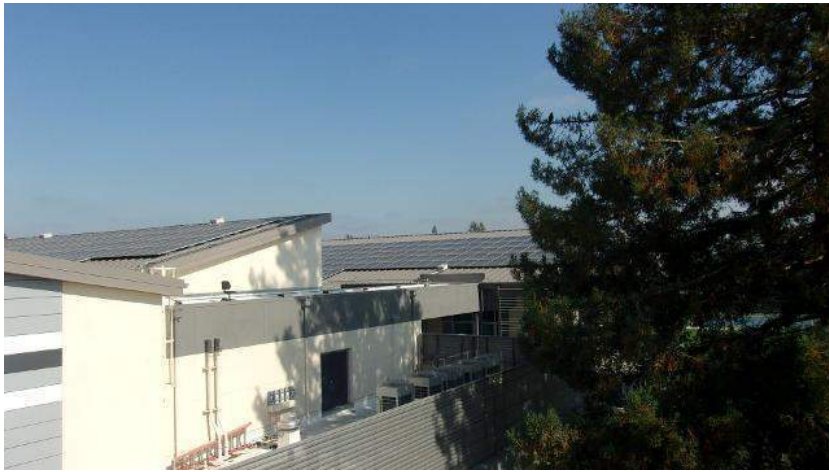
**Photo 243**

Building 900 Building is new. Completed in 2013.

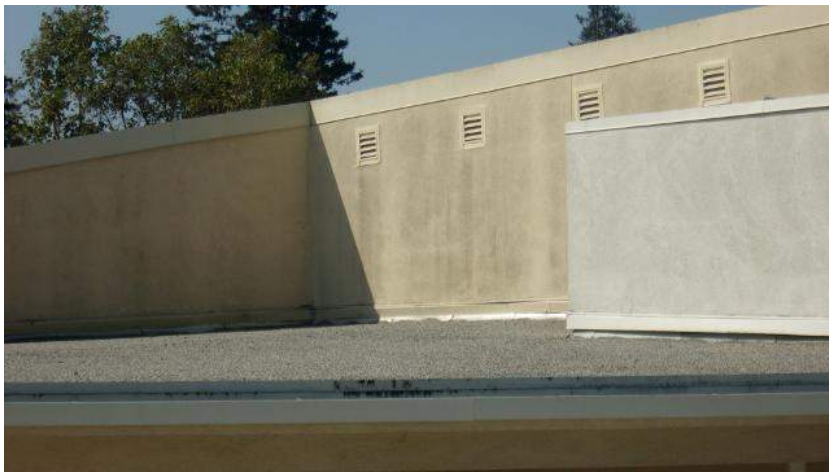
**Photo 247**

Roof areas (where visible) appear to be in fair condition.

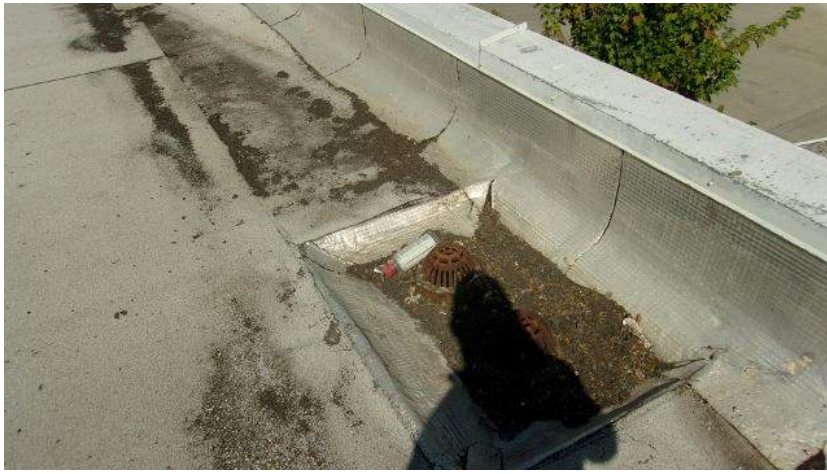
**Photo 254**

Granular erosion noted to the mineral cap sheet roof areas. Roof coating/restoration is recommended.

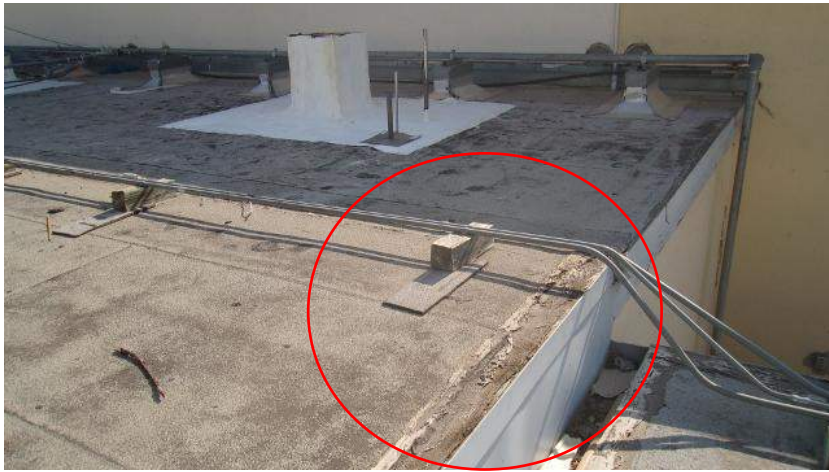
**Photo 279**

Roof/flashing repairs are in progress.

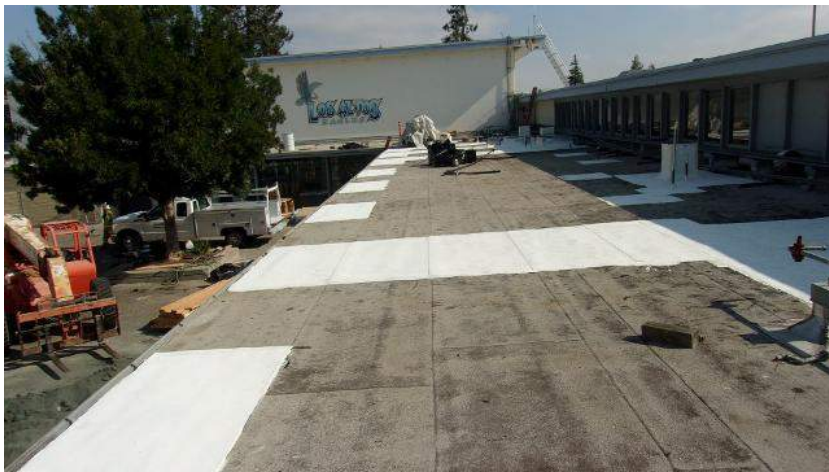
**Photo 280**

Many old patches.

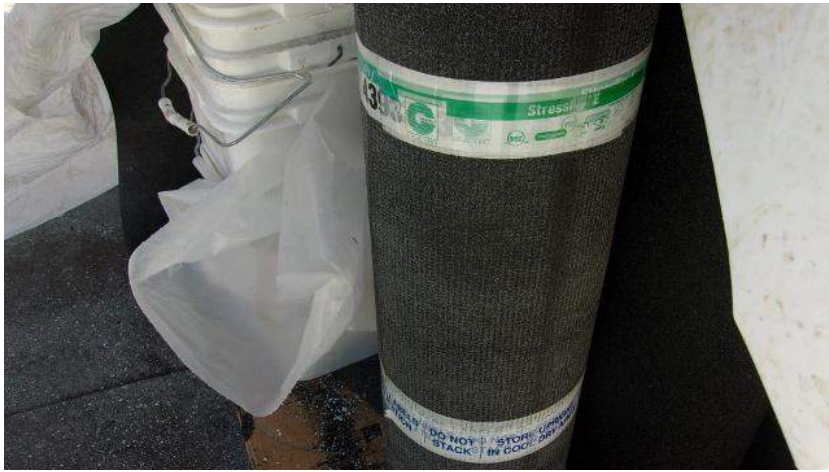
**Photo 291**

The Garland Co. materials are on-site.

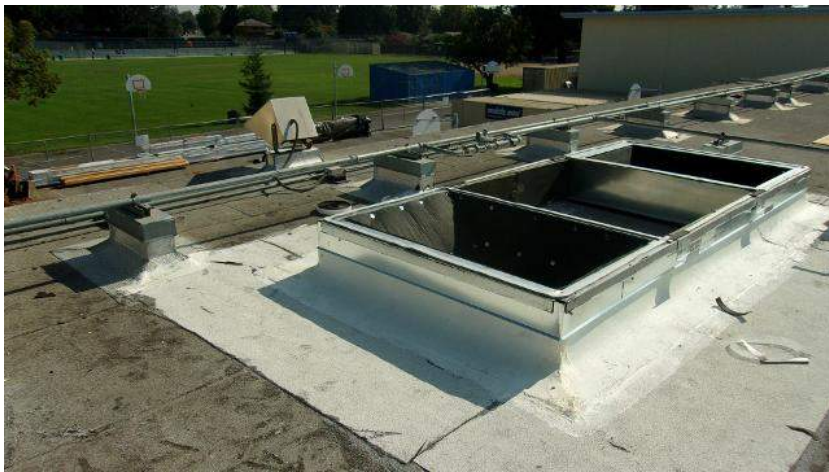
**Photo 307**

Solar hot water system in very poor condition. Will need to be replaced when roof is replaced as it will not be salvageable.

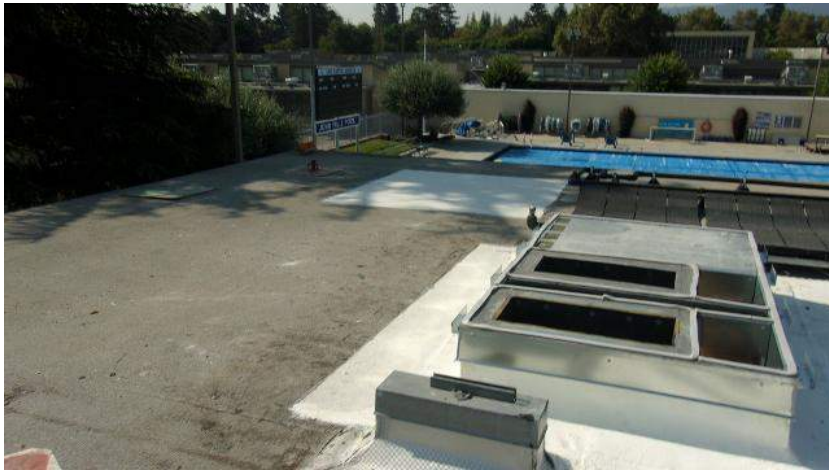
**Photo 314**

Severe granule erosion.

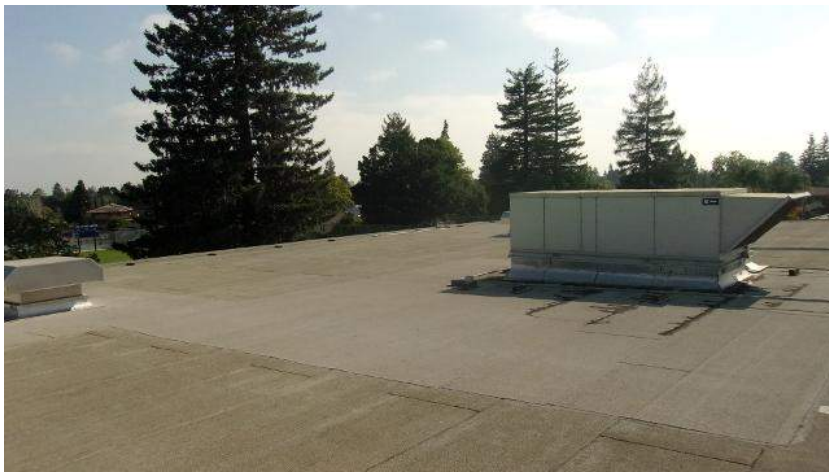
**Photo 319**

Extensive large patches.

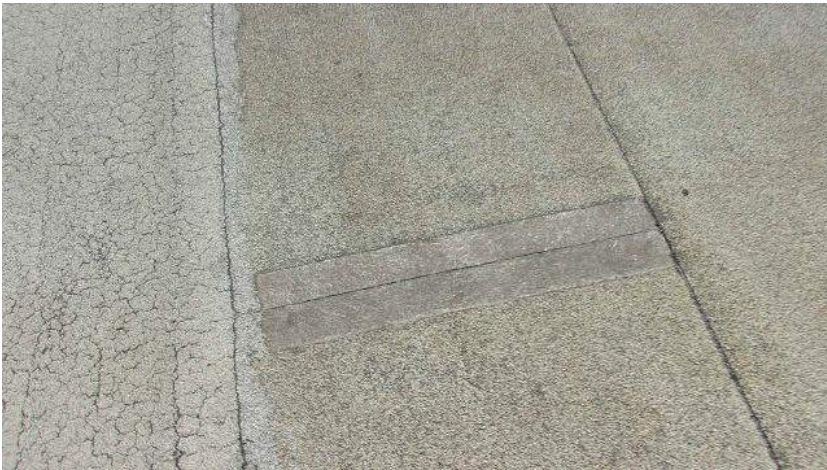
**Photo 322**

Cap sheet is failing.

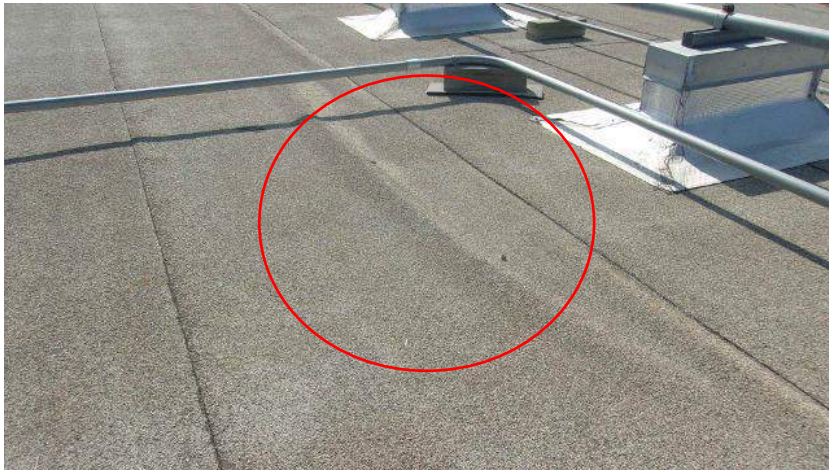
**Photo 323**

Old patch.

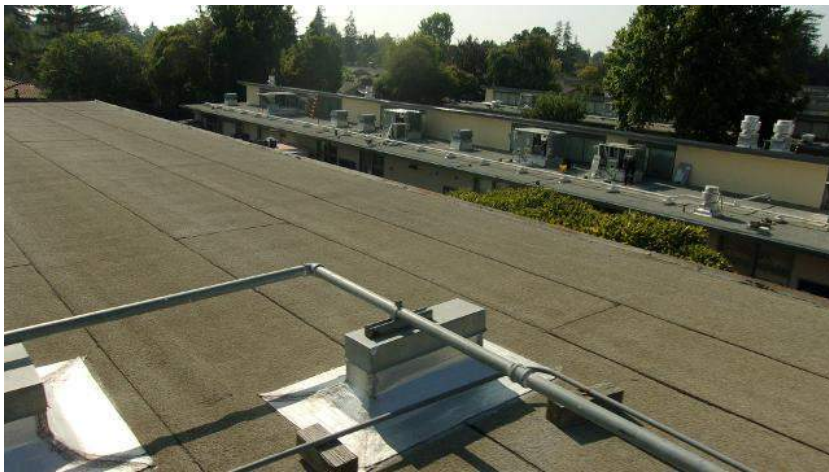
**Photo 325**

Extensive patching

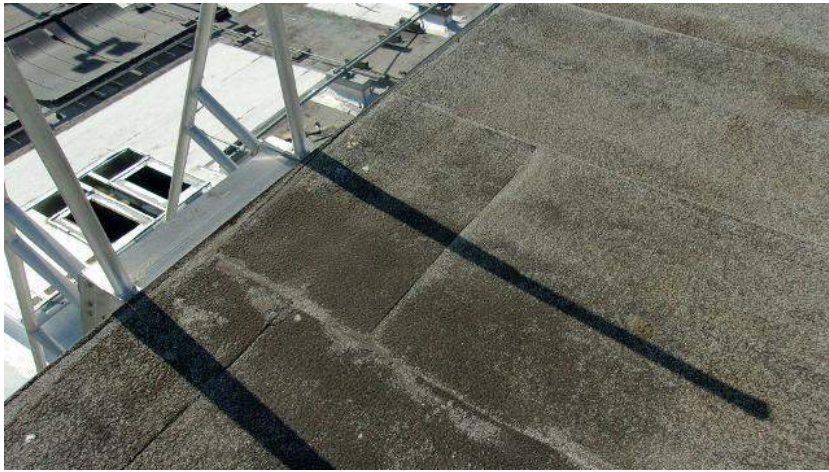
**Photo 339**

Heavy granular erosion is present at the upper gym roof areas.

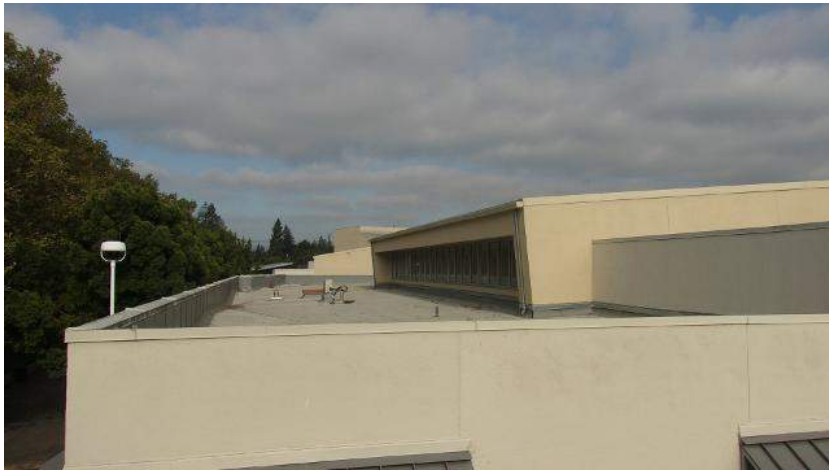
**Photo 351**

Library/Tutorial Center

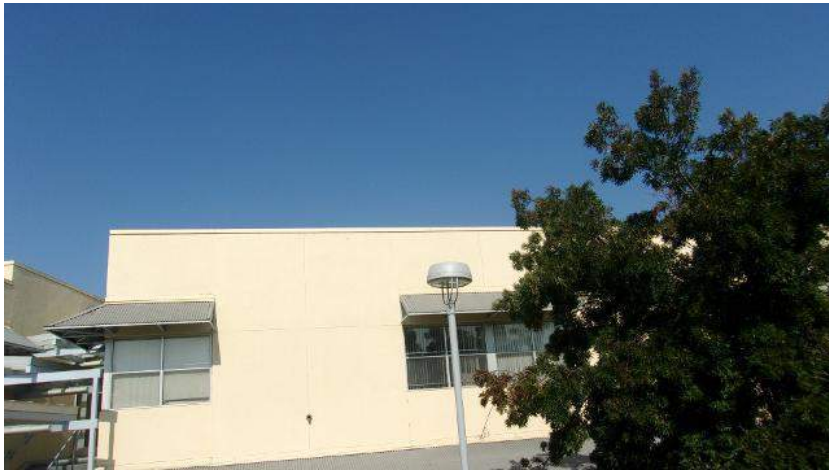
**Photo 353**

Areas (where visible) appear to be in good/fair condition.

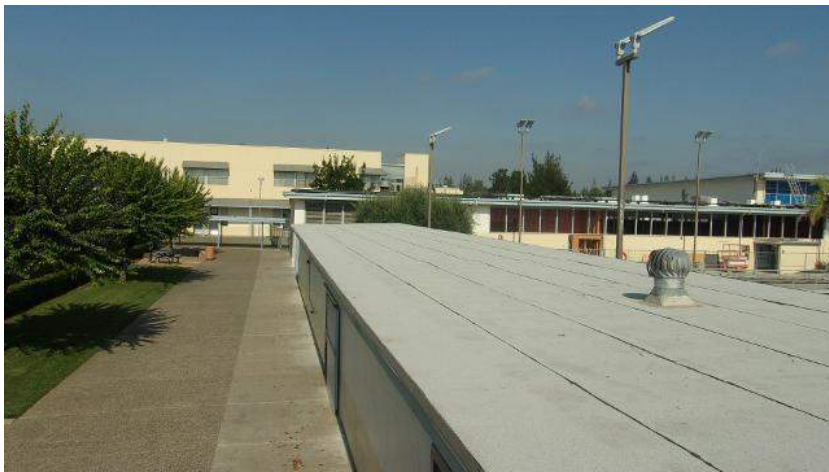
**Photo 362**

The storage building roof was found to be in good condition.

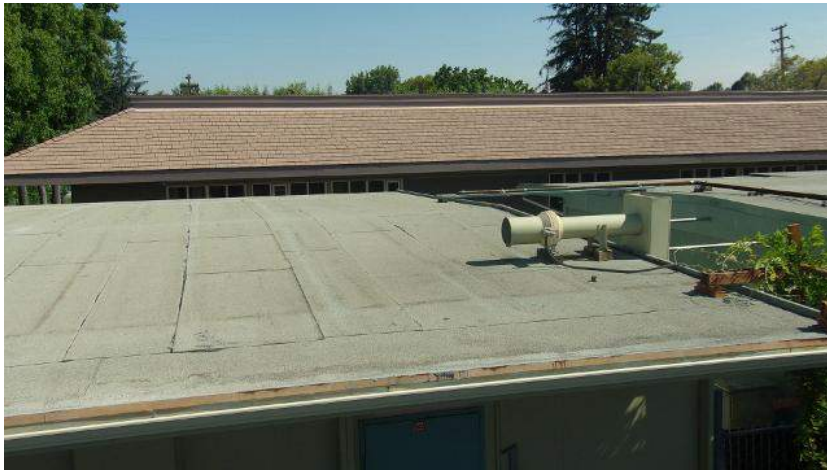
**Photo 4**

Overall, the roof system was found to be in fair condition.

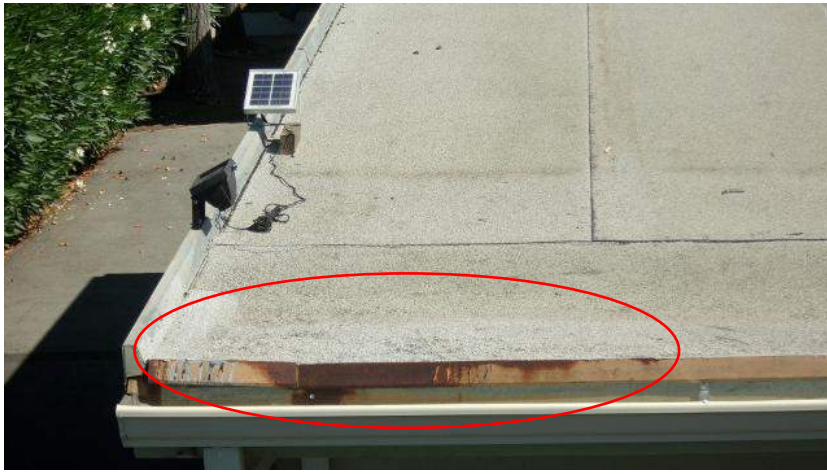
**Photo 6**

Rust/corrosion noted at the edge metal.  
Maintenance repairs are recommended.

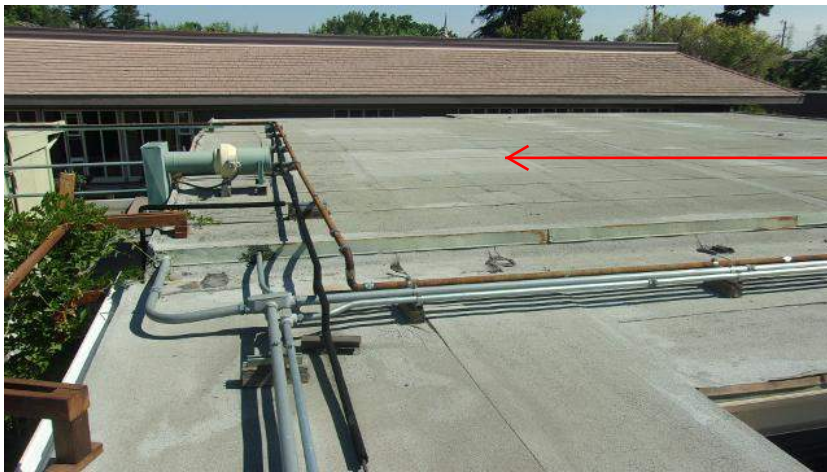
**Photo 8**

Overall, the flat roof area was found to be  
in poor condition. This roof has numerous  
patches.

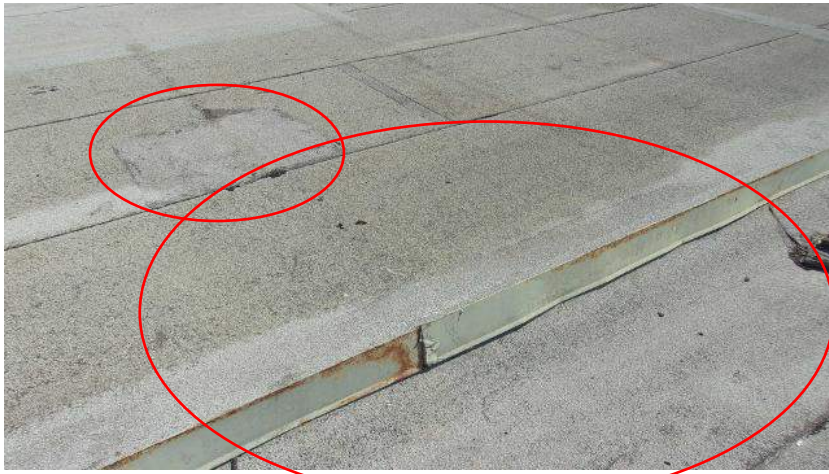
**Photo 9**

Past roof repairs noted at the time of inspection.

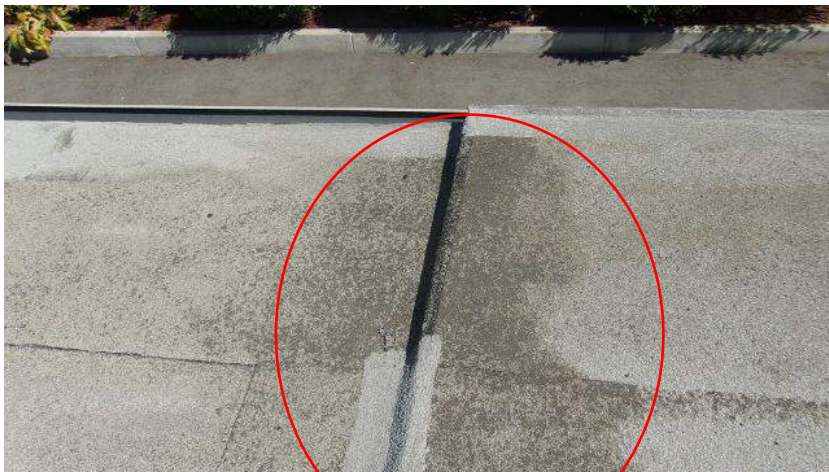
**Photo 11**

Granular erosion noted to portions of the roof area. Roof system coating/restoration are recommended.

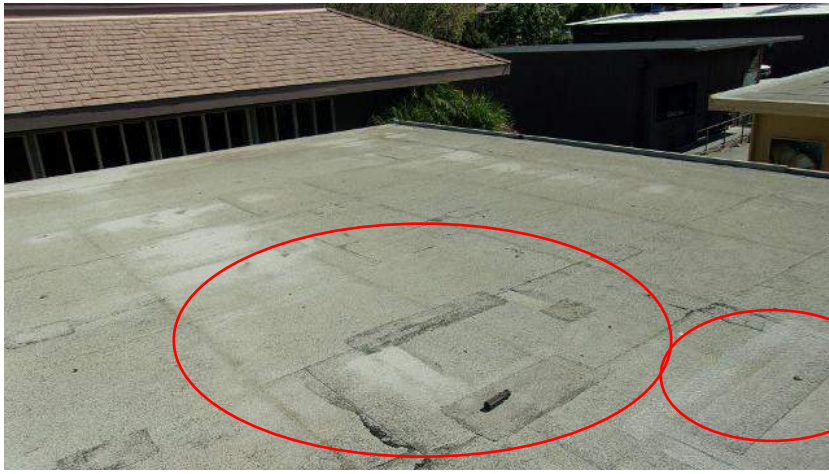
**Photo 15**

Roof has numerous patches and needs to be replaced.

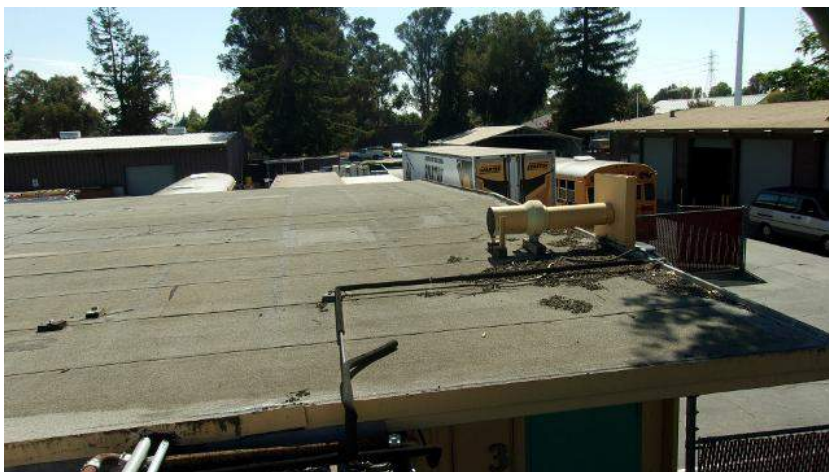
**Photo 20**

Overall the flat roof area at building 3 was found to be in poor condition. Roof is heavily patched.

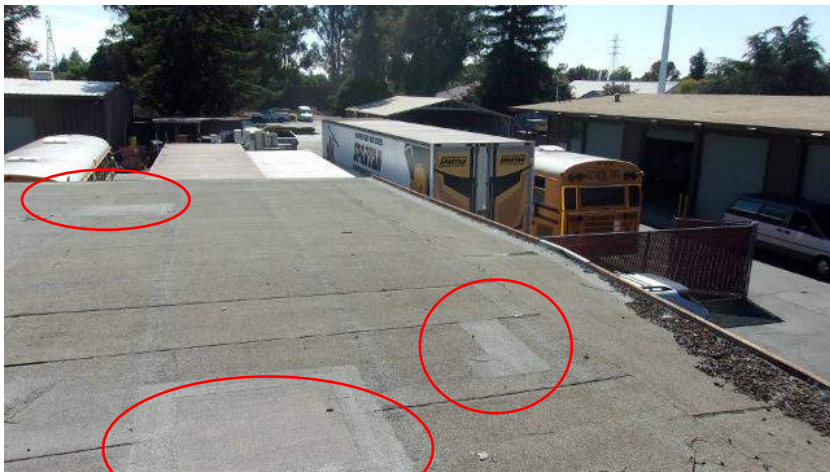
**Photo 23**

Past roof repairs noted at the time of inspection.

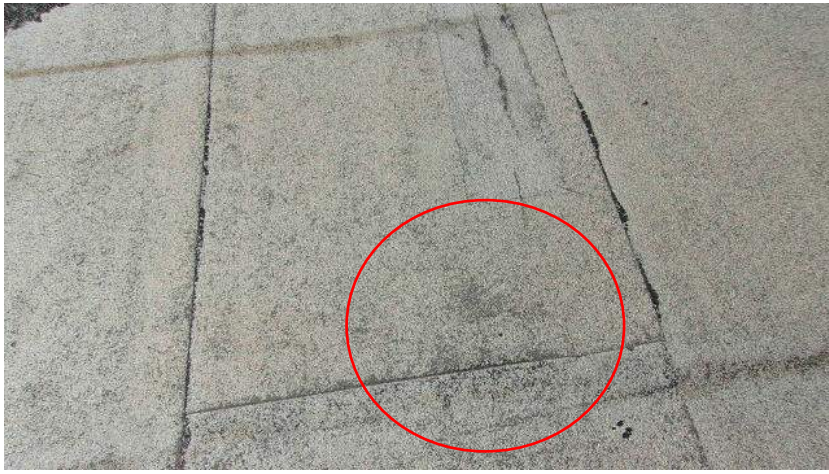
**Photo 24**

Granular erosion noted to portions of the cap sheet. Roof system coating/restoration is recommended.

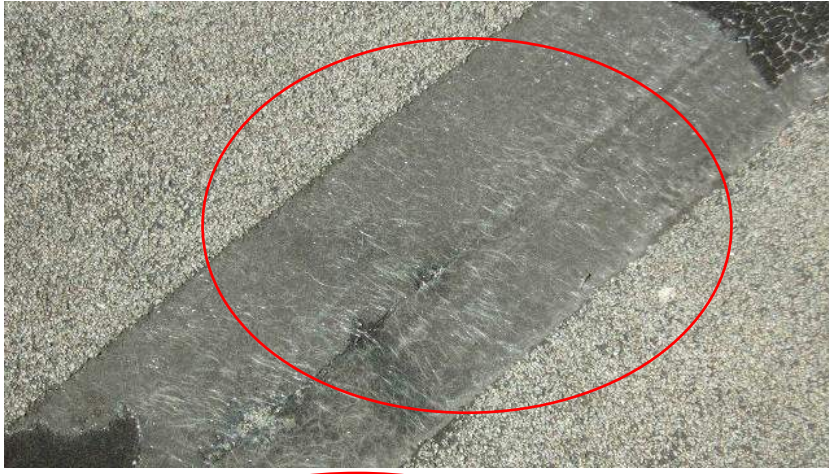
**Photo 35**

Voids noted at the roof edge/cap sheet  
connections.

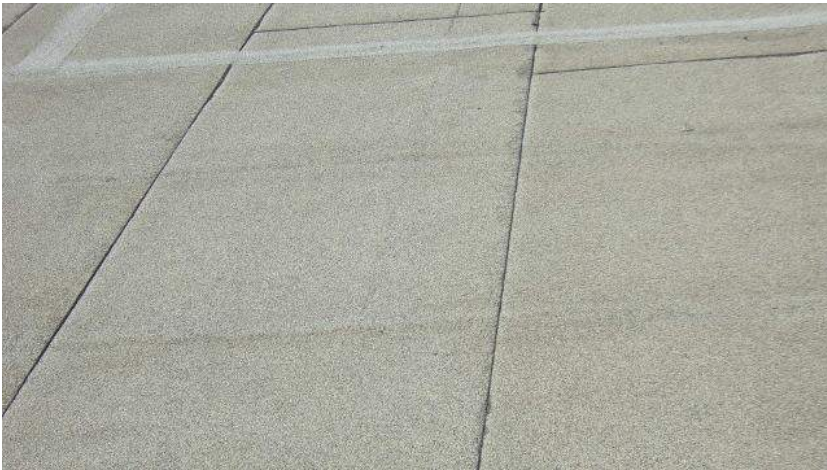
**Photo 43**

Overall, the flat roof system was found to be in poor condition. Regular system maintenance is recommended.

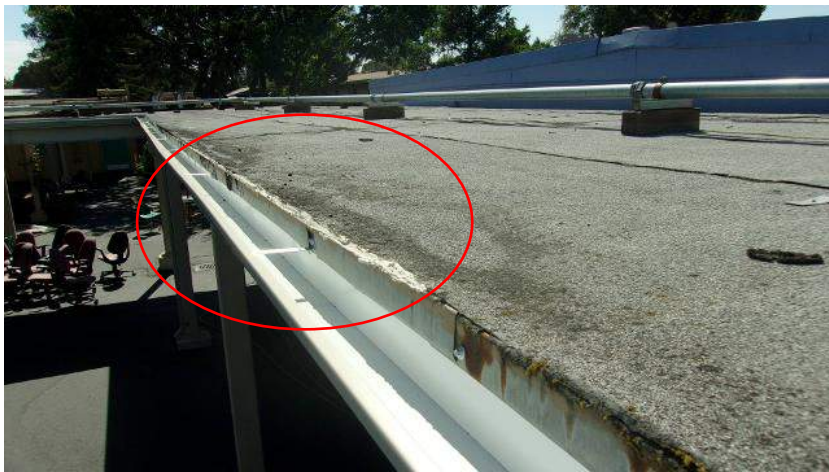
**Photo 49**

Covered walkway roof areas were found to be in poor condition with moderate wear noted. Roof system restoration or replacement is recommended.

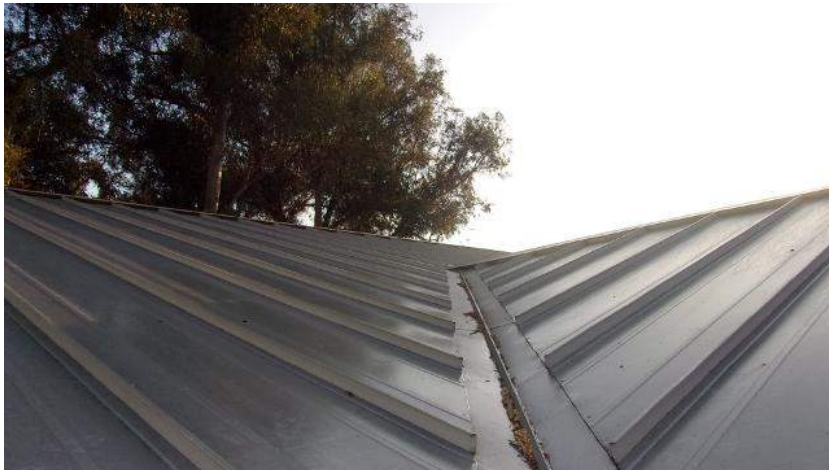
**Photo 3**

Metal roof panels at building A were found to be in good condition.

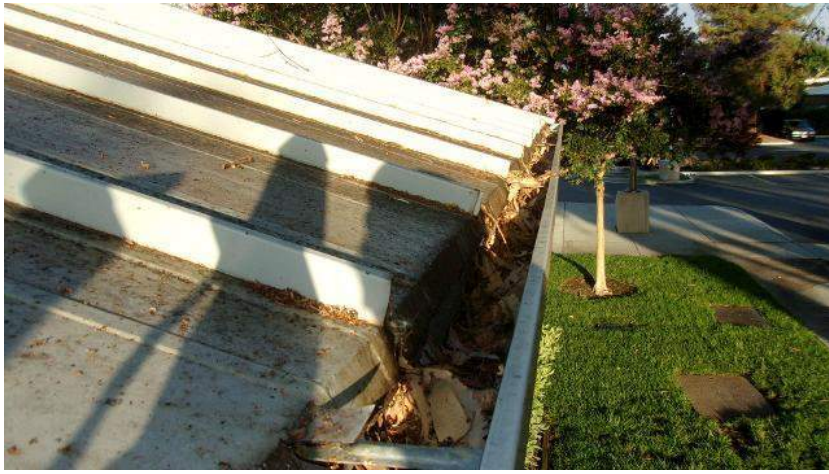
**Photo 5**

Debris build-up noted in the face mounted gutters. Gutter cleaning is recommended.

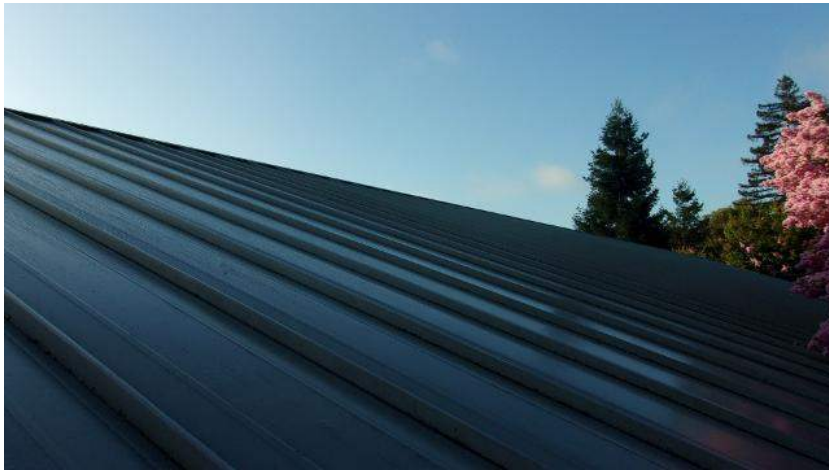
**Photo 15**

Building C roof panels were found to be in good condition.

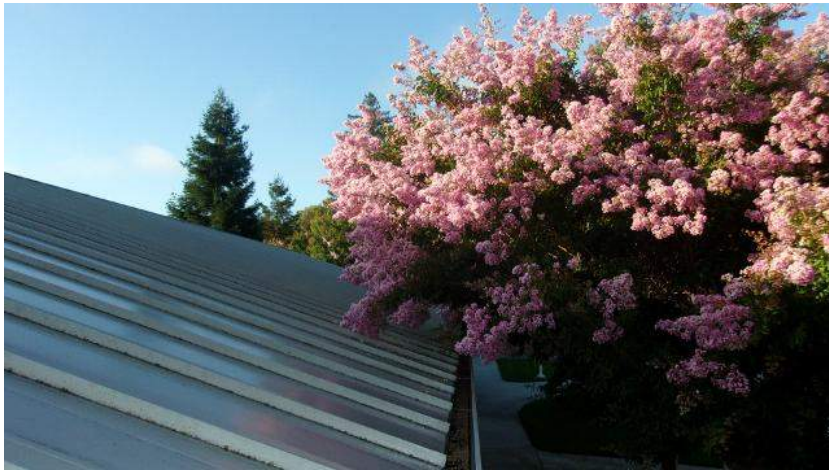
**Photo 17**

Tree debris noted in the face mounted gutter system. Gutter cleaning is recommended.

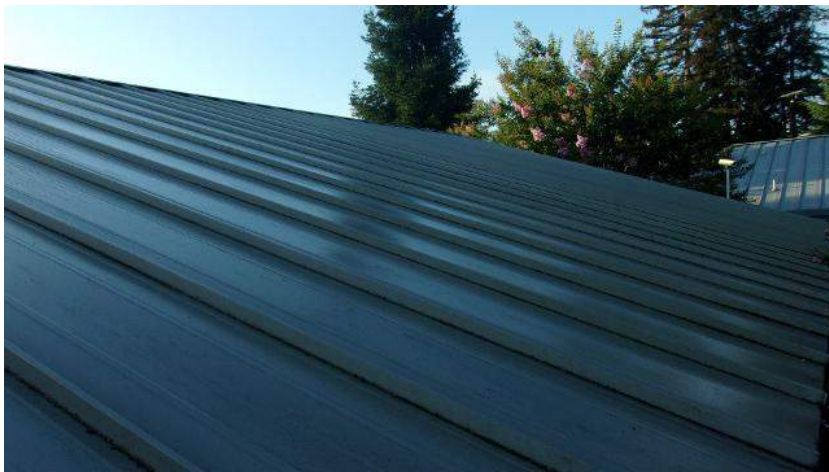
**Photo 19**

Signs of leakage noted at the gutter seam joints. Gutter seam joint re-sealing is recommended. (Check all)

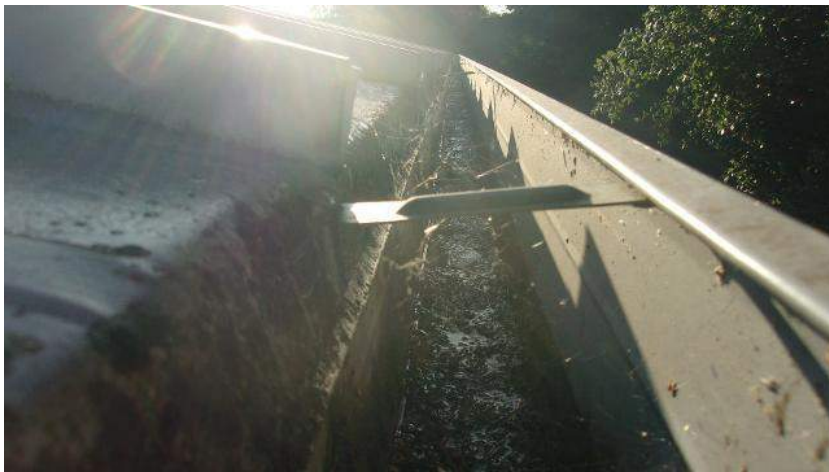
**Photo 28**

Signs of leakage noted at the gutter seams. Gutter seam re-sealing is recommended. (Check all)

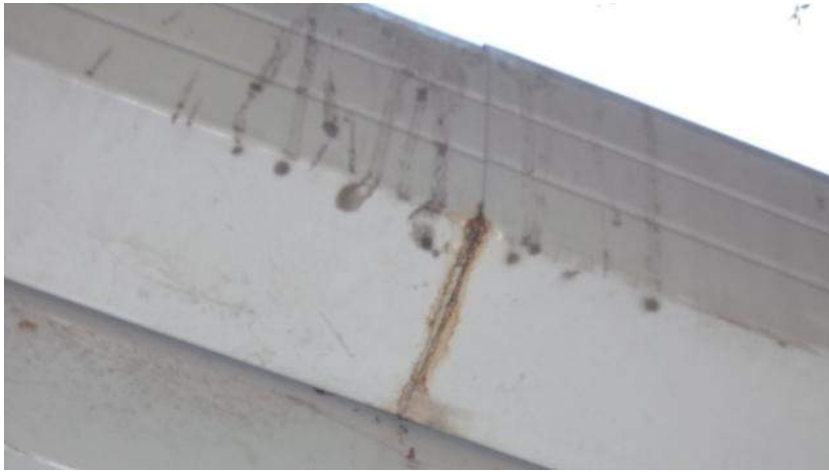
**Photo 39**

Signs of leakage noted at the face mounted gutter joints. Gutter joint re-sealing is recommended. (Check all)

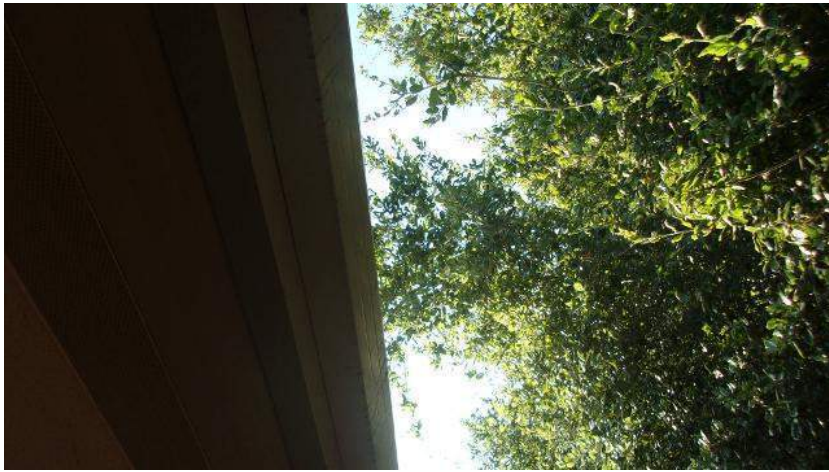
**Photo 42**

Debris noted in the face mounted gutters. Gutter cleaning is recommended.

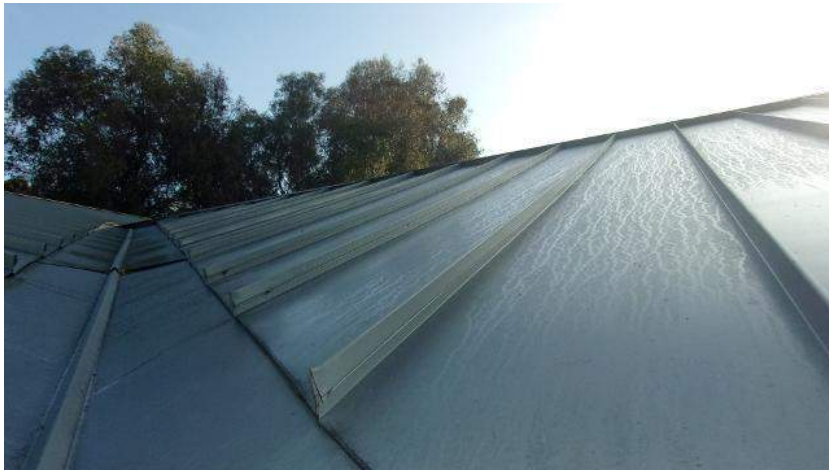
**Photo 54**

The metal roof panels at Building M were found to be in good condition.

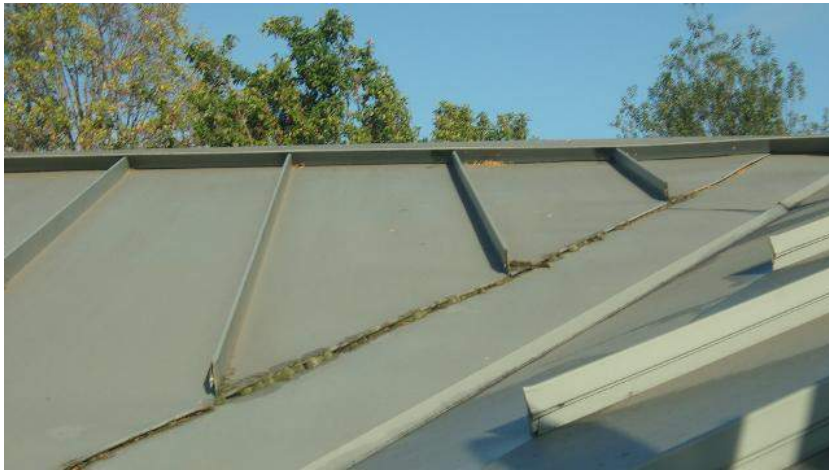
**Photo 55**

Moss growth noted at the roof valleys. Cleaning/treatment is recommended.
