## **Civil/Site Assessment & Recommendations**

### **Mountain View Los Altos High School District**

**Brelje & Race Consulting Engineers**

### **Campus Assessments**

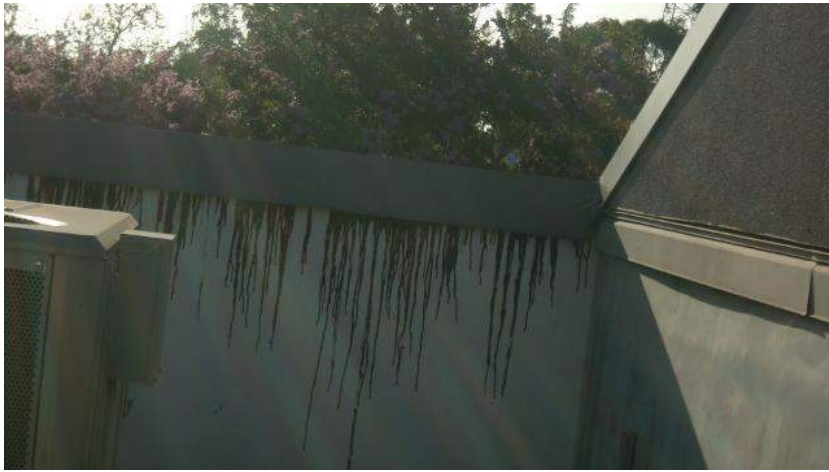
**Photo 73**

Mastic/adhesive is running down the parapet wall area. A compromised wall cap may be present under the wall cap. Corrections are recommended.

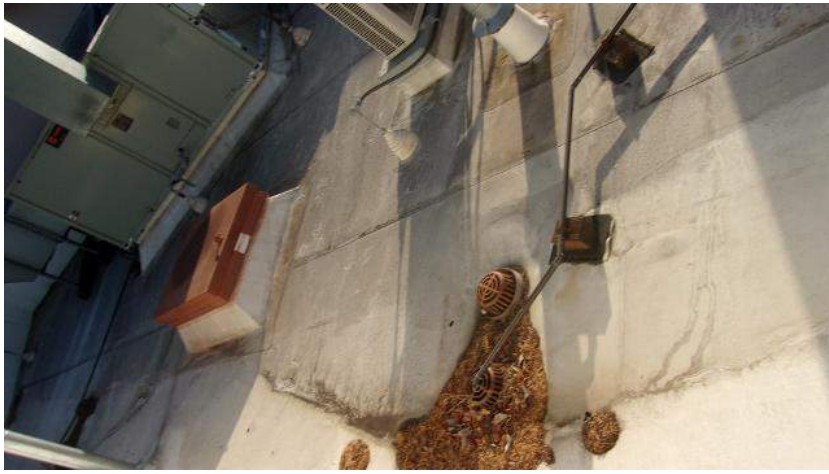
**Photo 75**

Recommend clearing tree debris from the flat roof/drain areas.

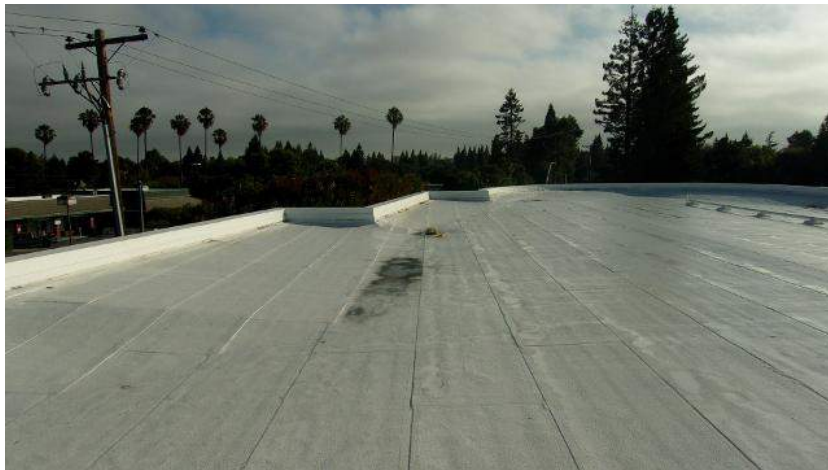
**Photo 2**

Overall, the roof area was found to be in good condition.

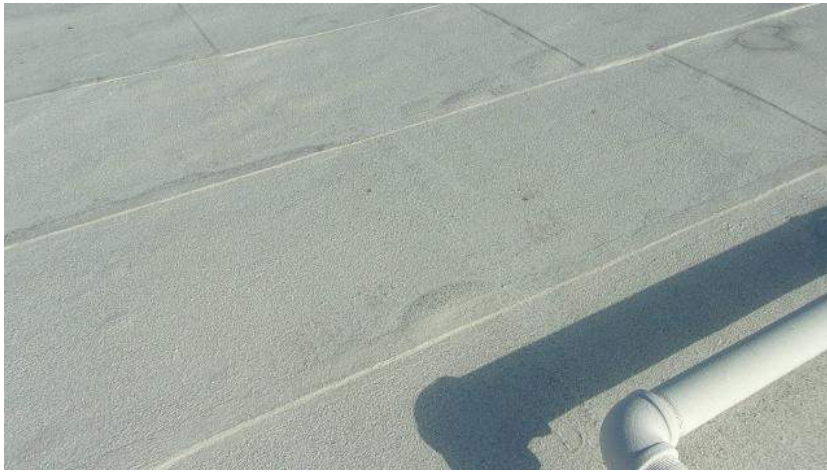
**Photo 3**

Small cap sheet blisters were noted. (Approx 10) Blister repairs are recommended.

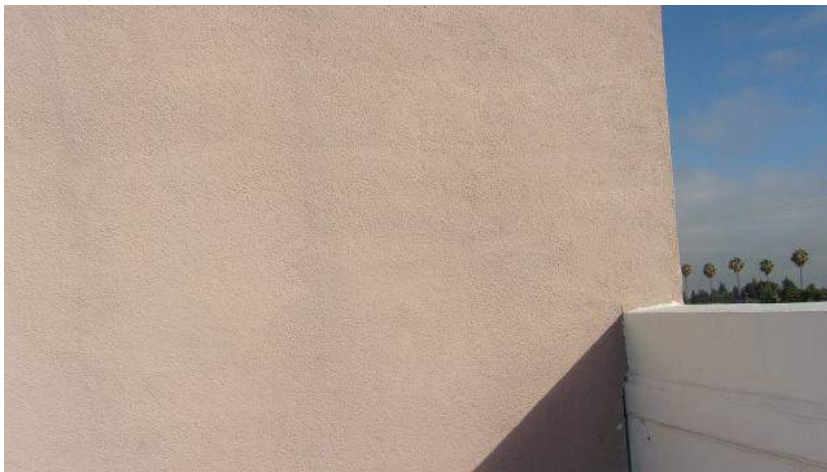
**Photo 5**

Small cracks noted at the upper stucco walls. Sealant/paint work is recommended.

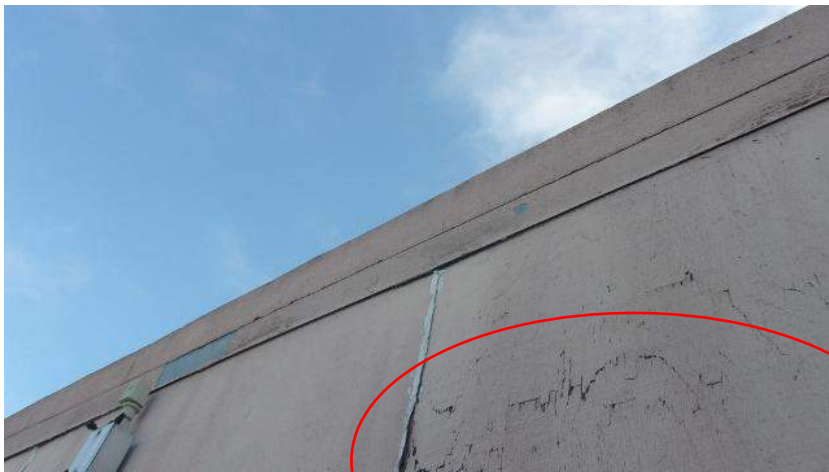
**Photo 8**

Plywood on the inside of the screenwall needs to be painted.

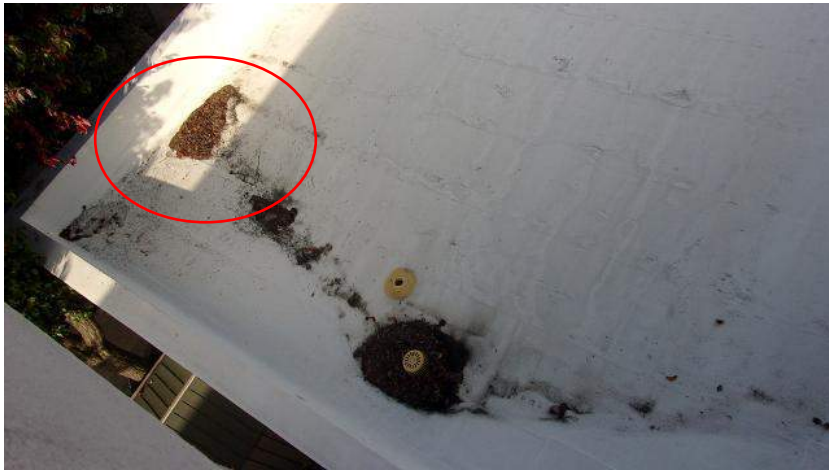
**Photo 10**

Recommend clearing tree debris from the roof/drain areas.

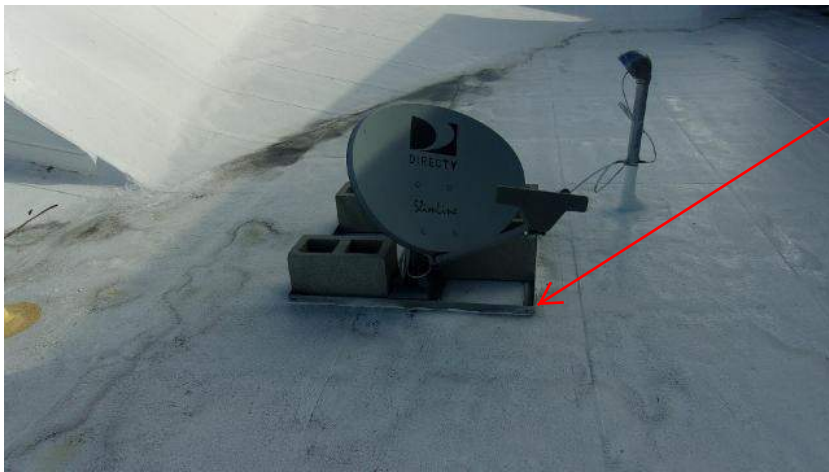
**Photo 11**

Recommend installing support pads under the satellite dish frame to help protect the roofing material.

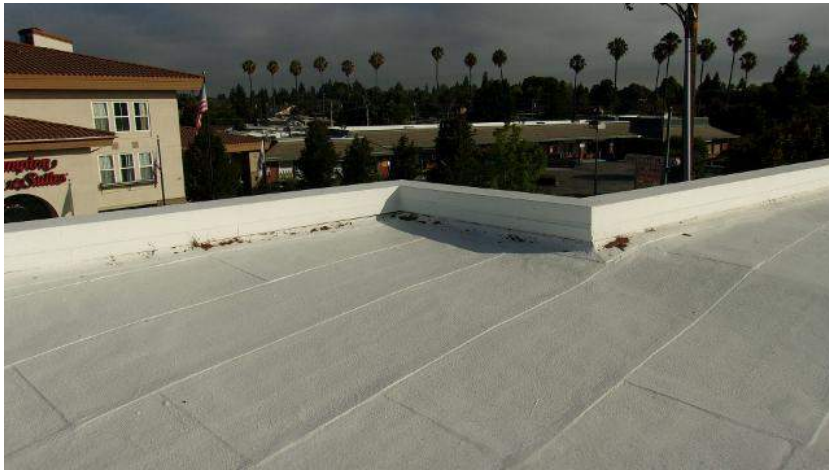
**Photo 12**

General roof area photos

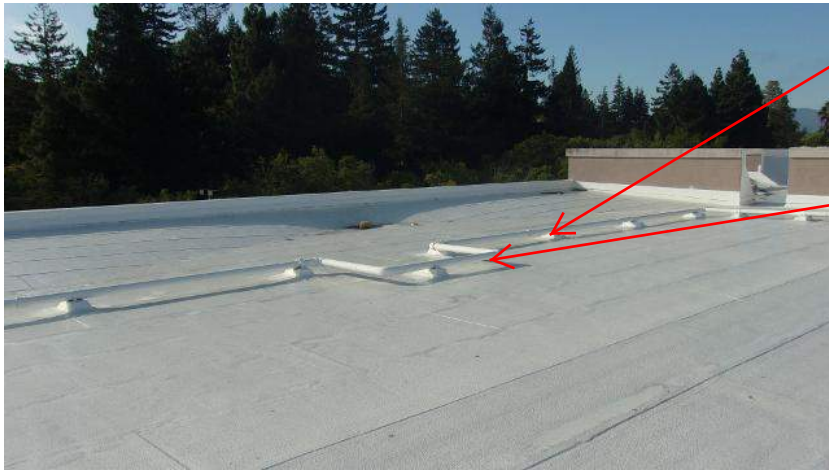
**Photo 14**

Some minor ponding on roof which should be corrected to get maximum longevity out of roof.

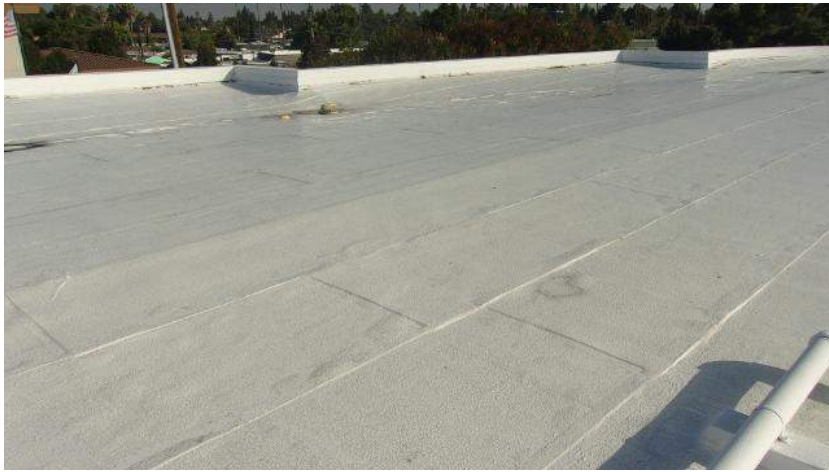
**Photo 15**

Gas line supports properly spaced.

Additional one needed at elbow in pipe.

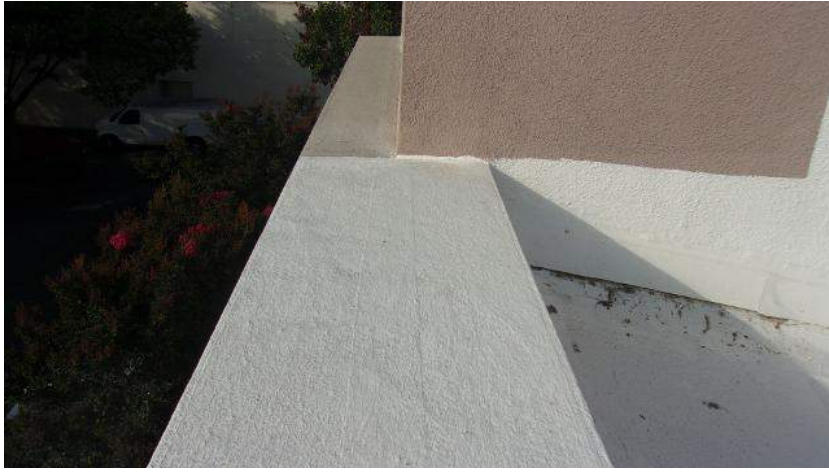
**Photo 20**

Wall coping appears in good condition.

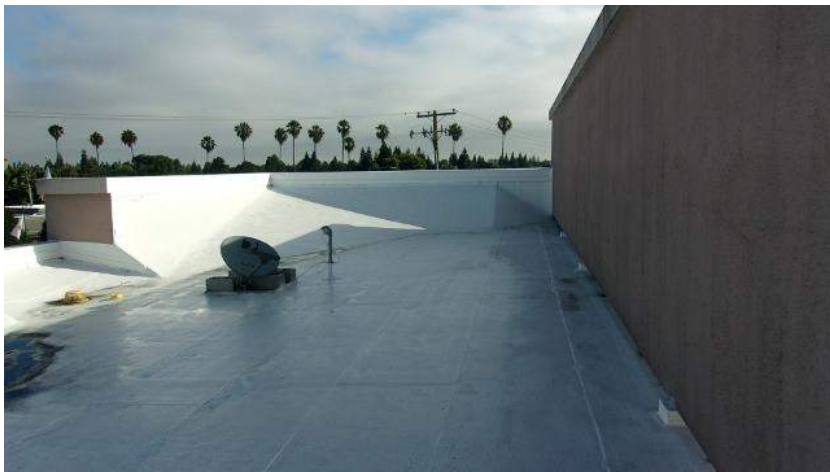
**Photo 25**

Some cracks in the stucco wall.

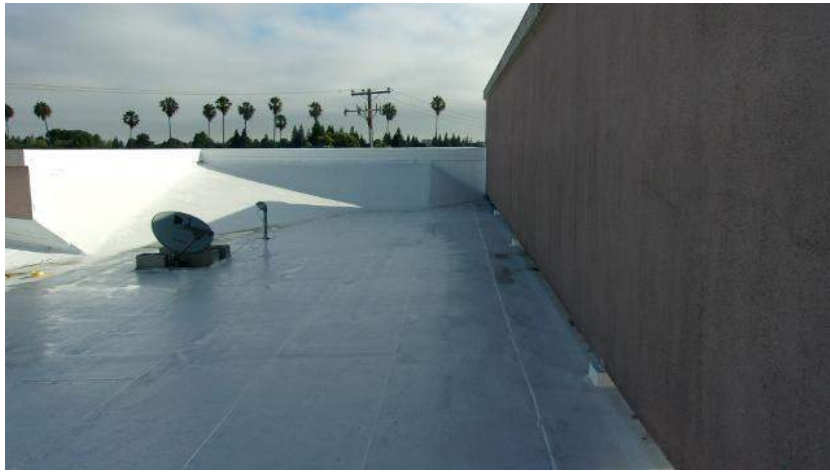
**Photo 27**

Some cracks in stucco screen wall.

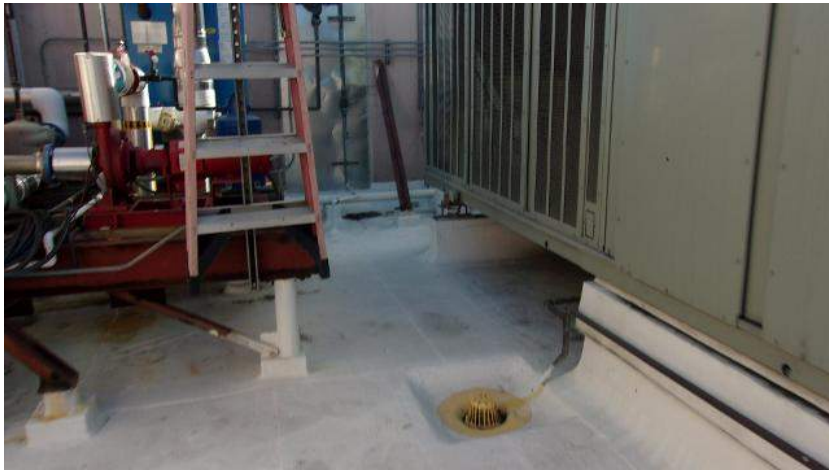
**Photo 33**

Steel wall supports showing rust. Wire brush and coat with rust inhibitive paint.

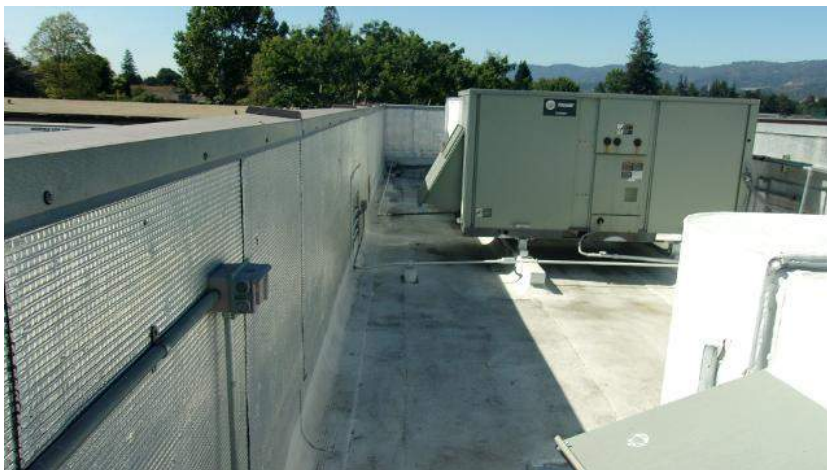
**Photo 2**

Overall, the BUR was found to be in good condition.

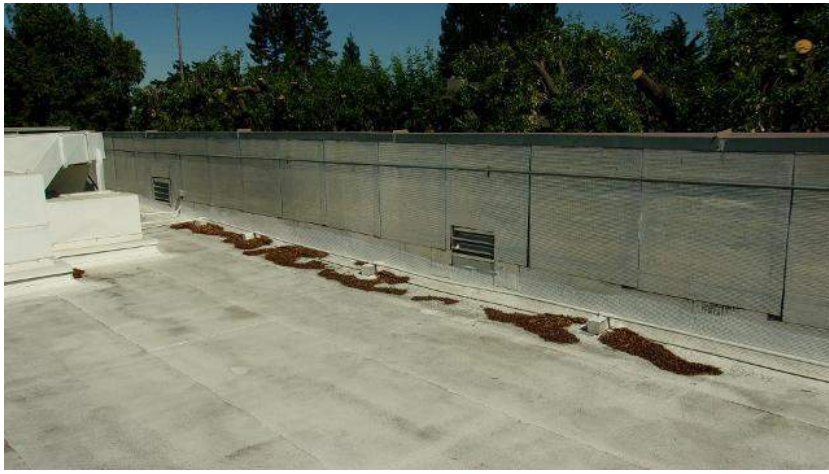
**Photo 3**

Tree debris noted at the roof area. Regular roof cleaning is recommended.

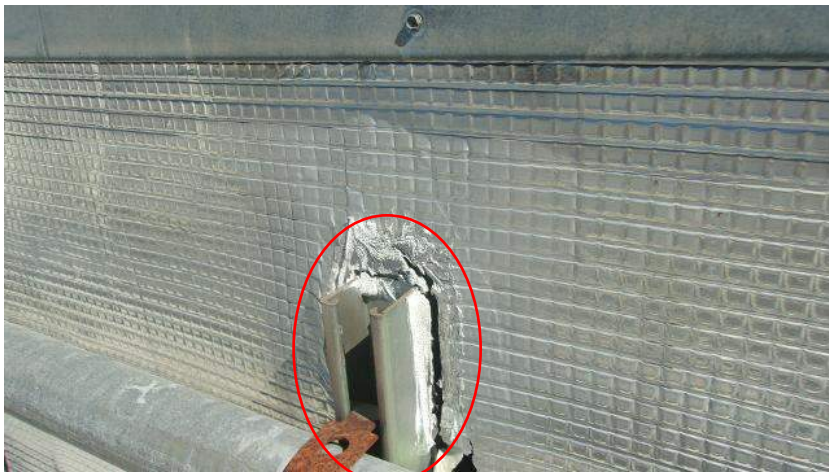
**Photo 5**

Sealant voids/weathering noted at wall mounted uni-strut brackets. Check all and seal as needed.

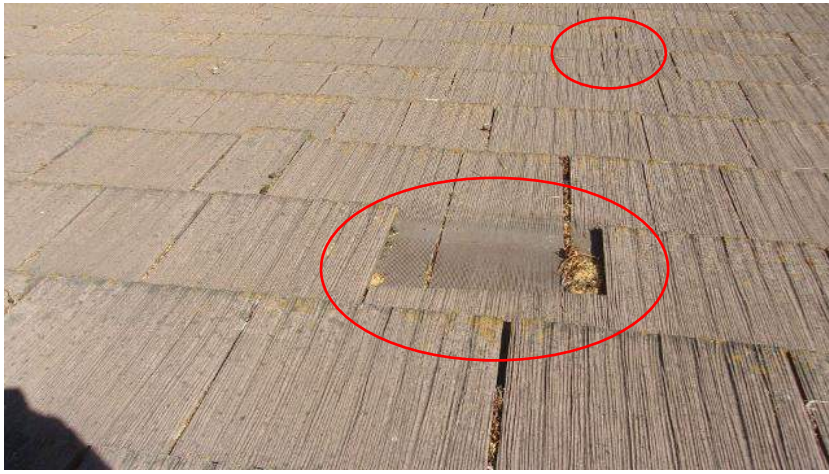
**Photo 6**

Damaged roof shingles are present.  
Corrections are recommended.

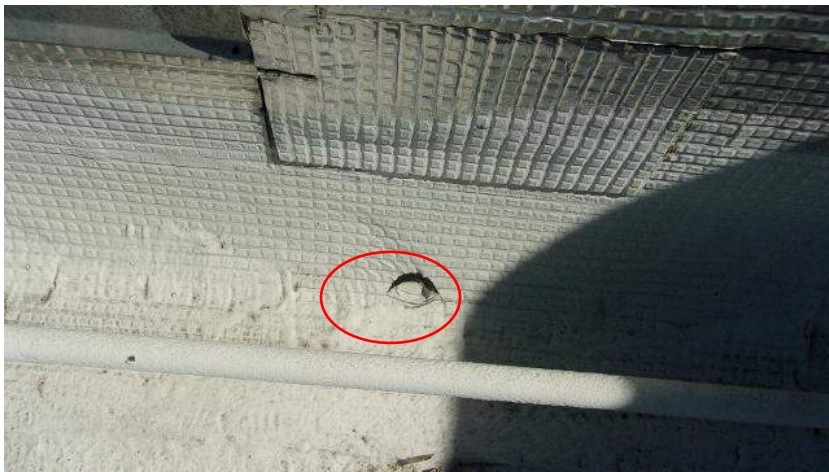
**Photo 8**

Minor damage noted at the wall/equipment  
flashing's. Check all and repair as needed.

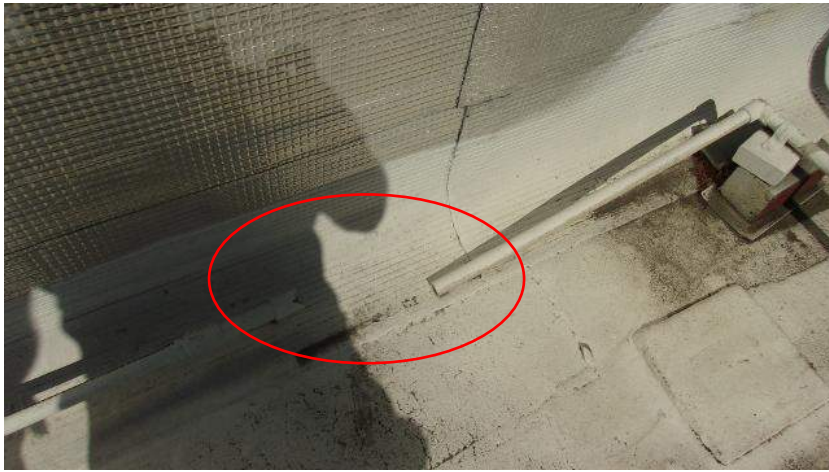
**Photo 10**

Disconnected condensate drain pipe noted. Corrections are recommended.

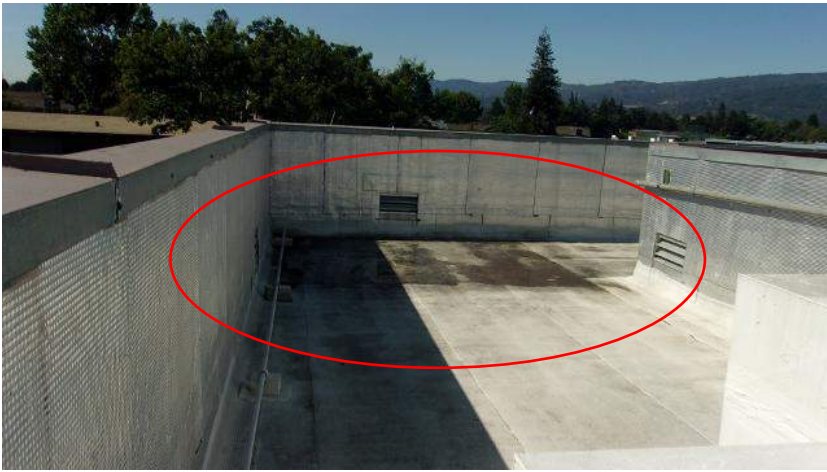
**Photo 16**

Some ponding water on roof.

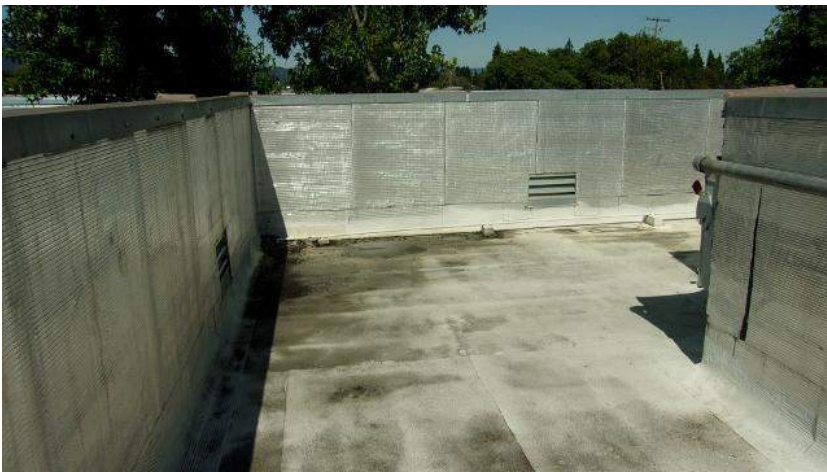
**Photo 20**

Ponding water at drains where debris builds up.

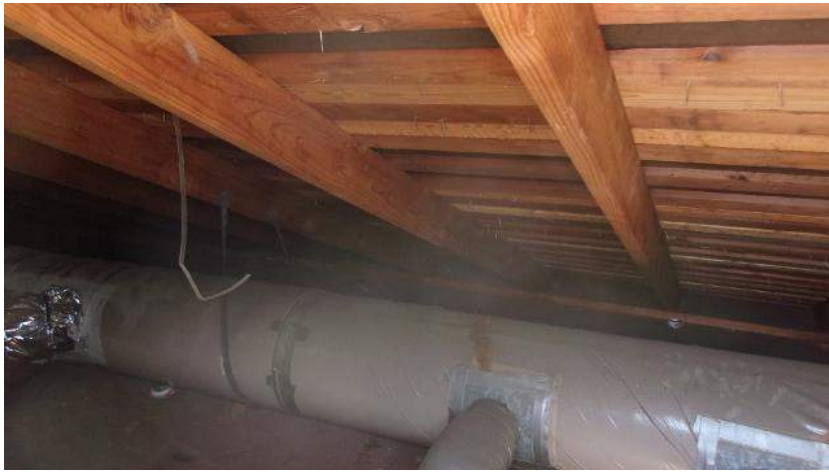
**Photo 30**

General attic area photos under synthetic shakes. Deck is skipped sheathing. Recommend going back with 1/2' plywood over entire deck.

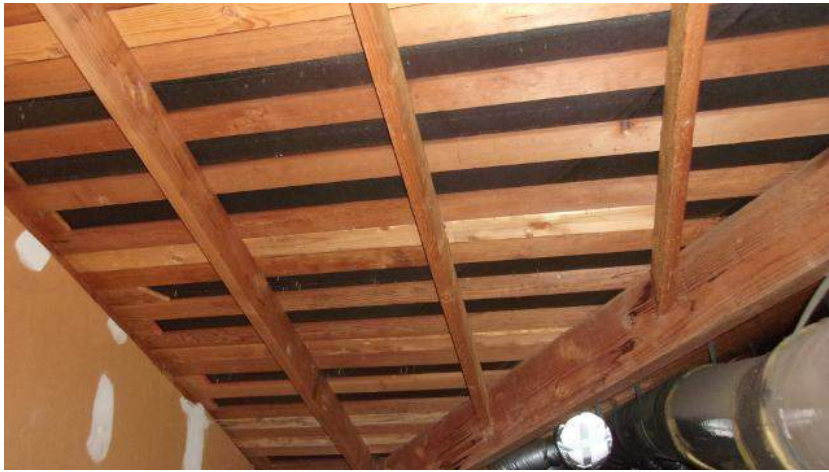
**Photo 31**

Rafter spacing at about 24" O.C.

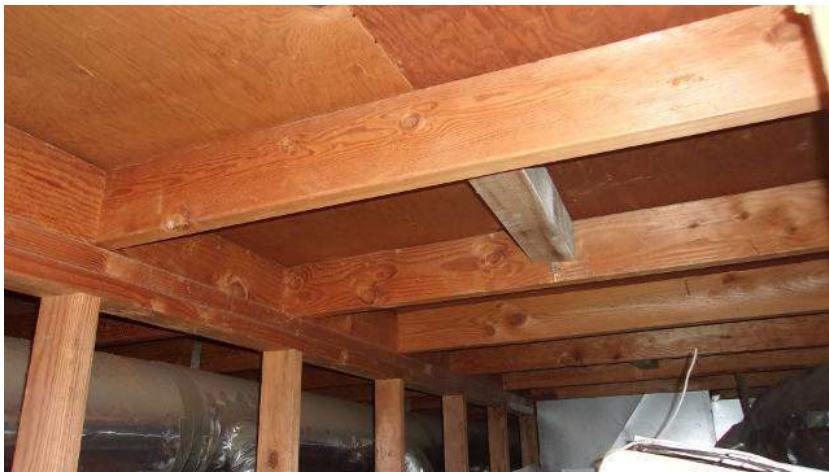
**Photo 32**

Deck below modified bitumen roof. Joists at about 24" O.C.

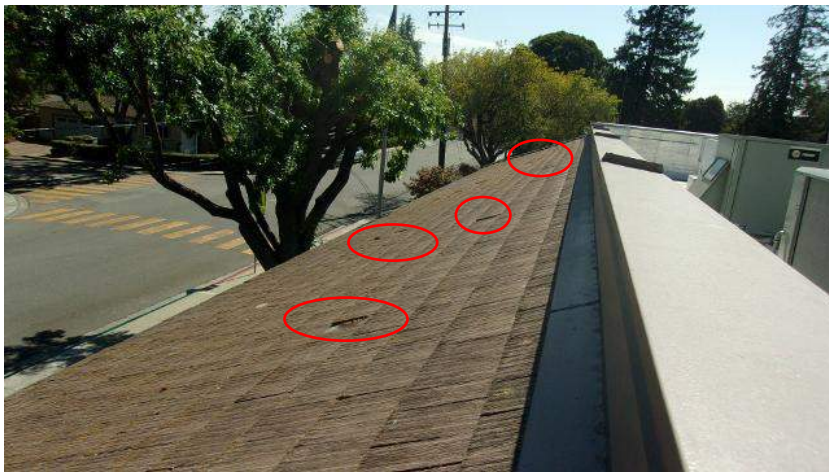
**Photo 35**

Shakes are starting to fail. Most of these products have been litigated out of the roofing market due to premature failure.
