MVLA

v1.0
DRAFT
September 2016

FACILITIES ASSESSMENT

Mountain View Los Altos Union High School District

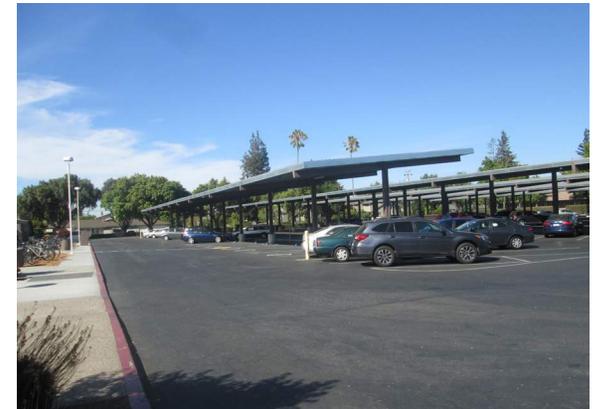
Student Parking

5. Remove and replace existing ramp with code compliant ramp near Student Parking lot.
 6. Student Parking: provide ADA loading area with ramps, domes and signage to comply with ADA requirements. Restripe angled parking to provide loading areas per ADA

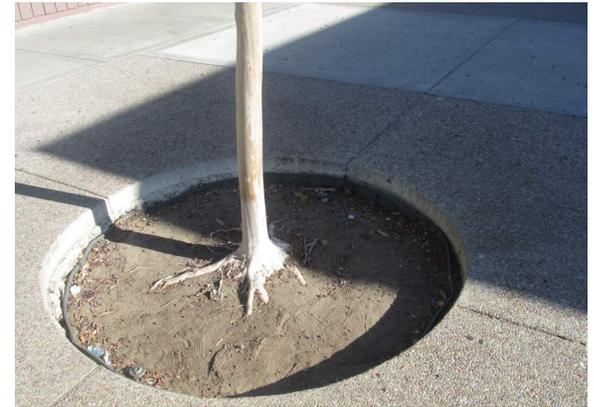
Potential trip hazards found throughout campus

2. Where surfaces exceed 1/2" vertical rise along the path of travel, it is recommended to grind asphalt or concrete edges where possible. For larger areas, it is recommended to remove and replace concrete with code compliance accessible walkways.

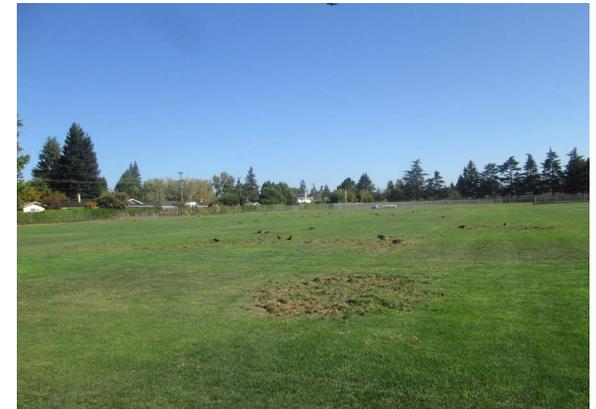
Field area with numerous divots

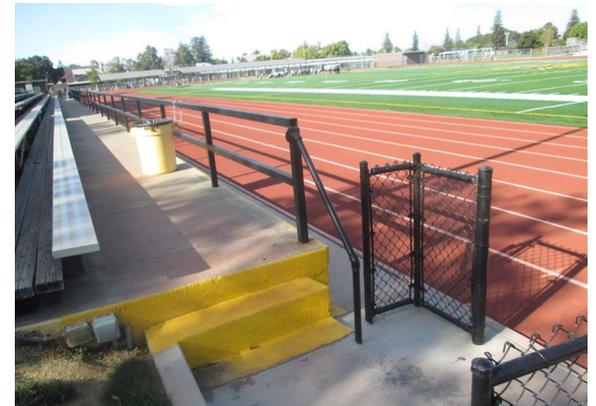
Non-compliant guardrail at front of bleacher walkway. No ADA seating areas provided.

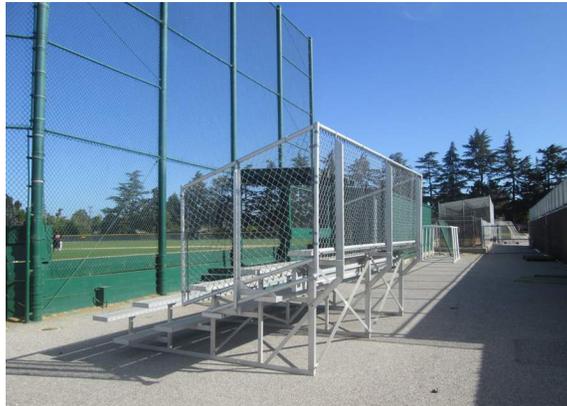
Portable bleachers do not provide ADA seating

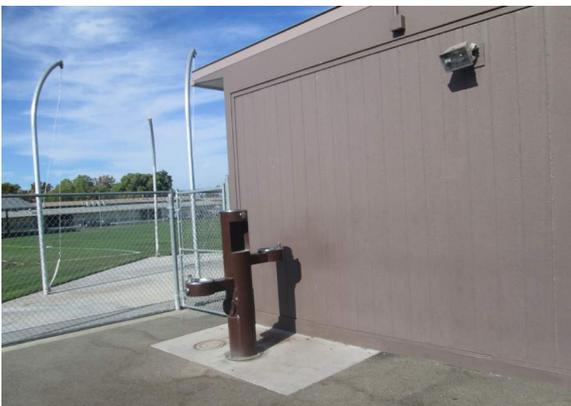
Non-compliant accessible drinking fountain

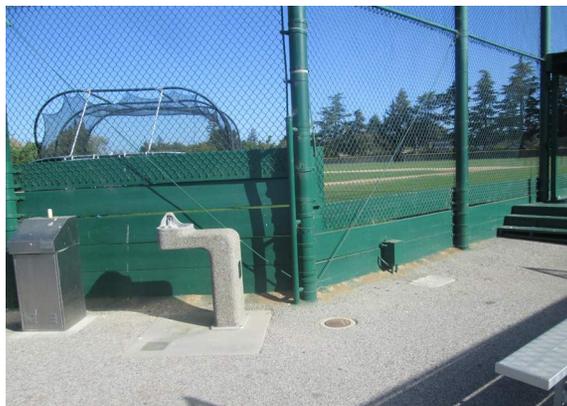
Non-compliant accessible drinking fountain

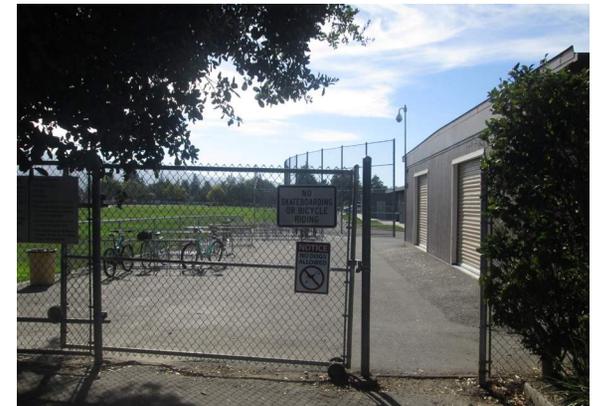
Non-accessible path of travel due to surface change

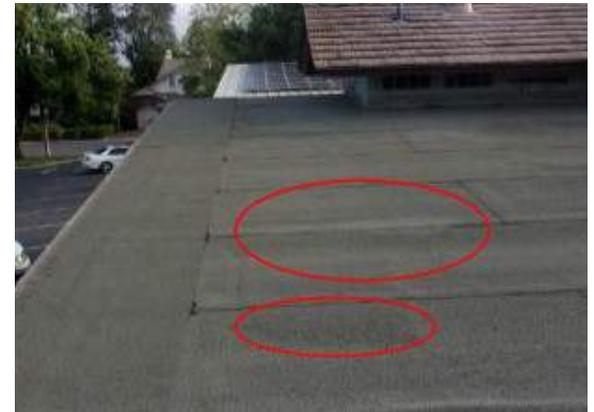
Blistering roofing cap sheet

- Roof maintenance/restoration program is recommended to repair cap sheet blistering, weathered flashing, granular erosion, cracked solder joints at metal cap curbs, and sealing at storm collar vent pipe roof penetration(s).
- Anchor all freestanding storage cabinets and shelving units. Remove and relocate unsecured items at top of tall cabinets. See Appendix A- Earthquake Safety.

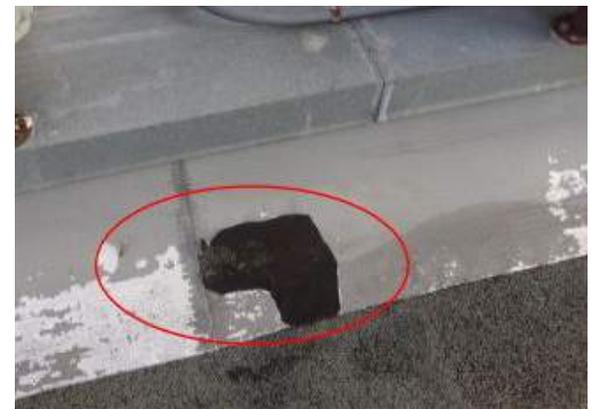
Weathered flashing at roof

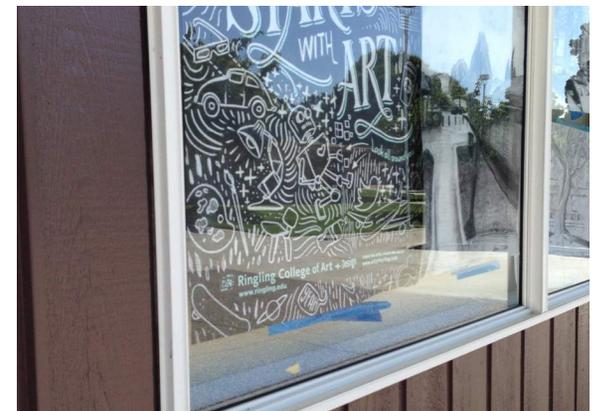
- Doors: hollow metal doors are in good condition for the age of construction.
- Windows: single-pane aluminum windows appear to be in fair condition. Windows appeared operable with no signs of leaks at the time of evaluation.

Single-pane windows

- For increased energy efficiency and acoustical mitigation, it is recommended to replace the single pane windows with thermally broken, Low-E dual glazing.

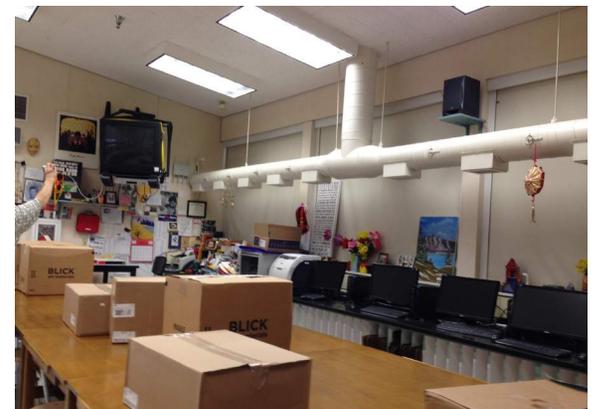
Low hanging ductwork

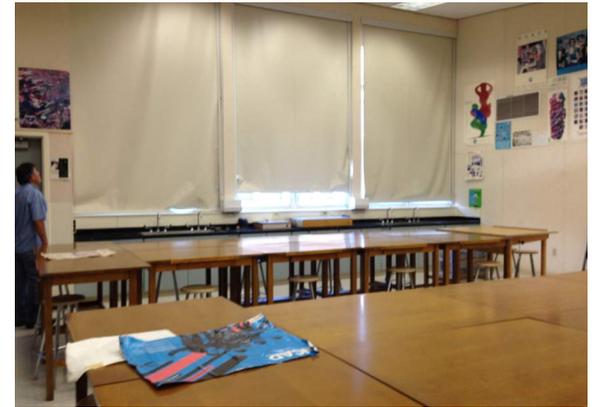
- Window Coverings: vinyl roller shades are worn. Chain operator appears to be broken and overall operation is obstructed by the paper towel dispenser mounted at the window wall. These type of blinds provide limited control of glare and natural daylighting.

Solid vinyl window shade

- Roof maintenance/restoration program is recommended to repair areas of granular erosion, unflushed penetrations, damaged flashing, unsealed exposed fasteners, and removal of debris.
- For classroom daylighting and glare control, it is recommended to replace the existing solid vinyl shades with visually-transparent rolling shades (Mechoshade) and room-darkening shades, if needed.
- Raise and insulate the HVAC ductwork for energy efficiency and increased safety.
- Replace Restroom signage with CBC chapter 11B compliant signs.

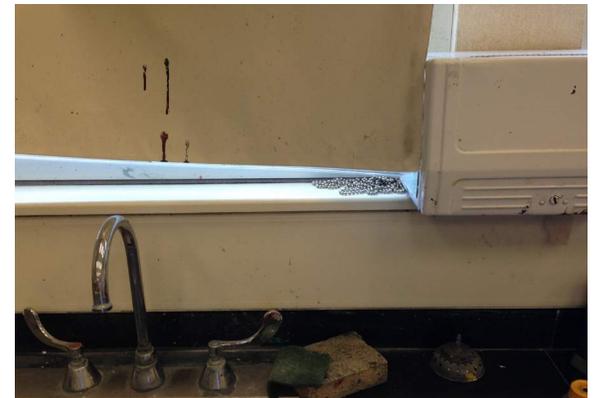
Paper towel dispenser inhibits proper mounting and operation of window shade. Damaged pull chain

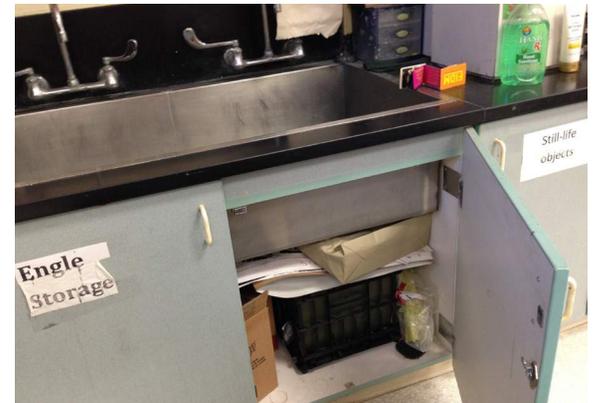
Cabinet base (non-removable) and sink depth do not allow for ADA access

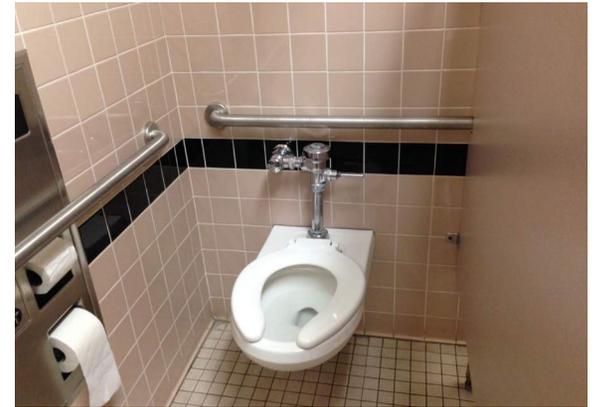
Dated finishes. Improper installation of grab bar/ toilet partition

- Future construction at this building will require Accessibility compliance upgrades to Restrooms.
- Update the aging Restroom finishes.
- Future construction at this building will require Accessibility compliance upgrades to Restroom entry landings. Remove and replace concrete at door landing to provide 2% max slope in any direction.

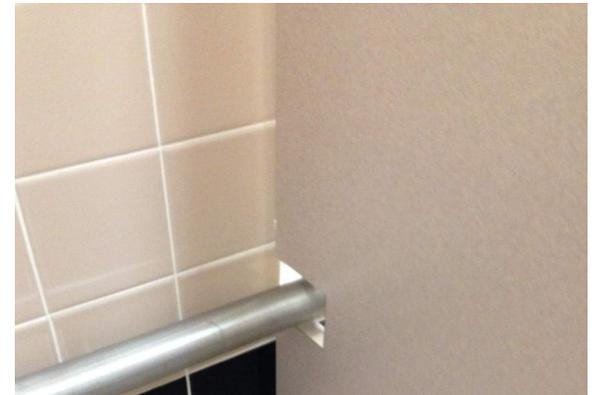
Grab bar continues through toilet partition

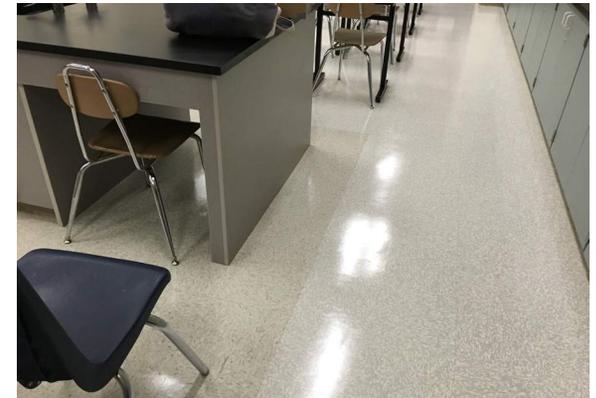
Flooring mismatch

- For increased energy efficiency and acoustical mitigation, it is recommended to replace the single pane windows with thermally broken, Low-E dual glazing.
- Replace stained/damaged and mis-matched flooring.
- Clean and paint interior classroom walls where staining has occurred.
- For classroom daylighting and glare control, it is recommended to replace the existing solid vinyl blinds with visually-transparent rolling shades (Mechoshade) and room-darkening shades, if needed.
- Future construction at this building will require Accessibility compliance upgrades as follows:
 1. Classrooms 120, 123 and 125- remove and replace concrete at door landing to provide 2% max slope in any direction.
 2. Remove existing Teacher Stations to meet ADA clearance/accessibility standards.
- Replacement of the HVAC rooftop packaged units will likely need to occur within the next 1-4 years.

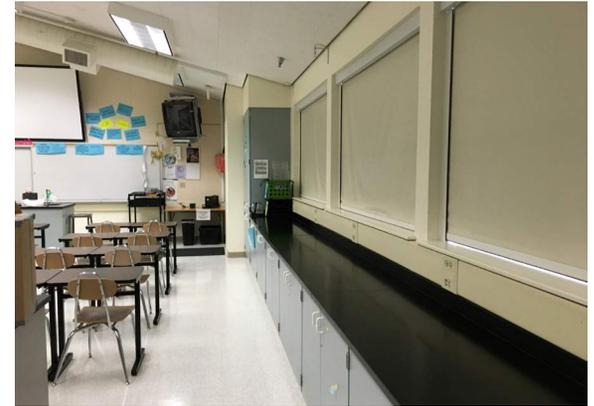
Solid vinyl rolling blinds

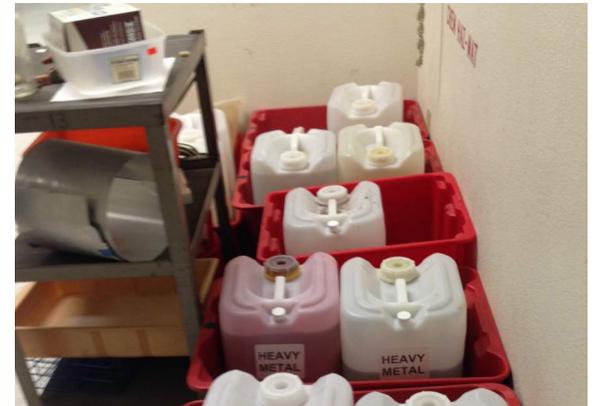
Chemicals were improperly stored in open bins and in fume hoods at the time of evaluation. Emergency Eye Wash Stations and Shower stations should be located within 50 feet or 10 seconds walking distance from all lab science workstations. No drain was provided at existing shower station.

Improper chemical storage

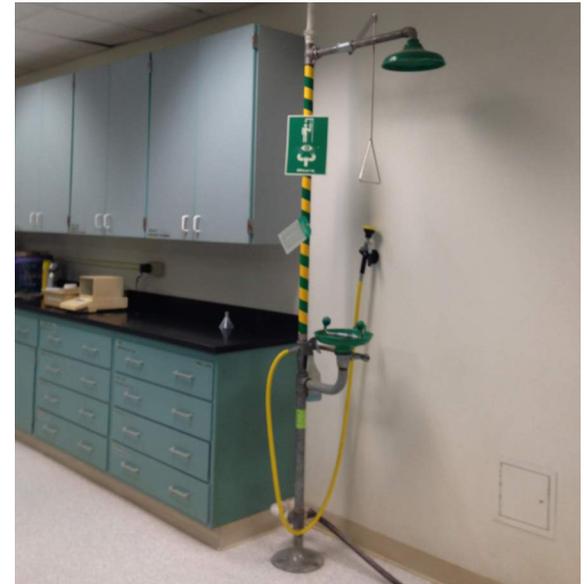
Emergency shower

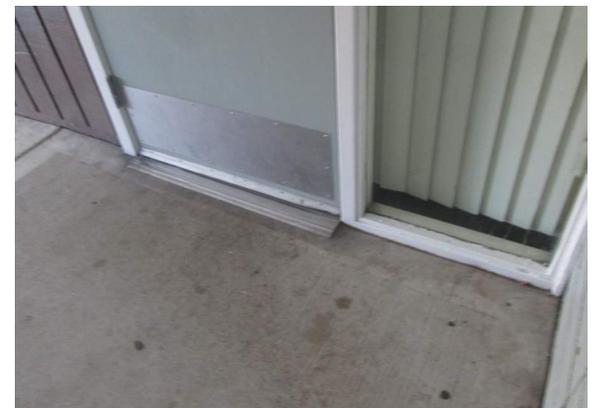
- Pedestrian Access: building entrances are located on the exterior facade with direct access to exterior walkways. Classrooms have non-compliant door thresholds (greater than 1/2" vertical) and landing with slopes greater than 2%. Refer to Civil/Site Assessment & Recommendations Report Appendix C for specific site deficiencies adjacent to this building.
- Classroom and Restroom signage is provided in accordance with CBC chapter 11B requirements.

Typical threshold

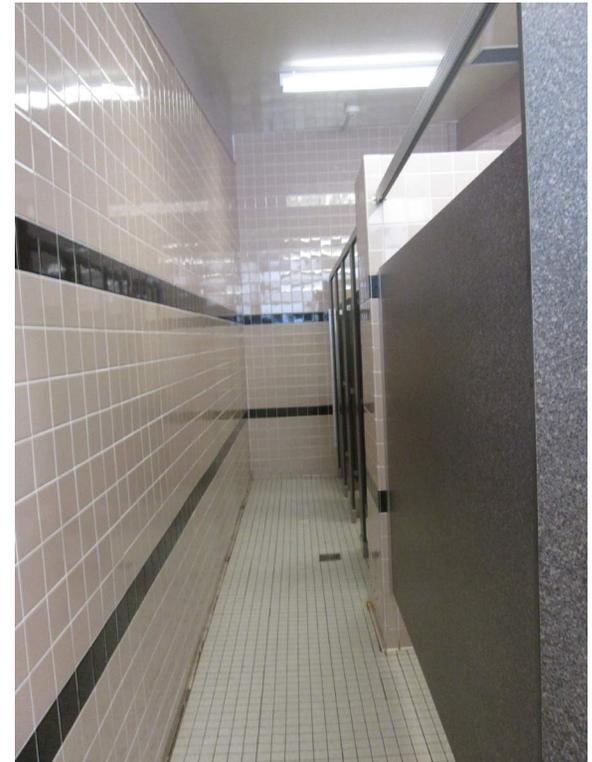
Typical Restroom finishes

- Update the aging Restroom finishes.
- Increase built-in casework to meet storage needs.
- Future construction at this building will require the removal of existing classroom sinks and cabinet base to meet ADA clearance/accessibility standards.

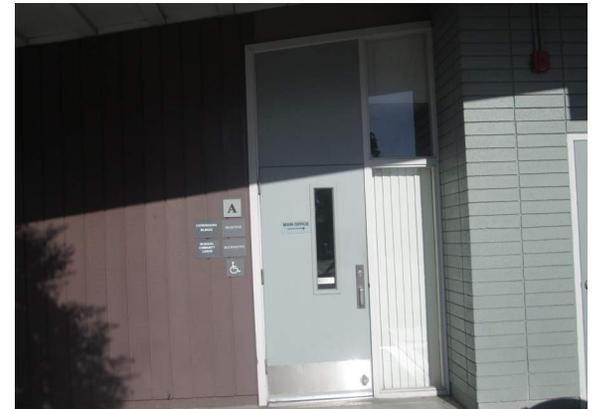
- Pedestrian Access: building entrances are located on the exterior facade with direct access to exterior walkways. Rooms A & B have non-compliant door thresholds (greater than ½" vertical). Door landing at Activities Office exceeds 2% slope. Refer to Civil/Site Assessment & Recommendations Report Appendix C for specific site deficiencies adjacent to this building.
- Most of the signage is in accordance with CBC chapter 11B requirements. Several signs are missing the Braille requirement.

Office signage/wayfinding challenges

- Roof maintenance/restoration program is recommended to repair siding deterioration found where roof meets the sidewall, curb flashing deterioration, cracked expansion joints, worn sealant at penetrations, damaged shingles, tree debris and moss removal.
- Anchor all freestanding storage cabinets and shelving units. Remove and relocate unsecured items at top of tall cabinets. See Appendix A- Earthquake Safety.
- Provide ADA compliant signage where Braille has not been included.

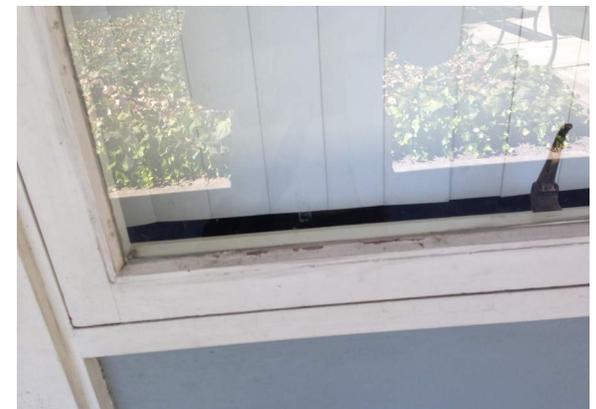
- Doors: hollow metal doors are in good condition for the age of construction.
- Windows: windows are original single-pane wood windows. Windows appeared operable with no signs of leaks at the time of evaluation.

Original single-pane wood windows

- For increased energy efficiency and acoustical mitigation, it is recommended to replace single-pane wood windows with thermally broken, Low-E dual glazing.

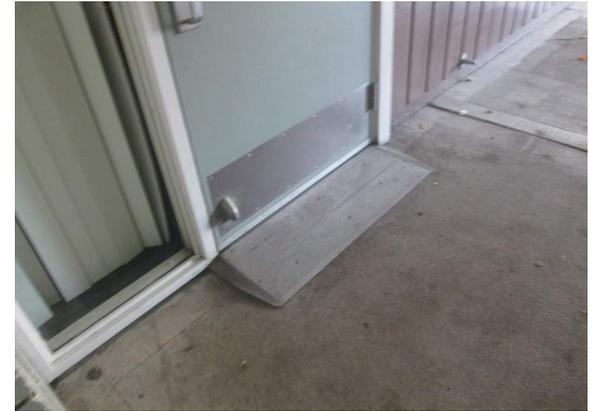
- Pavers around trees, adjacent to walkways create a potential tripping hazard.
- Metal threshold/entry ramps installed under previous DSA applications will need to be confirmed with DSA in any future work.

Threshold/entry ramp

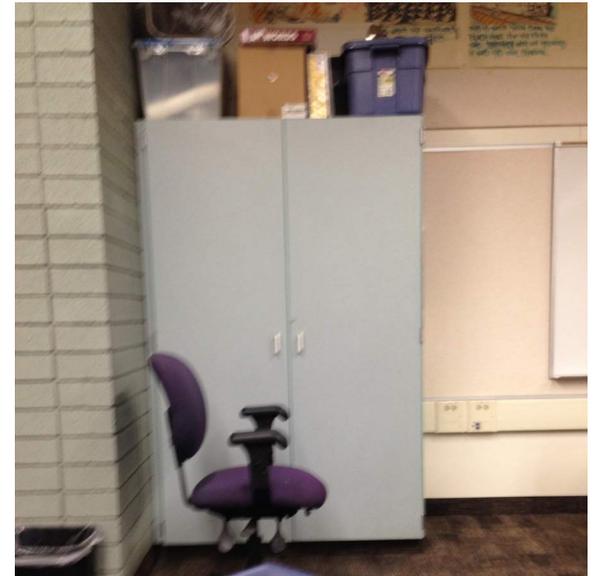
- Finishes: floor is in fair condition with areas that may require patching/replacement. Carpet squares in classrooms are in good condition. The wall and ceiling finishes appear to be in good condition.
- Interior doors: classroom doors are hollow metal in good condition for the age of construction.
- Cabinetry and Furnishings: built-in cabinetry is limited. Freestanding cabinets/shelves are being used instead and are not properly anchored to the walls.
- Window Coverings: vertical blinds are operational with minor damage. These type of blinds provide limited control of glare and natural daylighting.
- Specialty Equipment: stackable washer/dryer at Life Skills Classroom does not meet ADA height requirements. They also create a potential safety hazard when not secured to the wall.

Freestanding cabinets in classrooms

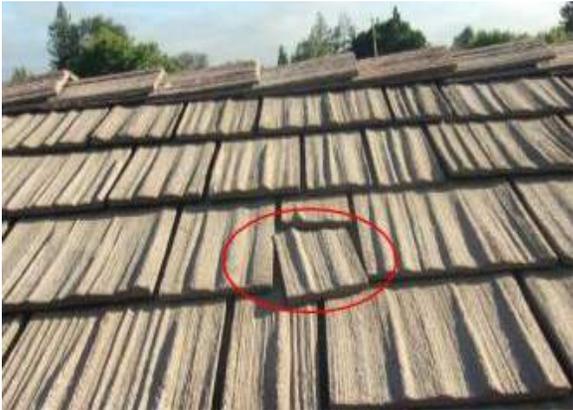
- Roof: roof is in fair condition. Minor siding deterioration found where roof meets the sidewall. Noted minor curb flashing deterioration, cracked expansion joints, worn sealant at penetrations, damaged and missing shingles, tree debris and moss growth at gravel roof. Refer to Roof Inspection Report Appendix D.

Damaged/missing roof shingles

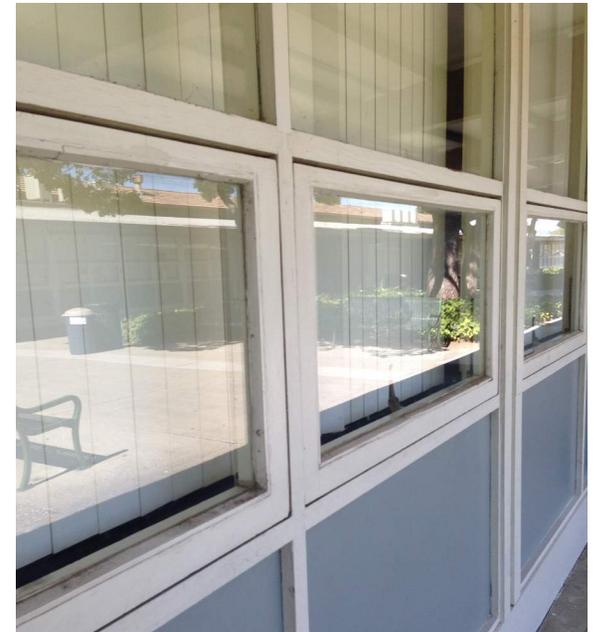
Original single pane wood windows

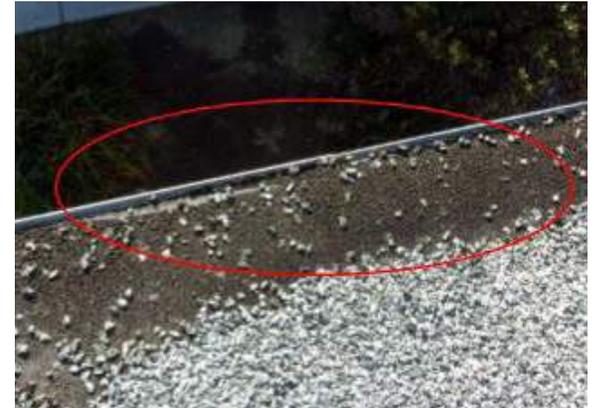
Exposed roofing piles

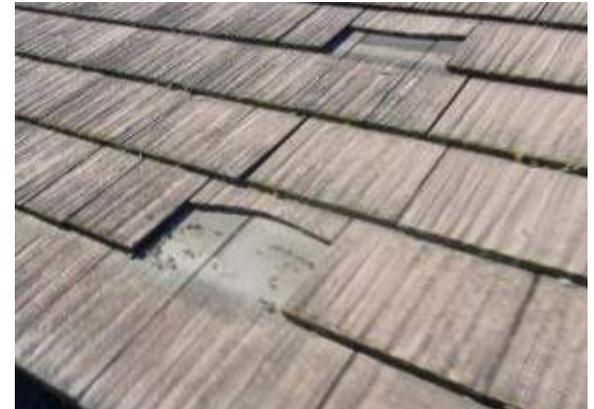
Damaged/missing shingle

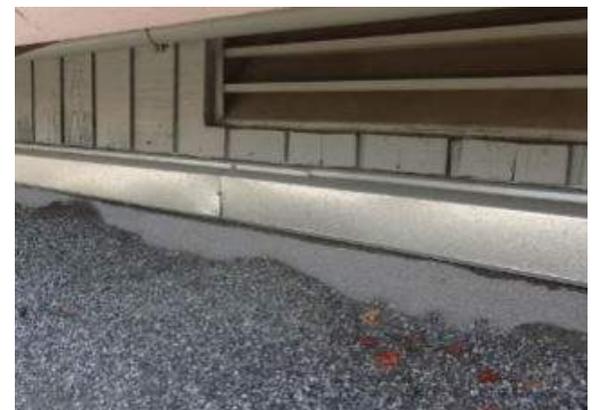
Damaged siding at upper roof sidewall

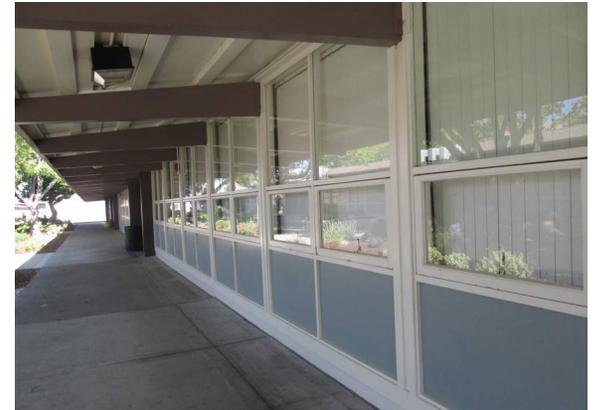
Original single-pane wood windows

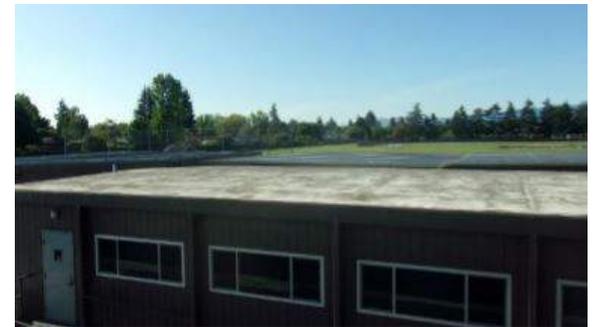
Roof condition

- Roof replacement.
- Anchor all freestanding storage cabinets and shelving units. Remove and relocate unsecured items at top of tall cabinets. See Appendix A- Earthquake Safety.

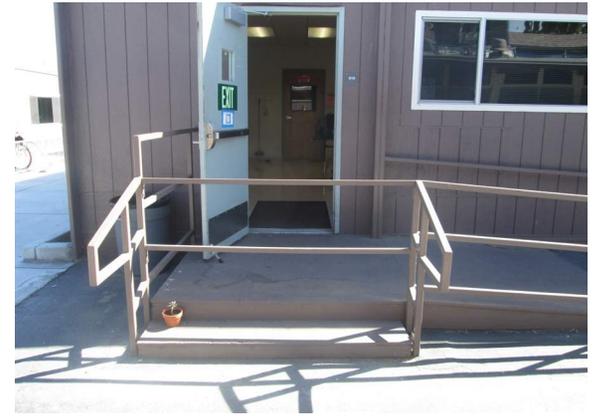
- Pedestrian Access: building entrances are located on the exterior facade with direct access to exterior walkways. Some rooms are accessed by ramps that are not in compliance with ADA requirements for path of travel and contain irregular railing configurations.
- Noted metal grate at Restroom doorway running in the same direction as the path of travel. Refer to Civil/Site Assessment & Recommendations Report Appendix C for specific site deficiencies adjacent to this building.
- Signage is in accordance with CBC chapter 11B requirements.
- Limited replacement of cabinets may be required for ADA compliance as classroom sink did not appear to be accessible due to a non-removable base. Lack of knee and toe clearance prevents access to the soap dispenser mounted behind the sink.

Egress ramp and railing

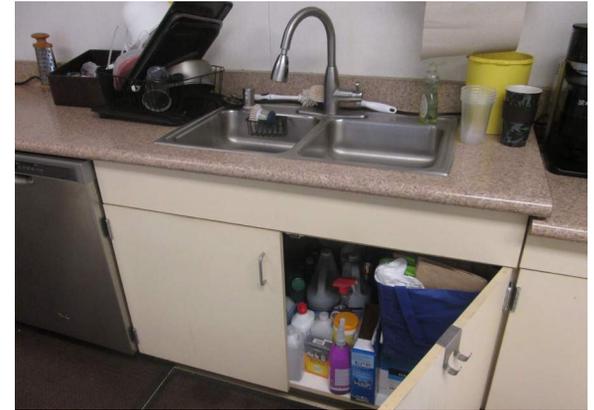
Non-compliant ADA cabinet base

- Future construction at these buildings will require the removal of existing classroom sinks and cabinet base to meet ADA clearance/accessibility standards.

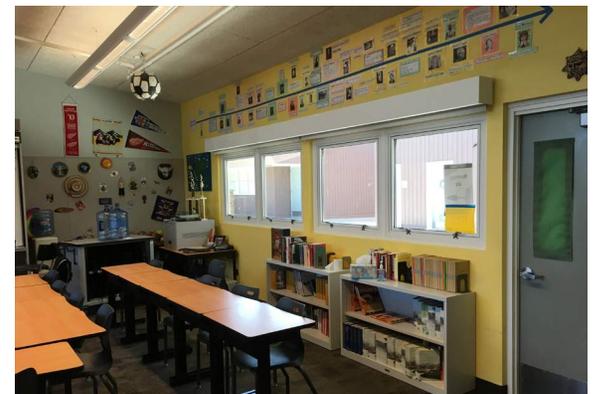
Freestanding shelves are unanchored

- Anchor all freestanding storage cabinets and shelving units. Remove and relocate unsecured items at top of any tall cabinets. See Appendix A- Earthquake Safety.
- Recommend regular roof system maintenance.

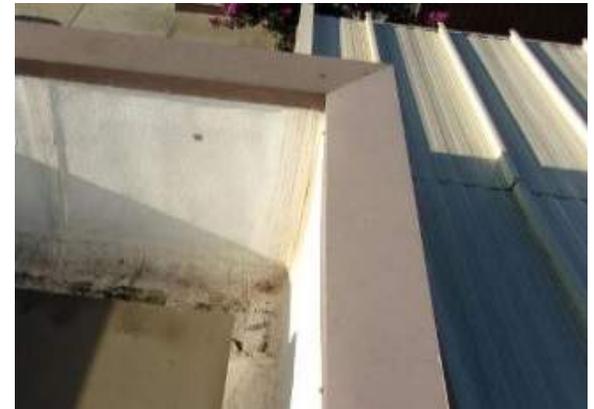
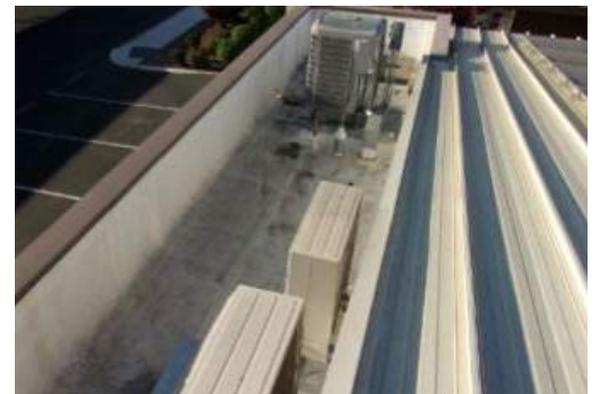
- Roof: built-up and standing seam metal roofs are in very good condition. Refer to Roof Inspection Report Appendix D.
- Exterior Cladding: building is comprised of fiber cement panels, split-face CMU veneer, and cement plaster. All materials are in very good condition.
- Doors: doors are in very good condition.
- Windows: windows are in very good condition.

Built-up and standing seam metal roofs

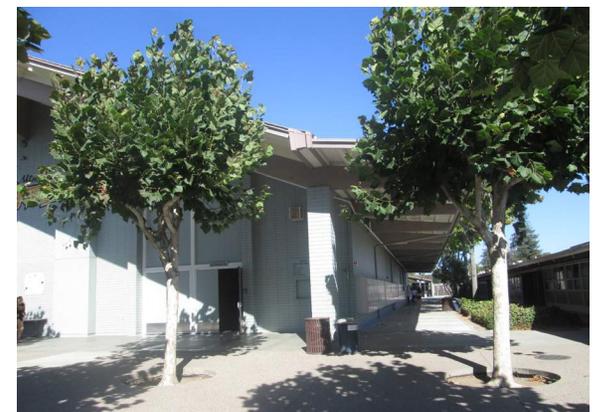
- Roof: shingle roof is in poor condition. The roof assembly is uninsulated without plywood over the plank decking. There are several damaged shingles, missing shingles and granular erosion (at covered walkway). Refer to Roof Inspection Report Appendix D.
- Exterior Cladding: building is comprised of painted oversized brick, exposed steel frames, steel beam soffits and concrete columns. The exterior appears to be well-maintained and is in fair condition for its age.
- Doors: hollow metal doors are in fair condition for the age of construction. Due to the heavy-use environment associated with a gym facility, the doors are showing typical signs of wear and tear.
- Windows: there are no windows.
- Lockers: the exterior lockers are in fair condition, but some doors are missing. ADA compliant lockers were not provided.

Covered walkway

- Roof maintenance/restoration program is recommended to repair damaged shingles, missing shingles and granular erosion (at covered walkway).
- Remove and relocate the trophy case to avoid potential safety hazard. If it needs to remain, properly anchor the trophy case. See Appendix A- Earthquake Safety.
- Replace signage with CBC chapter 11B compliant signs.
- Add wall crash padding behind the backstops at the small practice gym. . If there is less than 3 feet of unobstructed space outside any sideline or end line, a narrow, broken, 1-inch line should be marked on the court parallel with and 3 feet inside each sideline and/or end line.

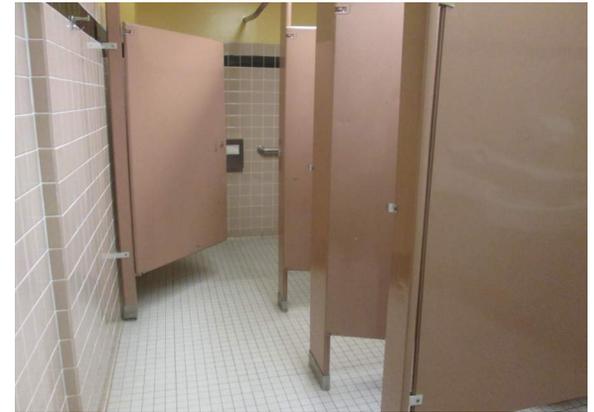
The Restrooms are well-maintained with finishes in fair to good condition for their age. There are minor discrepancies with ADA installation dimensions and clearances; although the building was reviewed and approved by DSA, these would have to be corrected during future construction phases.

Restrooms at Gym

- Replace the roof and add new plywood decking and insulation for increased energy efficiency.
- Evaluate the gym wood flooring for future replacement.
- Future construction at this building will require Accessibility compliance upgrades to Restrooms.

- Update the aging Restroom finishes.
- Due to the age of the HVAC gas fired heating units and the inefficiency of the gravity roof vents, replacement should be considered within the next 2-4years. Air distribution could be improved by adding exposed ductwork and a return air system. Units should be replaced with higher efficiency equipment. If cooling is desired, then the addition of cooling coils and condensing units would also be needed.

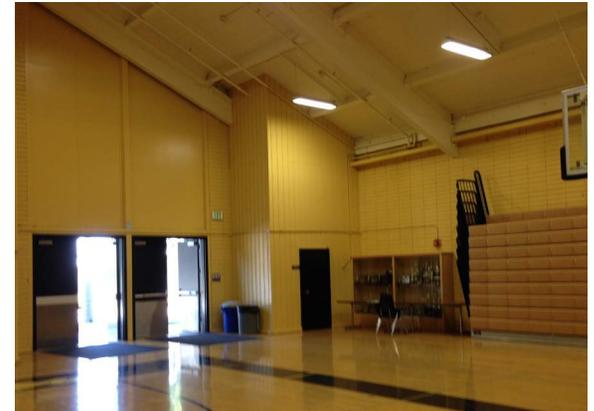
Trophy case located near Gym playing surface

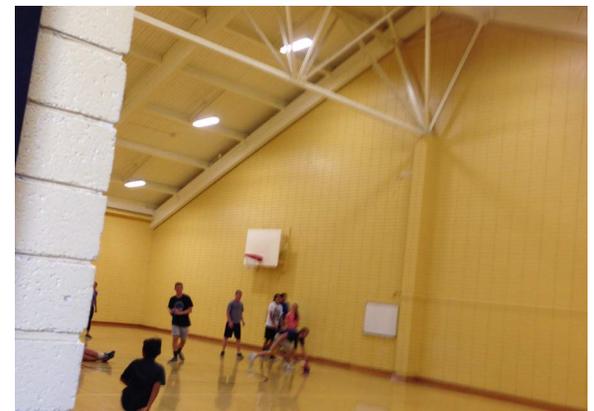
The small practice gym facility has limited clearances between the court perimeter boundaries and the wall surfaces. For safety reasons it is recommended to have a minimum of 3 feet around the perimeter, but 10 feet is ideal.

Wall crash padding appears to be sufficient at the Main Gym's East and West ends. At the smaller practice gym, wall crash padding is not provided. Walls are located behind the backstops with very little clearance around the court, creating a potentially dangerous condition.

Small practice Gym

- Install CO2 sensors for demand controlled ventilation.
- Evaluate the potential of increasing the size of the small practice gym facility to provide for safer clearances between the court boundaries and wall surfaces.

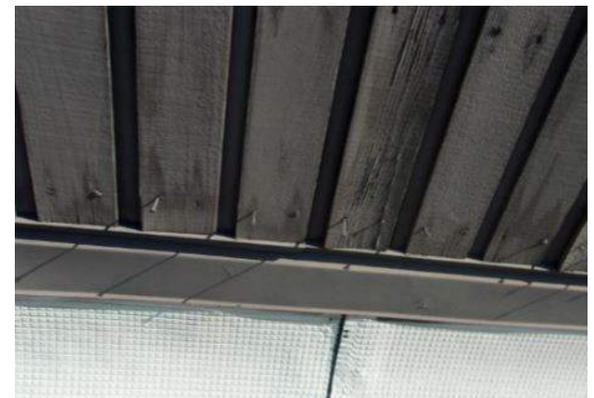
Loose fasteners at siding

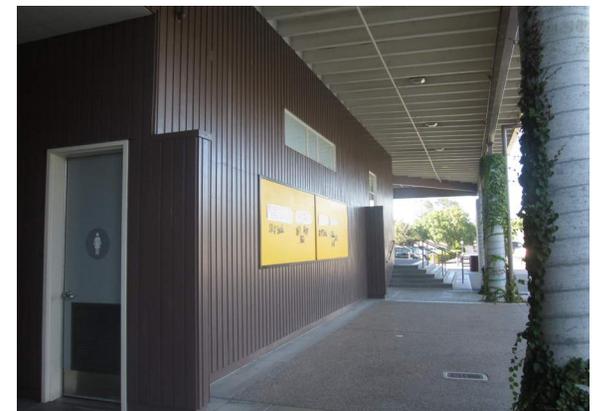
Building Exterior- vines at columns

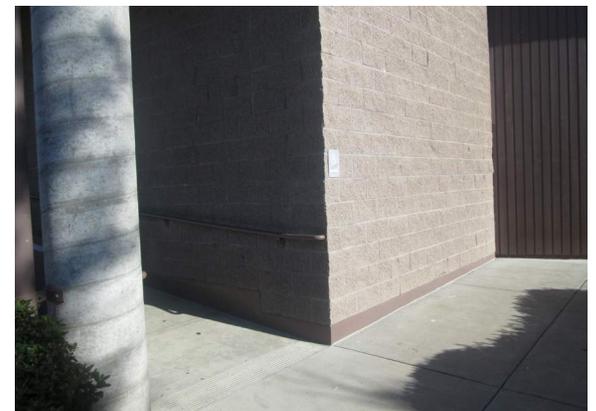
- Railings at exterior ramps do not continue beyond the slope of the ramp per current ADA standards.
- At the time of construction, the limited location for wheelchair seating was permissible, as was the dependence on back stage access for wheel chair access. Updated ADA requirements for dispersed seating and circulation pathways may be enforced in future upgrades.

Railing does not continue beyond sloped ramp

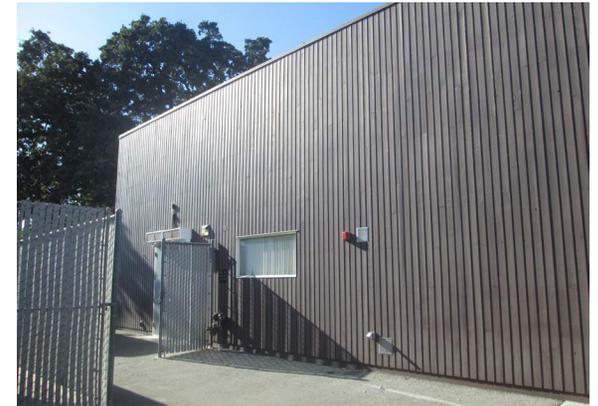
Loose fasteners at wood siding

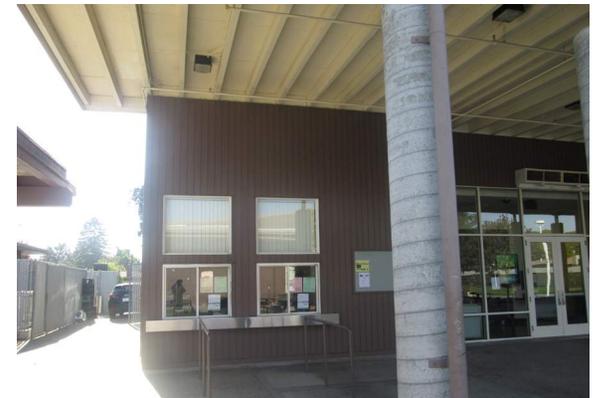
Accessible height ticket windows

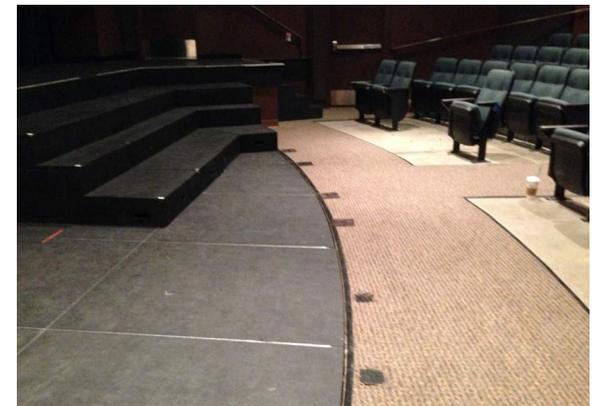
Accessible wheelchair seating

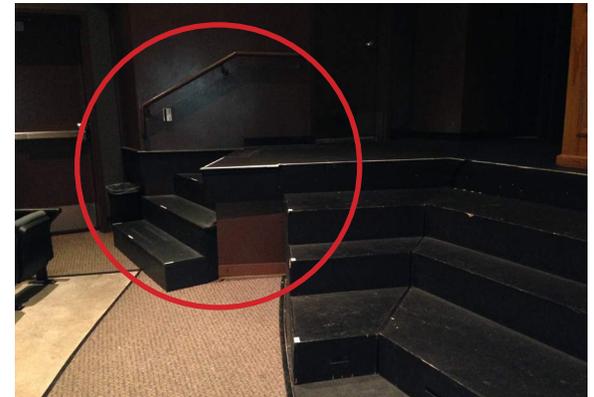
Non-compliant stair and railing at stage access

- Future construction at this building will require the relocation of the Dressing Room counter receptacle switches outside in Hallway per NEC 520.73.
- Future construction at this building will require Accessibility compliance for ramps leading to/from the Theater. It is recommended to remove and replace ramp to reduce the slope.

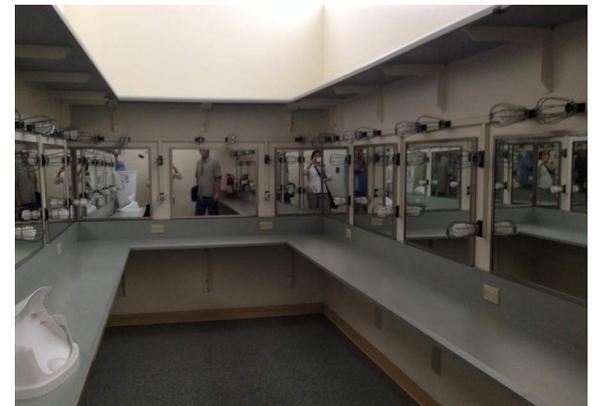
- During the site review of the Theater, it was noted that the code required dressing room counter receptacle switches, where installed inside the dressing rooms, in violation of NEC 520.73. This code section requires the pilot light switches to be installed outside the dressing room door, in the Hallway, in order to alert staff that receptacles at the counters / mirrors, may still be energized during or after a performance. Refer to Campus Summary for further electrical information.

Dressing room

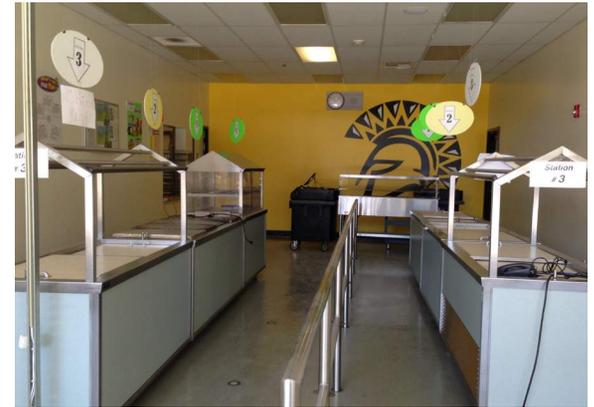
Food service line with limited circulation

- The existing Student Dining and Faculty Dining capacity is 173 persons. When the folding partition is in the closed position, the Student Dining capacity is 125 persons. If the student population grows, an additional space is recommended. Exterior dining areas can be developed with shade structures as well.
- Depending on the student population, the food service lines may want to be increased in size.
- Provide a dedicated kitchenette for Faculty Dining.
- Monitor the flooring at the Dining areas to see if the seams continue to deteriorate. Replace as needed.

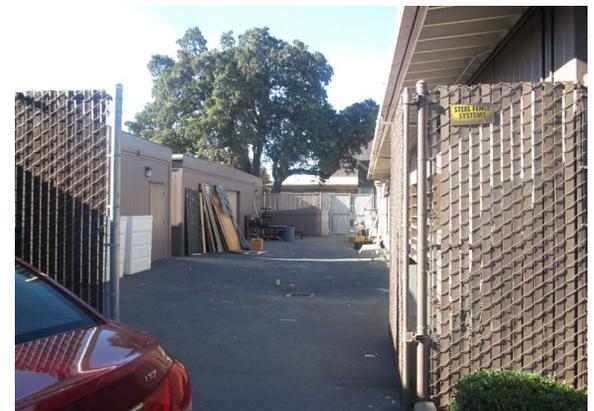
Yard with relocatable Storage Units

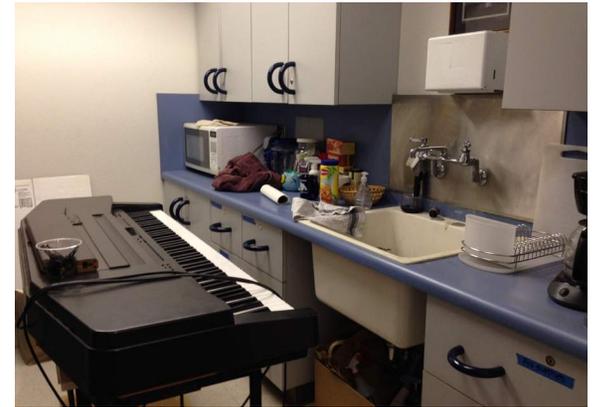
Kitchen area being used for instrument storage

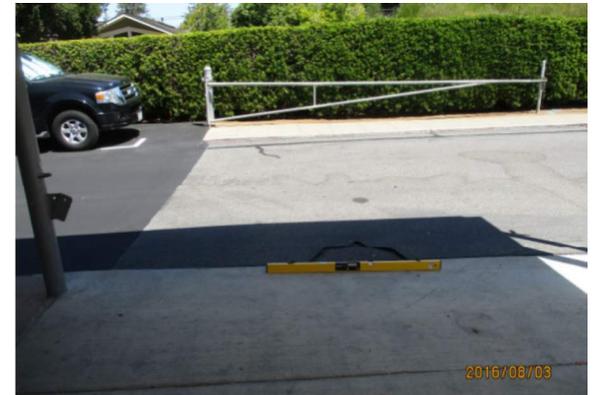
- Pedestrian paths of travel from the public right of way to the campus have cross slopes in excess of 2%.

Non-accessible path of travel

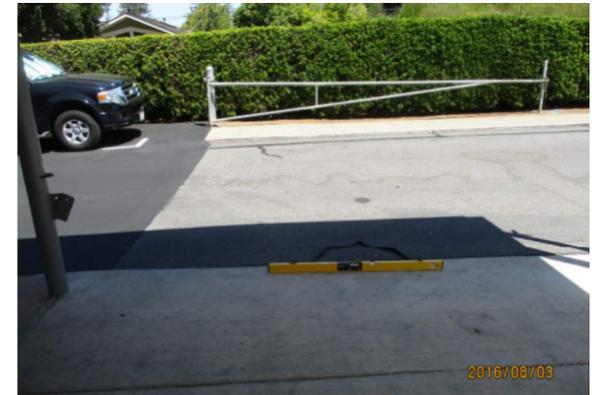
Non-accessible path of travel

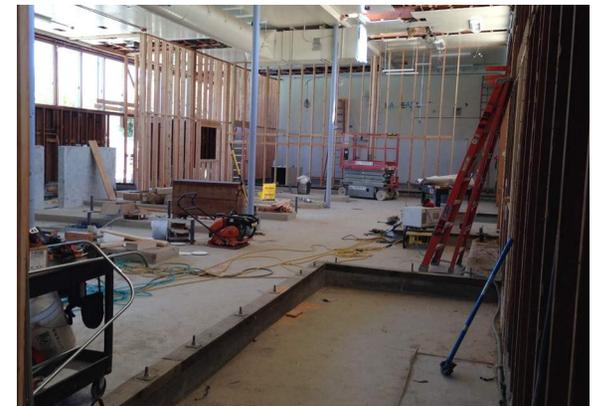
Locker rooms under construction

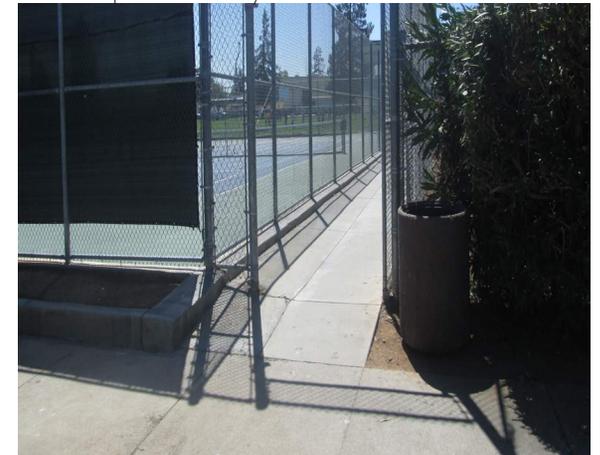
Excessive ramp slope

- Replace non-compliant ramp at tennis court.
- Provide new surfacing and striping at Basketball courts.
- Review the tennis programmatic needs to determine if 12 courts are required. Space may be used for future building locations, if needed.
- Excessive cross slope on path of travel between campus and tennis courts: remove and replace concrete walkway with code compliant accessible walkway.
- Recommend level entry gate walking surfaces to mitigate grade differences. Provide directional signage to accessible entries if required.

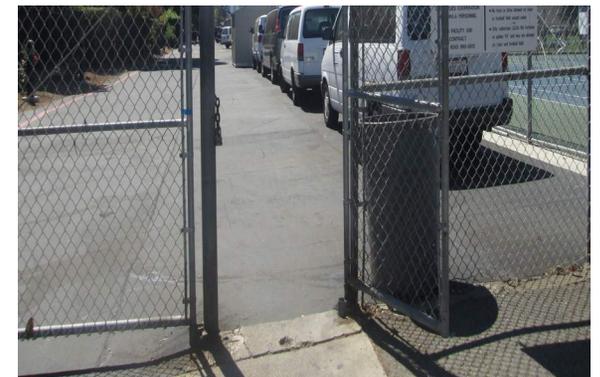
Non-accessible path of travel

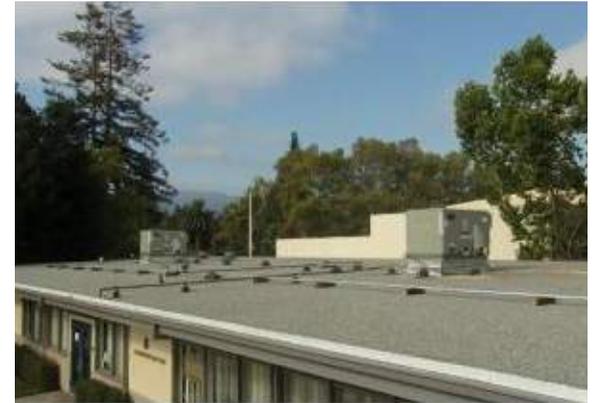
Admin Roof

- Roof: roof is in fair condition. There are roof areas, edges, and elements that need to be repaired.
- Exterior Cladding: building exterior is cement plaster and appears to be well-maintained and is in good condition for the age of building. At the time of evaluation, there was no evidence of moisture or insect intrusion.
- Doors: doors are in good condition for the age of construction.
- Windows: windows are the original wood single glazed awning windows and appear to be in fair condition for their age. Window operability varied, with no signs of leaks at the time of evaluation. Some window frames have minor deterioration.

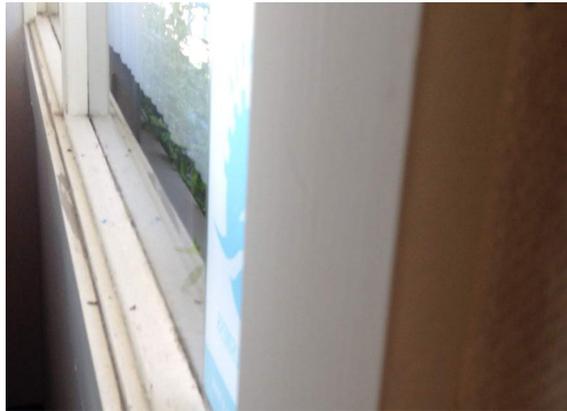
Single pane windows

- For increased energy efficiency and acoustical mitigation, it is recommended to replace the single pane windows with thermally broken, Low-E dual glazing.
- Future master planning should analyze the number and size of classrooms to ensure that program needs are met.

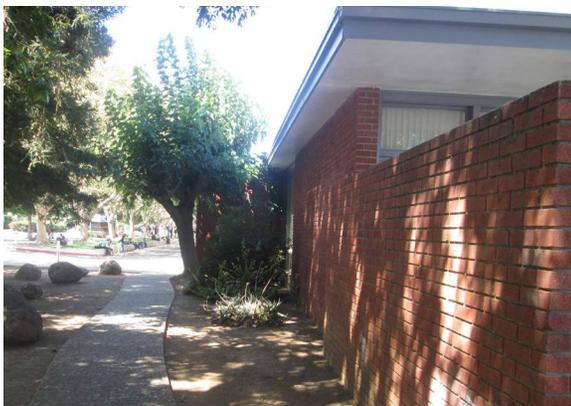
No wayfinding signage

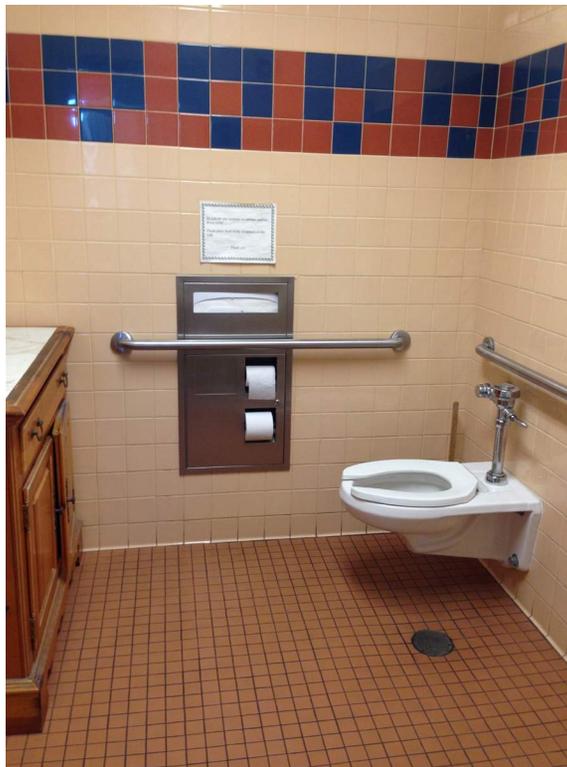
Storage in Restroom

- Repair existing sewer line at west of Admin to eliminate or by pass 90 degree bend.
- Substantial path of travel improvements are required due to excessive cross slope. All walkways for wing 100 will eventually need to be replaced.
- Remove furniture used as storage in restrooms.

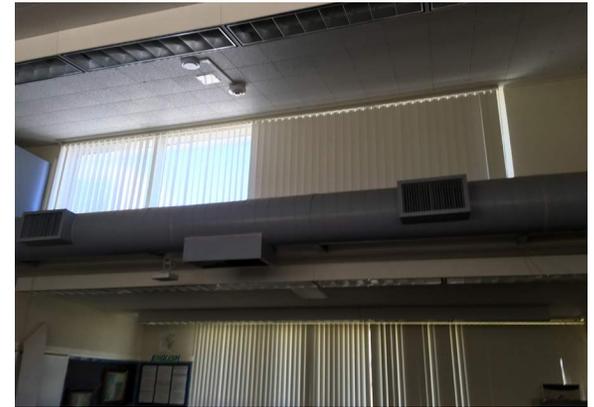
Room 201 with vertical blinds

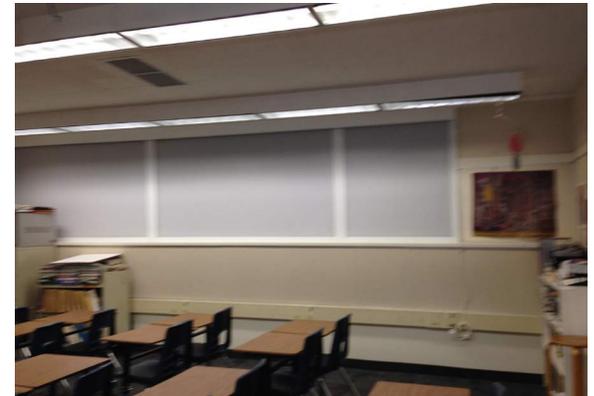
Room 301 Mechanized black out shades

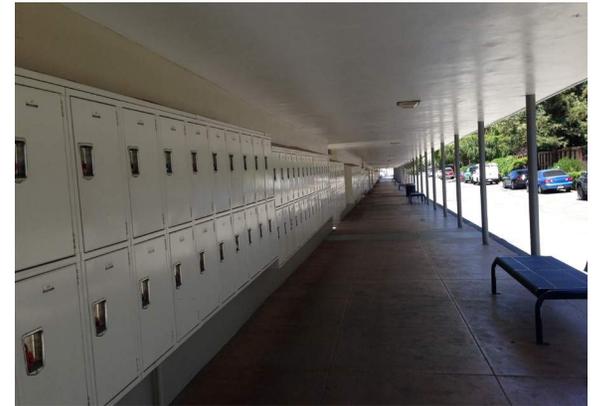
Stepped lockers along walkway

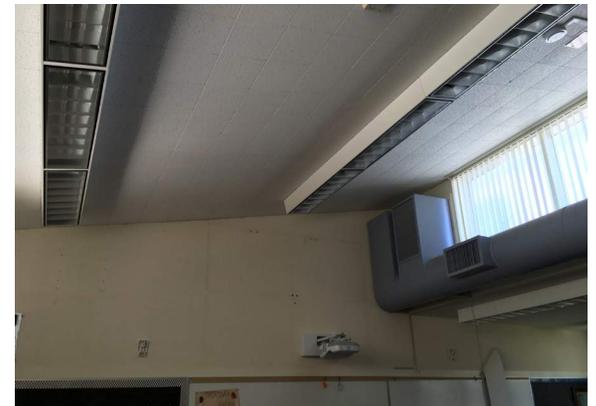
Damaged areas requiring repair

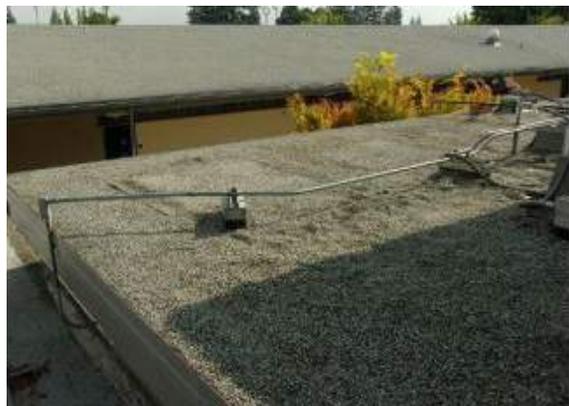
Roof at 300 - Replace

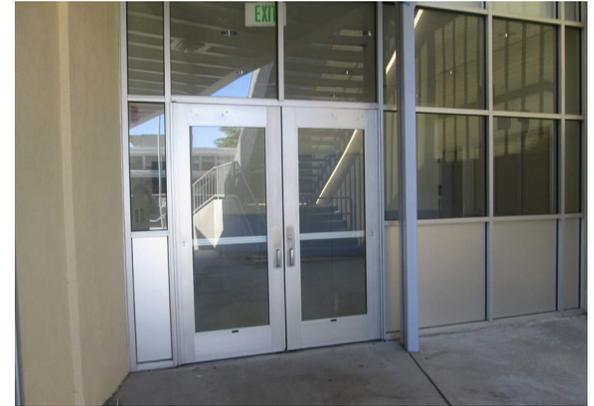
Building identification and ISA should be provided.

- Replace both exterior stairs with new concrete treads and traffic coating.
- Reconfigure circular stair to remove unsupervised-able areas.
- Provide supplementary signage program as required.

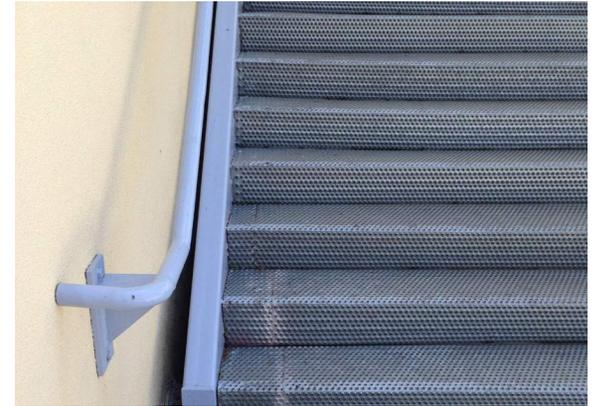
Exterior Metal Stairs

- Exterior metal stairs material is a hazard to the students.
- At circular stairs, odd and unsupervised voids have been created.
