MVLA

v1.0
DRAFT
September 2016

FACILITIES ASSESSMENT

Mountain View Los Altos Union High School District

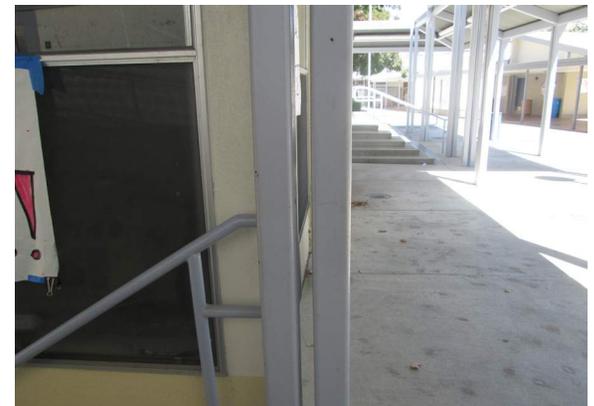
- Pedestrian Access: There are multiple entry points. An elevator is provided. Civil identified the exterior doorways at first floor west side as having sloped in excess of 2%.
- Signage is in substantial accordance with code requirements. Additional ISA signage, building entry signage, and directional signage to the elevator / 2nd story access is required.
- There are locations where the location of exterior covered walkway columns were not properly coordinated with exterior stairs which creates conflicts.

Railing and Column Conflict

- Address accessibility conflicts at columns - revise stairs as required.

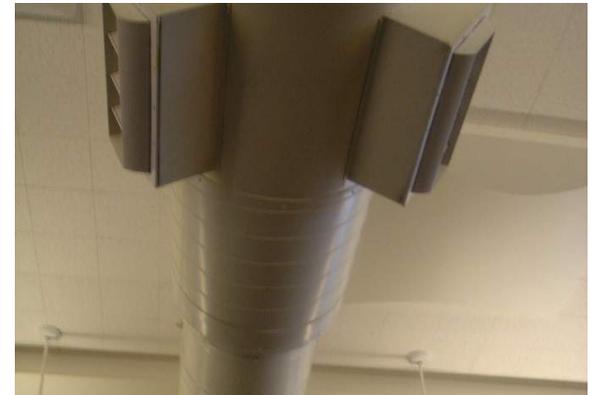
Exposed ductwork

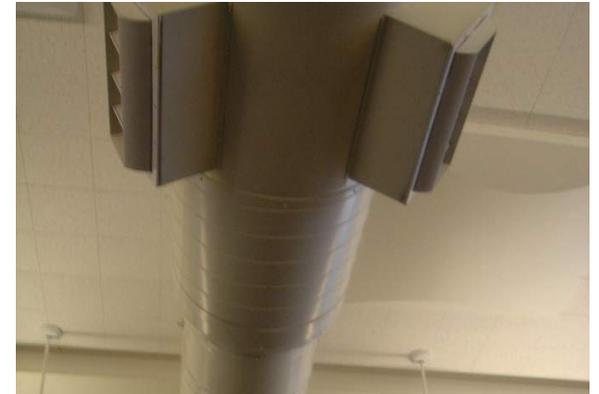
Exposed ductwork

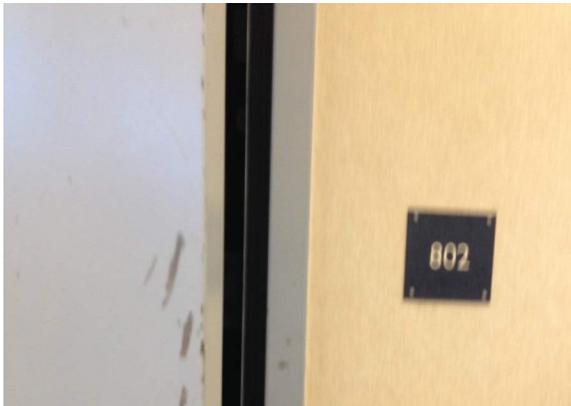
Wear and tear

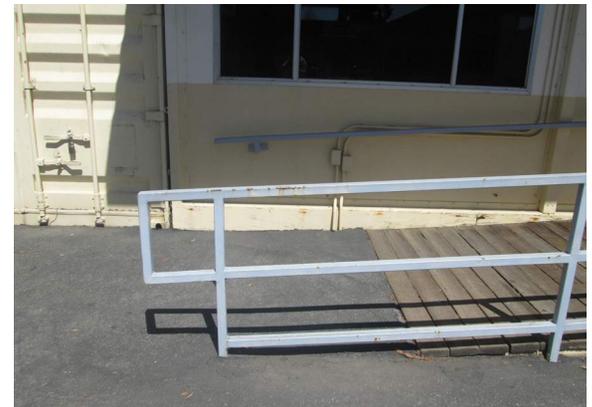
- Pedestrian Access: entrances are located on the exterior facade with ramps that are not in compliance with ADA requirements for path of travel. Ramps are rusted. Handrails are compromised by conduit locations.
- Asphalt pathways have cross slopes in excess of 2%.
- Signage is not provided in accordance with CBC chapter 11B requirements.

Non-complying ramp

- Storage containers have been placed immediately adjacent to portable classrooms. These must be 20 feet away.
- Clean roofs, repair areas showing damage.
- Substantial improvements required for ADA components including ramps and signage.

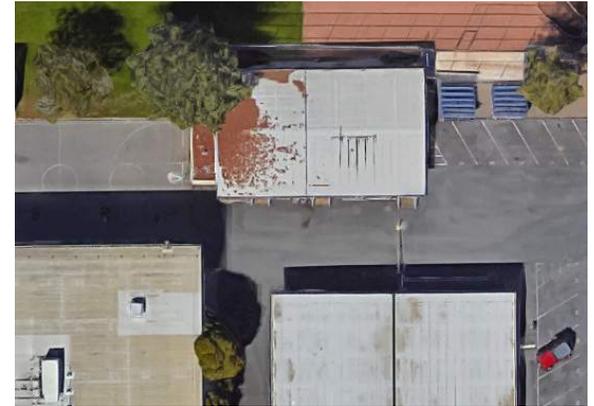
Container location

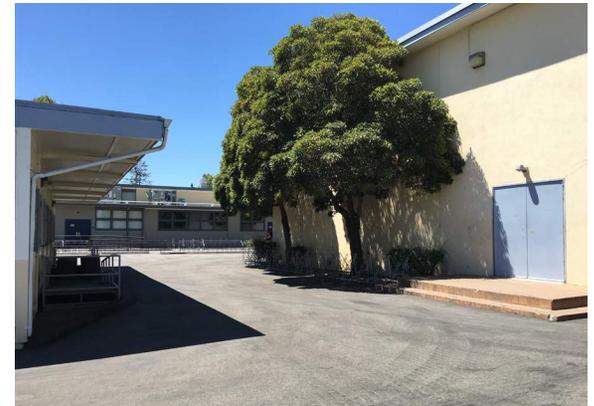
Asphalt paving path adjacent to practice gym

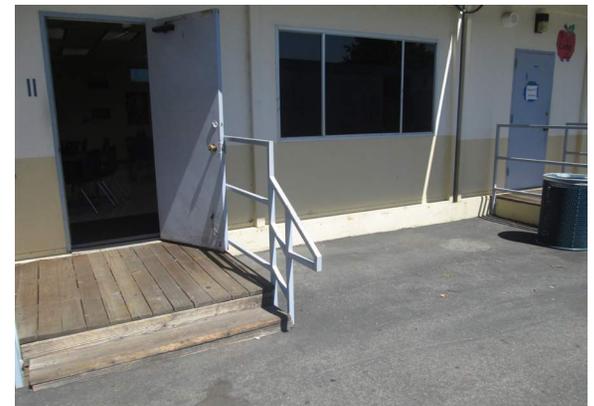
Ramps and Stairs in poor condition

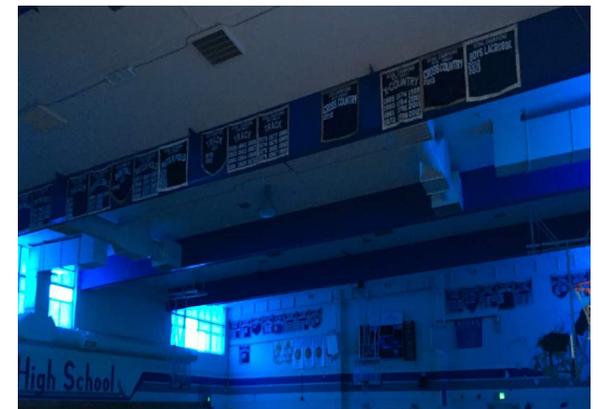
Interior Windows

- After adjacent construction is complete, verify condition of existing walkway as required to meet path of travel requirements for cross slope and threshold heights.
- Replace windows with thermally broken diffuse glazing to increase efficiency and allow daylighting.
- An updated and comprehensive signage plan is needed. Exterior tactile signage and ISA (International Symbol of Accessibility) to be provided.

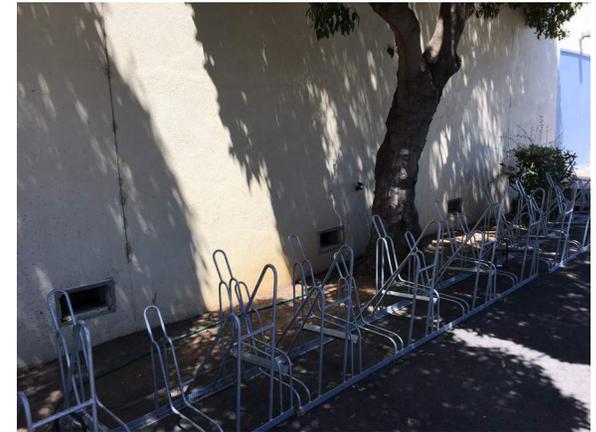
- Roof: roof is in poor condition.
- Exterior Cladding: building exterior is cement plaster and is in poor condition. The cement plaster is continuous down to the dirt. Areas of cracking, staining and water damage are evident.
- Doors: doors are in fair condition.
- Windows: windows are single glazed in poor condition.

Exterior walls

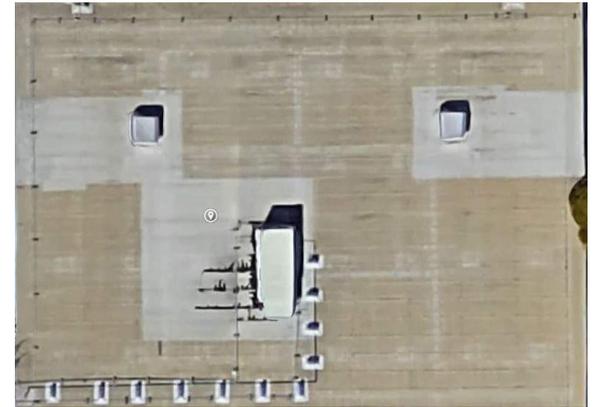
Roof of Small Gym

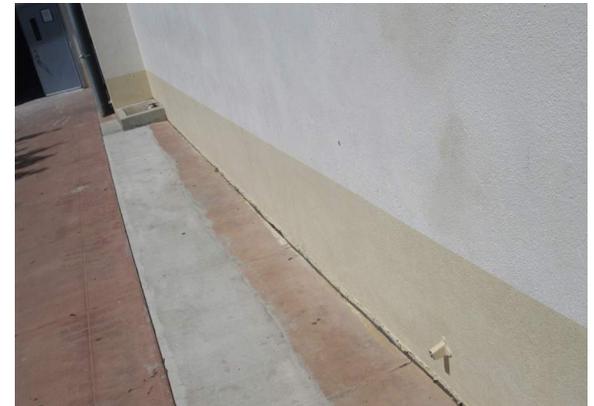
- Pedestrian Access: Exterior walkways show subsidence. Door thresholds at the main entrance have excessive slope. The second exit has a landing and step, which is allowed in existing buildings. The number of exits meets the code requirements (145 occupants @ 50 SF/ Occupant)
- Signage is in not accordance with code requirements.

Adjacent subsidence evident

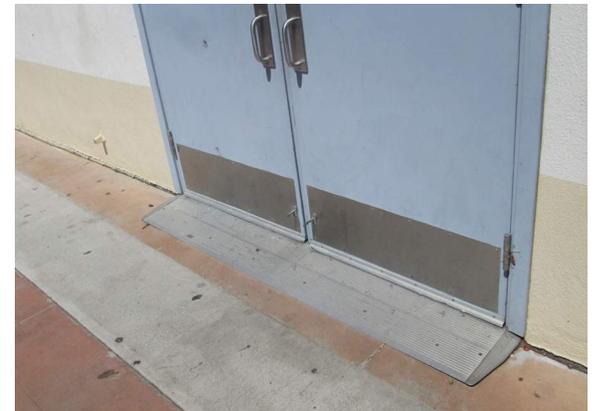
Entry slab subsidence

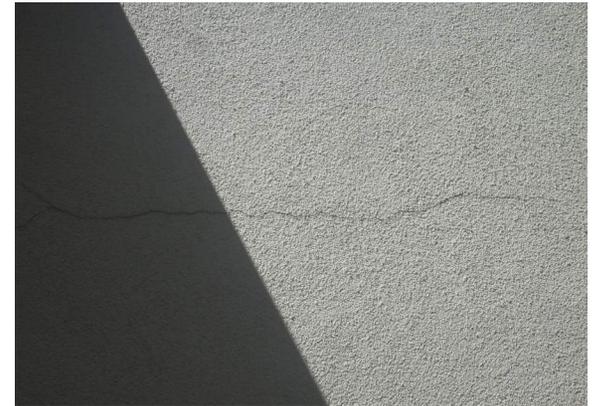
Minor plaster cracks

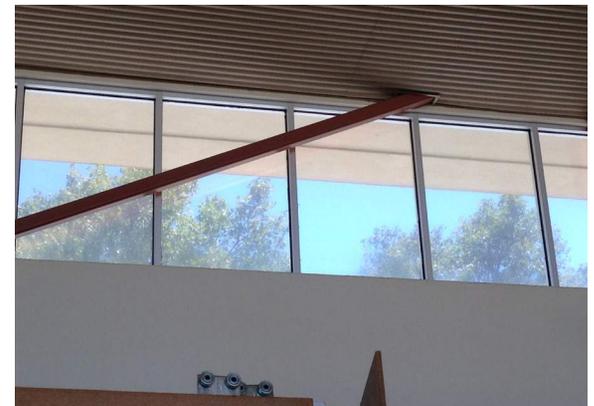
Clerestory windows

- Regular maintenance cycle for exterior finishes.
- Replace HVAC units with units of greater efficiency.
- Re-glazing of upper clerestory windows.

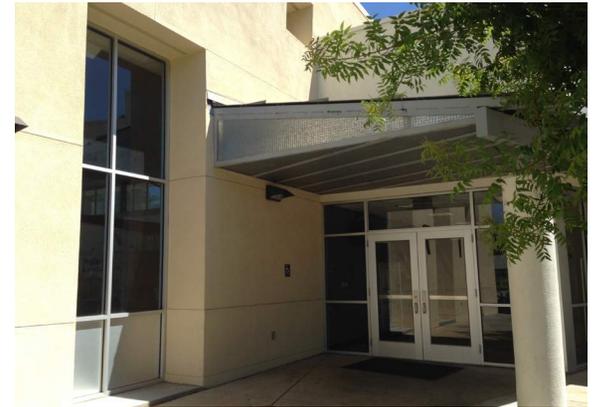
Exterior Entry Room identification and ISA required

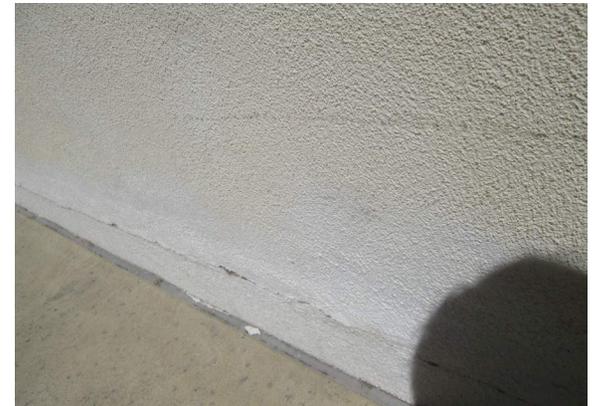
Damaged plaster at grade

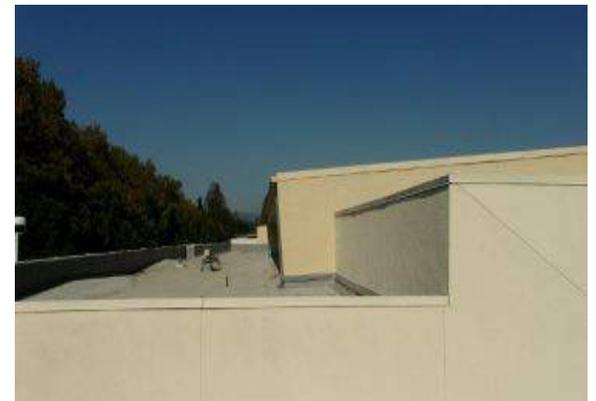
Library roof

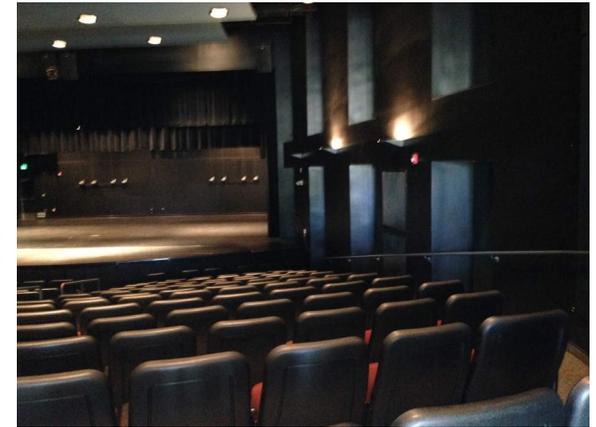
Theater Interior

The interior of the theater is in good condition, although some wear and tear on the stage risers was observed.

At the time of construction, the limited location for wheelchair seating was permissible, as was the dependence on back stage access for wheel chair access. Updated ADA requirements for dispersed seating and circulation pathways may be enforced in future upgrades.

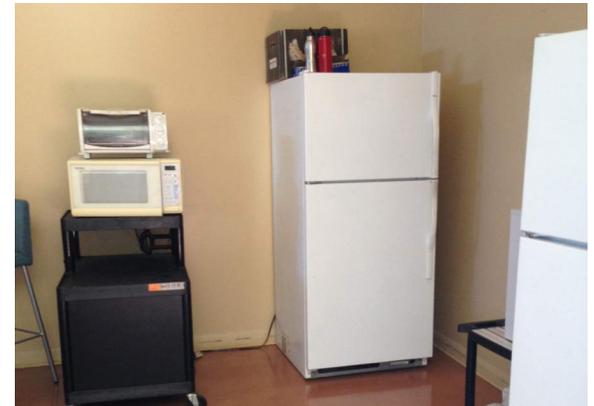
The faculty kitchenette area is inadequate.

Current Staff "kitchenette"

- The existing student dining capacity is 137. If the student population grows, an additional area is recommended. Exterior dining areas can be developed with shade structures as well.
- Provide shade at the exterior faculty dining patio with large shade structure.
- Provide a dedicated kitchenette for faculty dining.
- Replace HVAC units with units of greater efficiency.

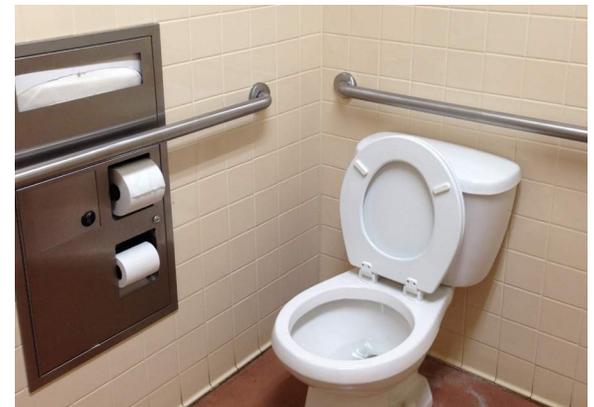
Staff WC lever handle on wrong side

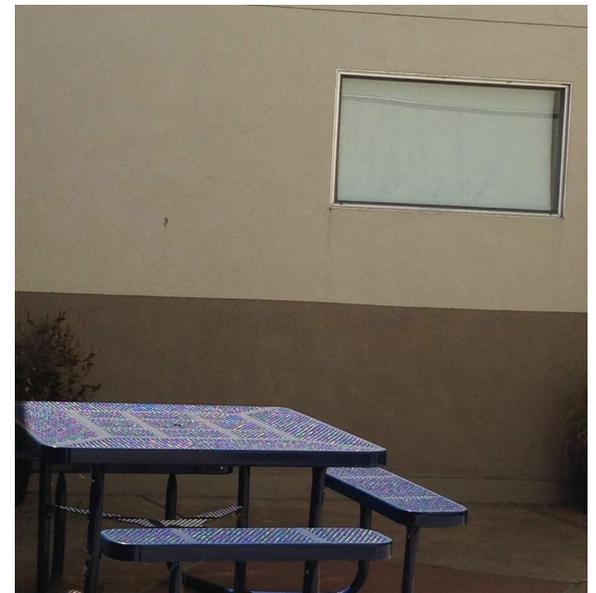
Faculty dining patio

- Roof: roof is in good condition for its age. Minor discoloration from dirt on the light metal roof.
- Exterior Cladding: building exterior is cement plaster and appears to be well-maintained and is in good condition for the age of building. There are minor cracks in the plaster.
- Doors: doors are in good condition for the age of construction.
- Windows: windows are double glazed store front /curtain walls in good condition.
- A sliding glass door at the student dining opens to the exterior, and is in good condition.
- Exterior faculty dining patio is fully exposed to the sun.

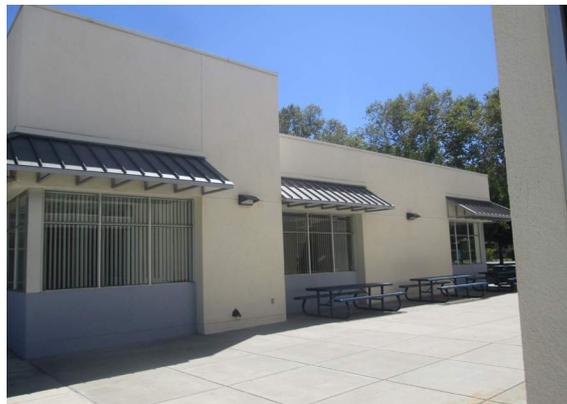
Lack of exterior shading

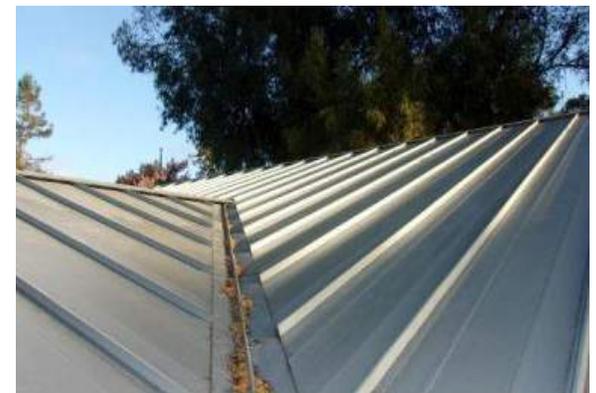
- Roof: metal standing seam roof is in fair condition for its age. Tree debris noted in face mounted gutter system. Gutter seams show signs of leakage.
- Exterior Cladding: building exterior is cement plaster and appears to be well-maintained and is in good condition for the age of building. At the time of evaluation, there was no evidence of moisture or insect intrusion.
- Windows: windows are single glazed vertical sliding units and appear to be in fair condition. Windows appeared operable with no signs of leaks at the time of evaluation.
- Doors: doors are in good condition for the age of construction. Hardware is code compliant.

- Roof maintenance program including debris removal and tree trimming is recommended. Repair all gutter leaks.
- Building M- repair parapet cap.
- Anchor all storage cabinets and shelving units. Remove and relocate unsecured items at top of tall cabinets.
- Replace exterior lighting fixtures.
- Provide compliant ADA signage at parking lot.
- Verify ADA wheelchair space at exterior drinking fountain.

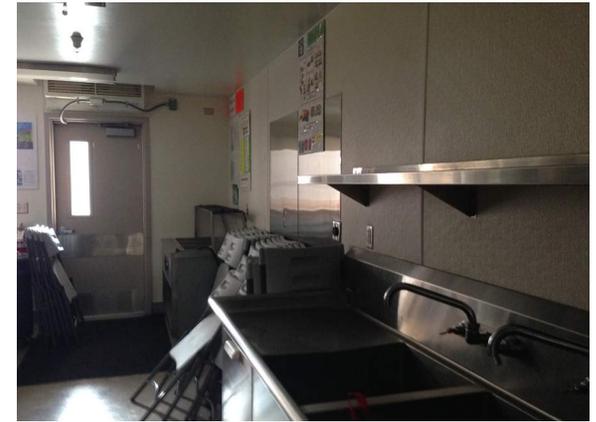
The Kitchen has minor damaged areas where it appears equipment has been relocated.

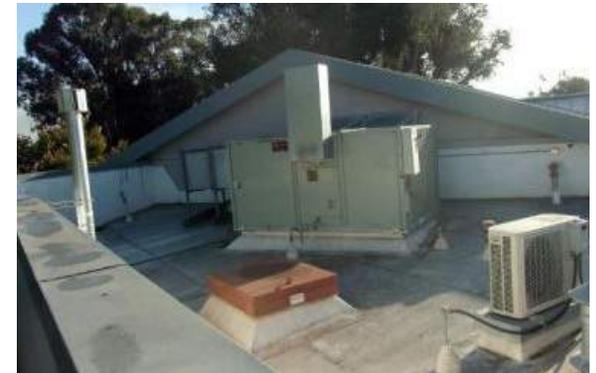
MPR HVAC

- All mechanical units are original to the date of construction, are in good condition. An additional 5-7 years of service is appropriate before replacement.
- Building A Administration – Fan coil in attic, ground mounted condensers, ducted delivery and return air
- Classrooms, Typical – Bard units with integral return air, ducted delivery,
- Multi Purpose – Roof Mounted Fan coil and condensers, ducted supply.

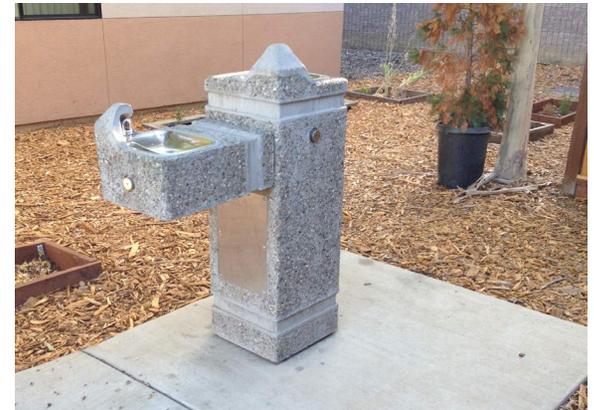
Drinking fountain wheelchair space clearances

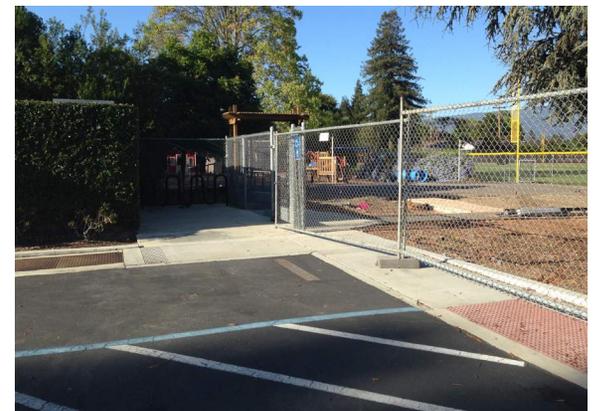
Parking: Non-compliant or missing ADA signage.

ADA parking signage required

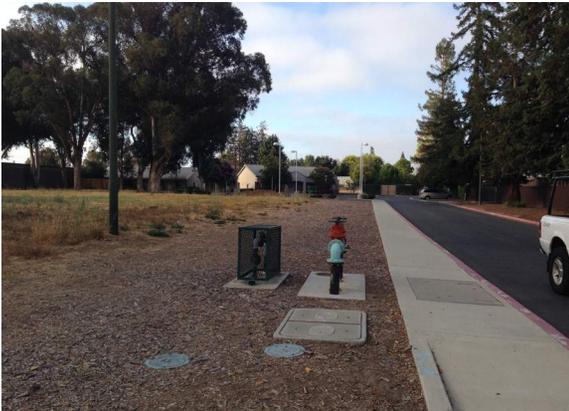
Entry walkway excessive cross slope

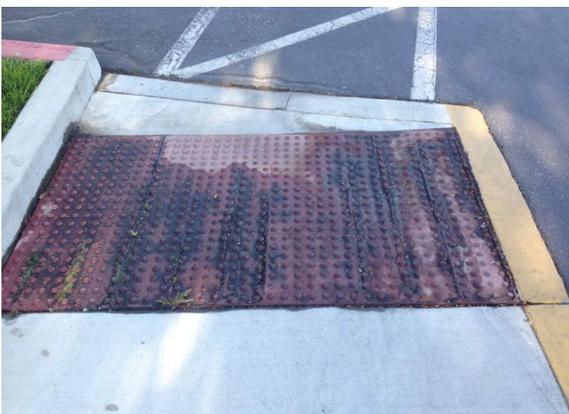
Ponding at walkway

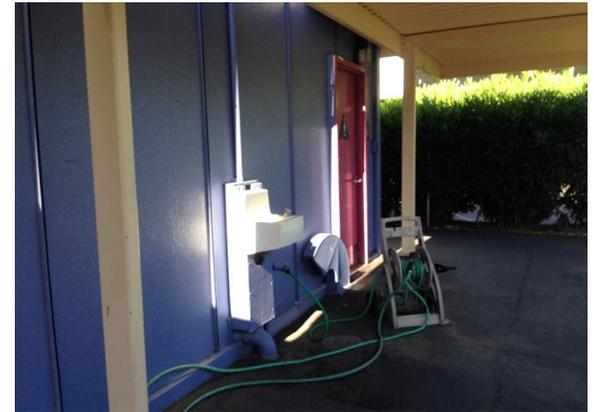
- Pedestrian access: Many of the exterior doors have asphalt landings that are excessively steep.
- Buildings 4 and 5 have wood decks with non compliant handrails. Building 5 has accessible exits, signed.
- Signage: a complete signage program for room identification and way finding is required.
- Restrooms: water closets do not meet ADA requirements. Location of paper towel dispenser in Restroom does not allow for proper ADA clearance.

Drinking fountain

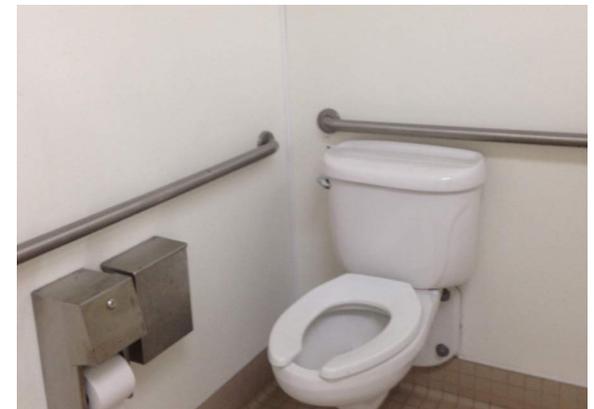
Water closet flush handle on wrong side

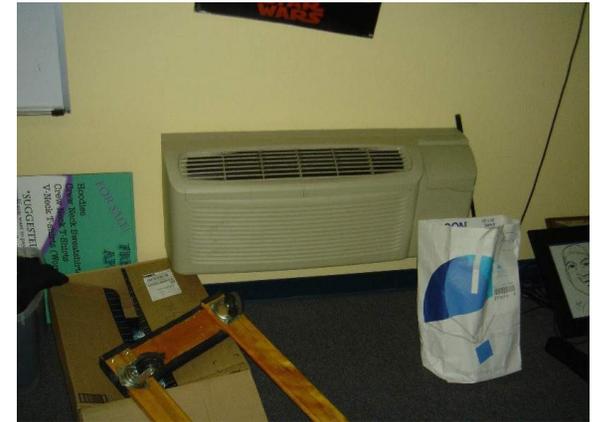
- Buildings are served by through the wall PTAC, (packaged terminal a/c) heat pumps, ductless mini splits and Bard heat pumps. Little can be done to improve these units except for replacement in kind.
- Air conditioning condensers for Room 1 are located on grade.

Wall PTAC - Interior

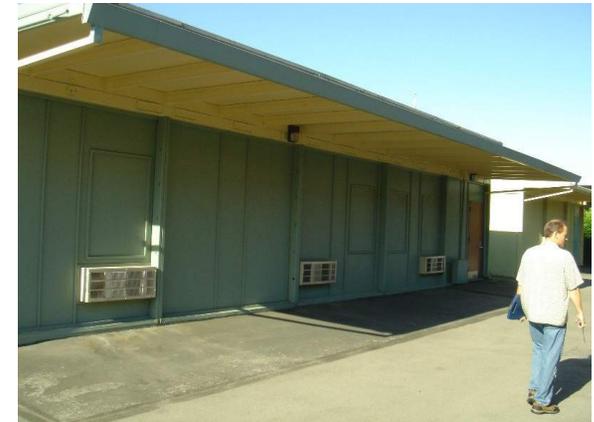
Wall PTAC - Exterior

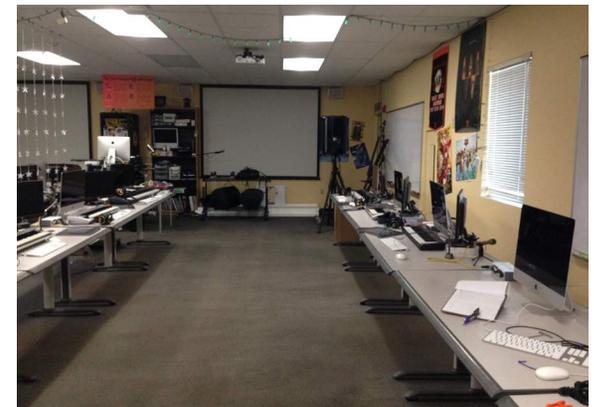
- The campus is fed from the adjacent District office building. Connections are in fair condition.
- Interior classroom lighting with fluorescent T8 lamps is in generally good condition. Interior lighting controls are switches, no occupancy sensor systems.
- Exterior lighting are wall mounted, yellowed in fair to poor condition.
- Data fiber infrastructure at the campus is older single mode. Individual station cables are Category 5e in fair condition.
- Clock speaker / AV systems are in good condition.
- Fire Alarm is in good condition, with full smoke detector coverage and horn /strobe devices in the classrooms as well as manual pull stations.

Classroom Lighting

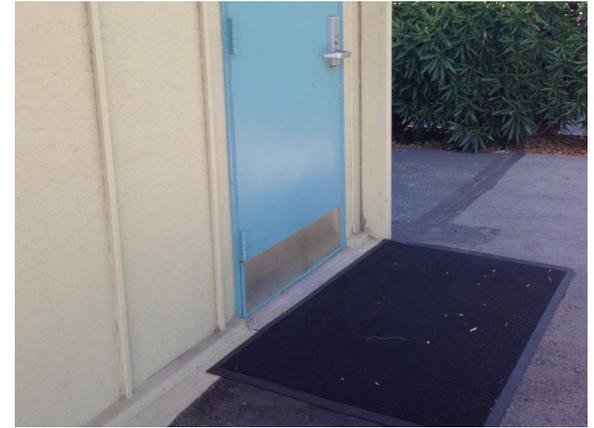
Non accessible door landing

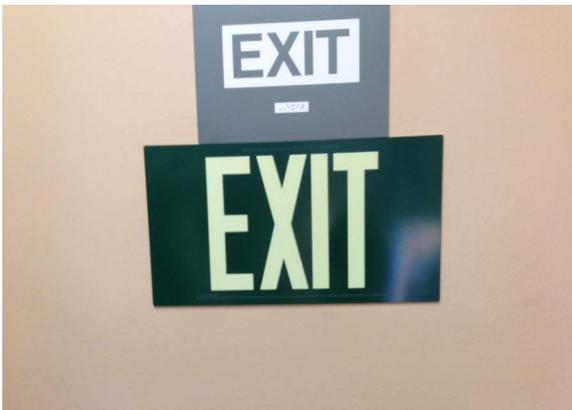
- Finishes: floor is in fair condition with areas that may require patching/replacement. The wall and ceiling finishes appear to be in good condition.
- Interior doors:
- Cabinets and furnishings: most of the classrooms use furniture instead of built-in cabinets. Classrooms appeared cluttered at the time of evaluation. This could be due to insufficient amounts of storage areas or lack of organization.
- Equipment: Styrofoam baffles in Audio Studio should be verified as meeting FLS requirements.
- Window Coverings: horizontal mini blinds at windows are functional, with a few damaged units.
- The large classroom is oversized. It requires two exits with panic hardware and powered exit signs.

Classroom exit signs at Building 5

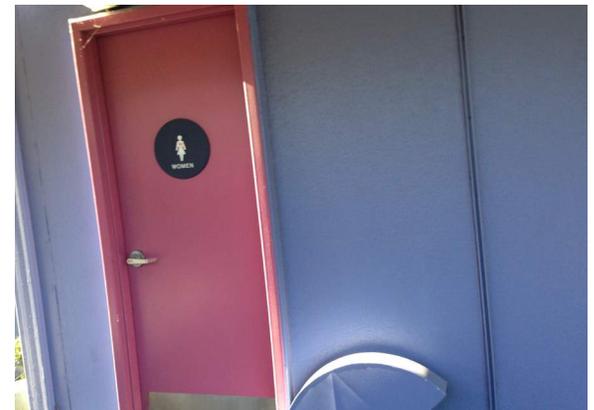
Restroom signage lacking

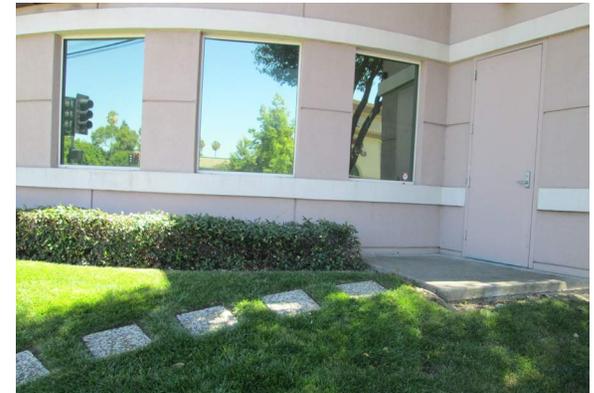
Inaccessible egress along Moffett Boulevard

- Pedestrian Access: sidewalks are provided around the perimeter of the building, but multiple areas of excessive slopes create non-compliant ADA access to the building. The main entrances were architecturally defined by column and projected building elements. The main entrance off of the parking lot felt constricted and unwelcoming. Refer to Civil/Site Assessment & Recommendations Report Appendix C for specific site deficiencies adjacent to this building.

4. East Sidewalk along Parking Lot: remove and replace concrete walkway with code compliant accessible walkway.
 5. Handicap Parking: remove and reconstruct to provide code compliant slopes on parking and loading area. Provide ADA signage and striping of parking, loading and accessible path to the ramp. Consider relocation of ADA parking and combining with other site ADA parking.

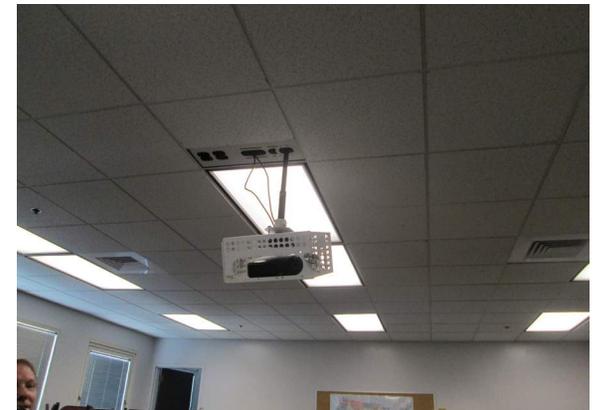
- Specialty Equipment: ceiling mounted projectors did not appear to be properly anchored.

Older style projector mounted at ceiling

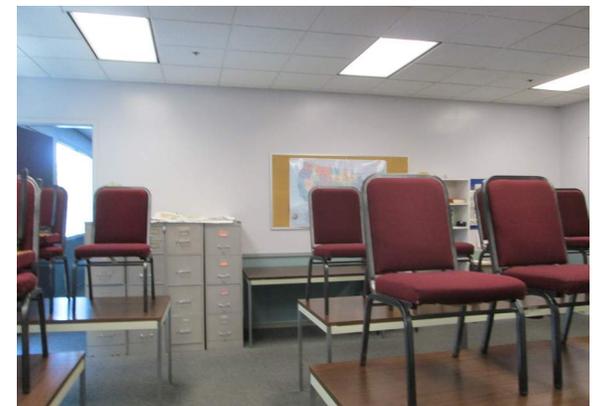
- Interior doors: classroom doors are in good condition for the age of construction.
- Cabinetry and Furnishings: built-in cabinets and countertops at the Administration Office and Staff Lounge are in good condition for the age of construction. Built-in casework is limited at classrooms. Freestanding cabinets and shelves are used instead. These items are not properly anchored to the walls.

Classroom cabinets not secured to walls

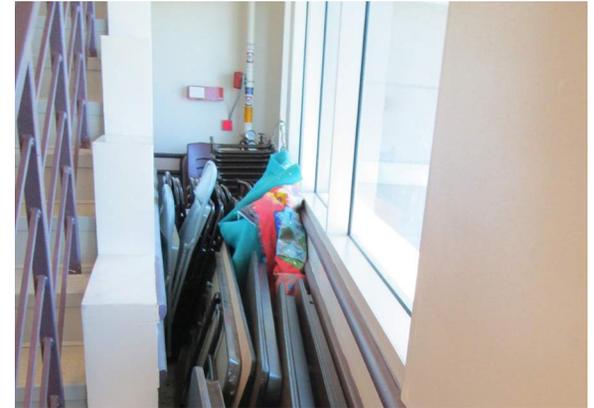
Tables and chairs were being stored in the Dining Room between the stair and exterior wall. This potentially suggests inadequate storage space.

Stored items between stairs and window

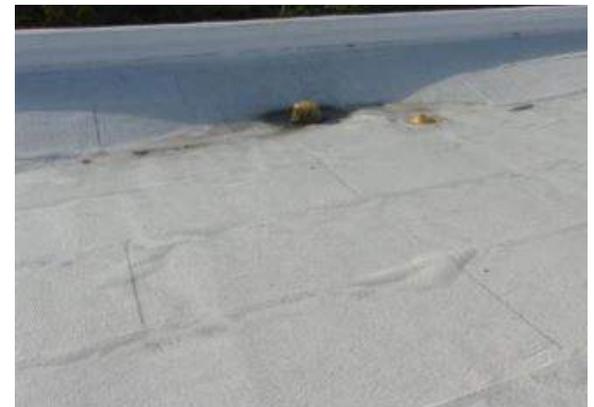
- Roof: overall is in good condition. Small cap blisters were noted. Minor ponding and debris were present at the time of evaluation. Noted, improper mounting of satellite dish, lack of crowning at pitch pockets and missing gas line support at elbows. No visible leaks were detected at the time of evaluation. Refer to Appendix D for full Roof Inspection Report

Blistering and minor ponding present at the roof

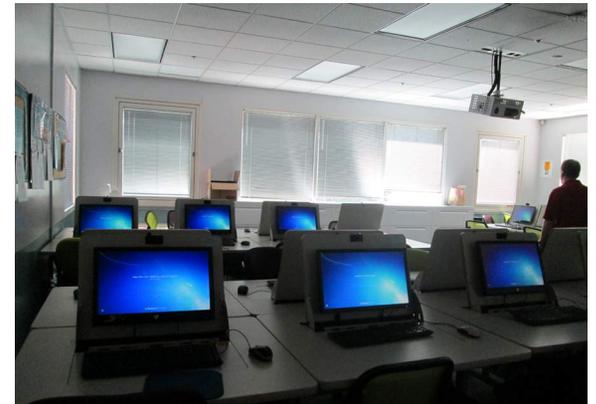
- Window Coverings: horizontal blinds are operational with minor wear. Excessive glare was noted at classrooms with south-facing openings. These type of blinds provide limited control of glare and natural daylighting. No window coverings were provided at the Lounge.

Computer Classroom with south-facing window openings

- Replace carpeting in areas where excessive wear and tear is evident.
- For better control of classroom daylighting and glare, it is recommended to replace the existing horizontal blinds with visually-transparent rolling shades (Mechoshade) and room-darkening shades, if needed.
- Remove or relocate light fixture at Dining Room where reachable from 2nd level balcony.

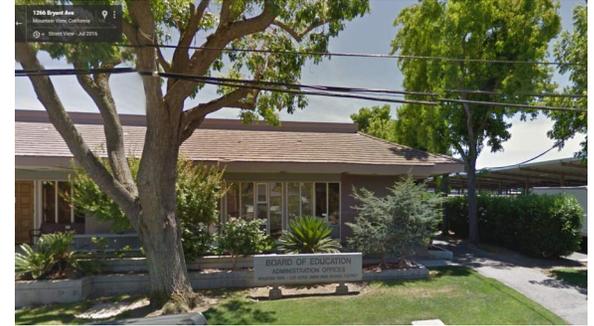
Street Facade

- Pedestrian Access: A single accessible ramp is at the street frontage. Front entry stairs handrails non-compliant with current code.
- Some of the secondary side stairs do not have handrails. These are not required to be accessible but any stair must have railings.
- Secondary exit doors have non-compliant thresholds. These are not required to be accessible.
- Ramp at Portable P- slope in excess of 2%.

- Synthetic shake roof complete replacement with new sheathing and roof materials.
- Clean and repair built up roof areas.
- ADA improvements at entry. Railings at side stairs.
- Portable 1: replacement of ramp will be required if building is to remain in service.
- Regrade / repair asphalt paving to reduce ponding.

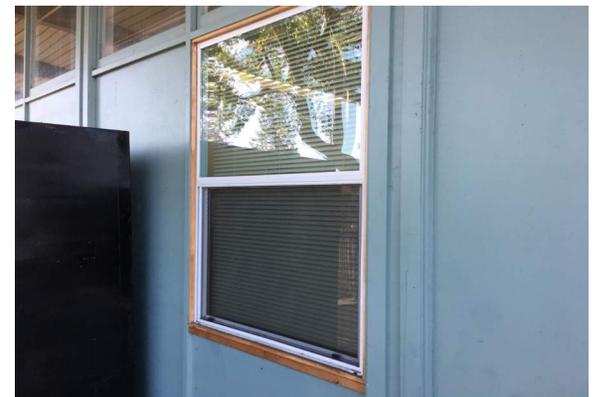
- Roof: built-up roof is in good condition.
- Exterior Cladding: building is clad with painted wood siding and appears to be well-maintained and is in fair condition for the age of building. At the time of evaluation, areas of dry rot were noted at overhangs and siding.
- Doors: doors are in fair condition for building type/use and the age of construction. Noted areas of deterioration or dry rot.
- Windows: windows appear to be in fair condition for their age.

Window repair- untreated wood

- MDF / Data room install code-required emergency power off feature.
- Insulate condensate drain at MDF room.
- Repair dry rot areas to prevent further

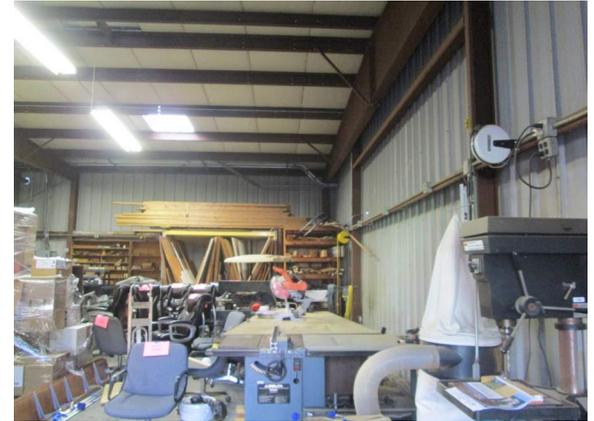
Warehouse interior

- Shop areas of building are heated by gas fired unit heaters of original vintage and are in poor condition.
- MDF/ Data Room outfitted with dedicated cooling with horizontal split systems in good condition. Fan coil condensate drain pipe needs to be insulated to prevent condensation and dripping.
- IT department is conditioned by rooftop gas fired packaged a/c units and vertical gas fired furnaces with exposed ductwork throughout. The roof equipment was not inspected, however looking at the age and vintage of the furnace unit, it is likely in need of replacement.

- Replacement of Shop unit heaters.
- Replacement of IT roof top unit.

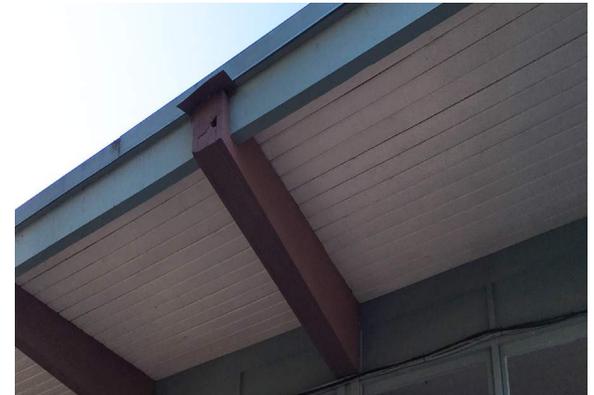
Deterioration at overhangs
